DATA SUMMARY

Registration	EC-IJO
Type and model	BEECHCRAFT 1900-D
Operator	NAYSA. Navegación y Servicios Aéreos Canarios

Type and model	PT6A-67D
Number	2

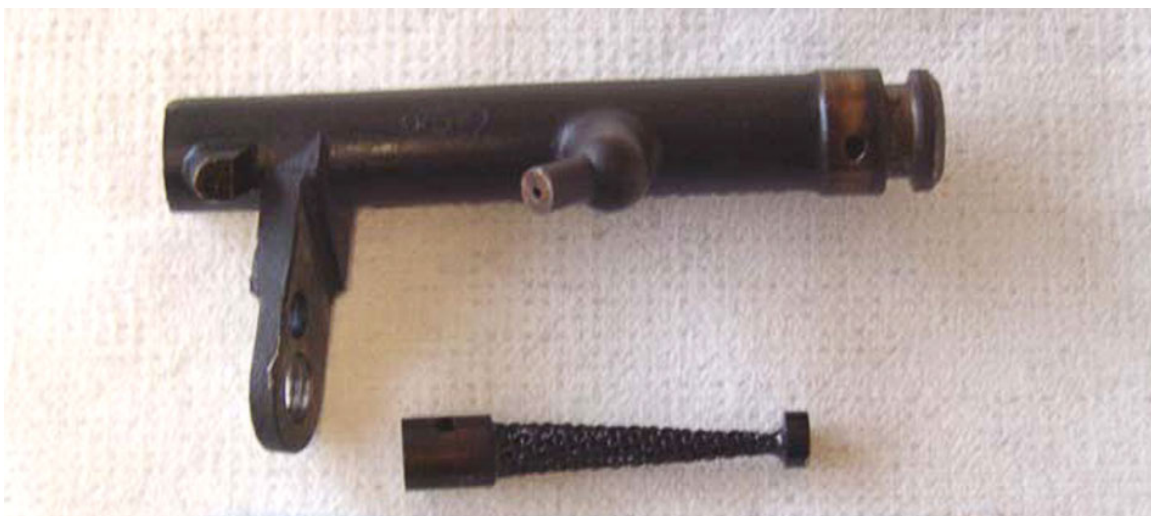
Figure 5. No. 2 bearing oil nozzle and oil nozzlestrainer

The no. 2 bearing oil nozzle strainer was not clogged. There was a small amount of burned oil in the no. 2 bearing housing. The main oil pump, the scavenge pumps and the accessory gear box were partially seized. Metal particles were found in the main oil tank and in the accessory gear box.

The carbon build-up that was noted in the oil nozzle for the no. 2 bearing indicates that rather than a build-up of particles, it was the remains of a layer that was growing inside the nozzle. The experience of Pratt & Whitney indicates that this was not a typical case of residue accumulation. The gradual formation of this layer resulted in a lack of lubrication to the no. 2 bearing, and possibly in the damage that was seen in this bearing.

- The no. 2 bearing was not being properly lubricated because the oil nozzle for said bearing was partially clogged.
- The crew identified the engine failure and secured the engine.

The most likely cause of the engine failure was the lack of lubrication to the no. 2 bearing caused by a partially clogged oil nozzle. The high temperatures reached in the area of the no. 2 bearing could have resulted in the formation of carbon deposits that led to the obstruction.

The first, no. 14346, states that oil leaks can occur because the no. 2 bearing oil nozzle strainer is held in place by a retaining pin that oil can leak through the retaining pin hole. The bulletin suggests replacing the pin with a ring to hold the strainer in place. This Service Bulletin was modified in February 2009 to change its category from 8 to 6, i.e., of application when the sub-assembly is disassembled and access is available to necessary part. Afterwards, it was modified in May 2011 to clarify new oil nozzle was provided with an increased oil flow.
