DATA SUMMARY

Date and time	Sunday, 11 March 2007; 08:30 h UTC
Site	Cuatro Vientos Airport (Madrid)

Registration	EC-EZY
Type and model	PIPER PA-28RT 201T
Operator	Aeromadrid

REPORT

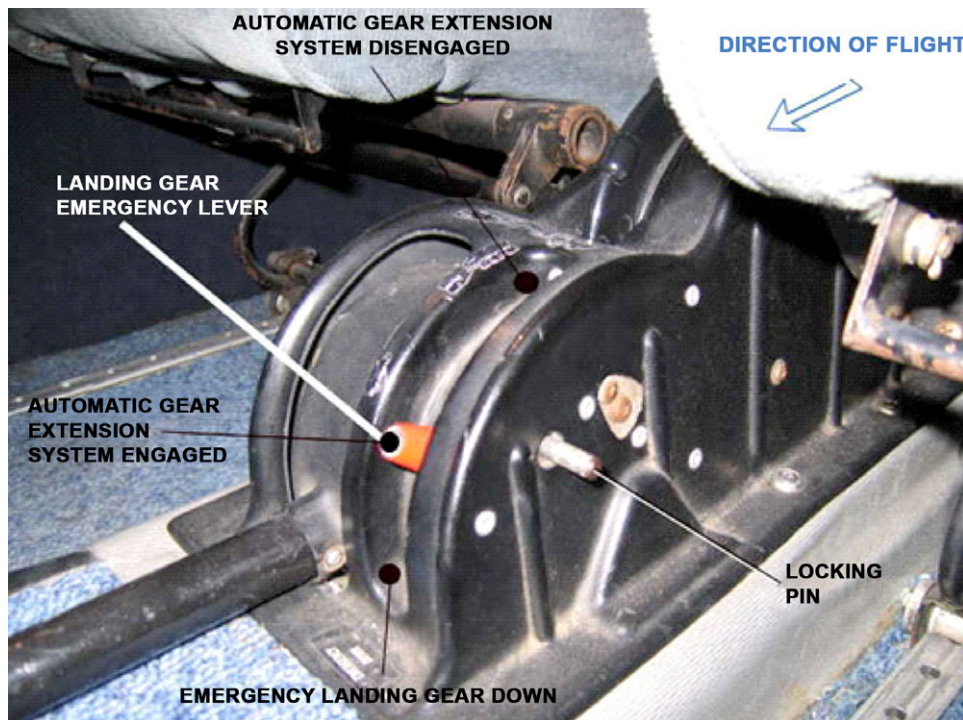
Figure 1. Back-up gear lever

There is a back-up lever for the landing gear between the pilots' seats that regulates the operation of the automatic landing gear extension system. This lever has three positions:

The gear failed to lower despite repeated attempts by the student-pilot. Emergency lowering the gear was possible, as confirmed later during the hangar test. It may be concluded, then, that the student probably did not execute the procedure properly in terms of pulling the back-up gear lever upward in order to release the locking pin. Of note is the fact that the existence of a locking pin, or of the procedure for releasing it, is not mentioned in the emergency procedures or checklists.

No mechanical reasons were found that would have precluded the emergency lowering of the gear. The inability to lower the gear was possibly due to the improper execution of the emergency gear extension procedure.

As a consequence, a reference to the locking pin should be included in Section 3 of the aircraft flight manual so that its function is not overlooked, which would make lowering the gear difficult or impossible. A safety recommendation is thus issued to the Federal Aviation Administration (FAA) to modify said manual.

REC 09/11. It is recommended that the Federal Aviation Administration (FAA) modify the aircraft's flight manual to include in the emergency procedures pages 3.7, 3.8, 3.12 and 3.16 of the PA-28RT-201T Flight Manual on the gravity extension of the gear, and to reference the locking pin that is described in Section 7 of the manual, page 7.7.

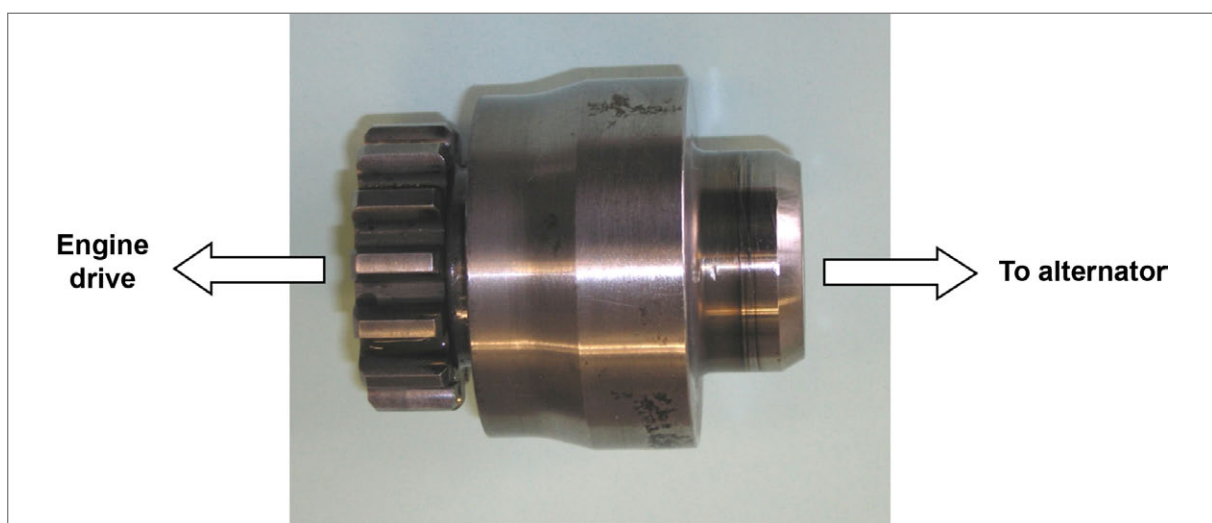
Figure 2. Engine-alternator coupling

The alternator is coupled to the engine via P/N 635796, which consists of a gear attached to a slip clutch that is joined to the alternator axle. The elastomer of which the clutch is made allows the alternator axle to slip if the alternator seizes or when the drag on it is excessive, thus protecting the engine from more serious damage.

- **Alternator.** The brushes showed normal wear and were properly insulated. The alternator produced electricity when it was installed and rotated directly on a test bench. However, when the coupling piece was subjected to the slippage tests described by the manufacturer in SB 95-3B, it was noted that the clutch slipped before a torque value of 20 inch-pounds was reached. A visual inspection revealed that the clutch was greased. Removing the grease and drying the oil with rags yielded slippage torques of 40 inch-pounds, still far from the 100 inch-pound value required to pass the test.

This coupling piece, the slip clutch, failed by allowing excessive slippage, which kept the alternator from turning and thus producing electricity to recharge the battery to adequate levels.

The accident stemmed from the simple, internal fault of a clutch in the piece that couples the engine to the alternator axle. This fault prevented the alternator from generating current to supply airplane loads and charge the battery. The reason for the slippage in the coupling could not be determined, though the increased friction present after cleaning the oil that saturated the component is indicative of an improperly greased gear or of a failed seal.
