Report A-041/2007

Accident involving a
CENTRAIR 101 PEGASE A
aircraft, registration F-CHLH,
in Collado del Río Foratón,
within the municipal limits
of Hecho (Huesca), on 6
September 2007

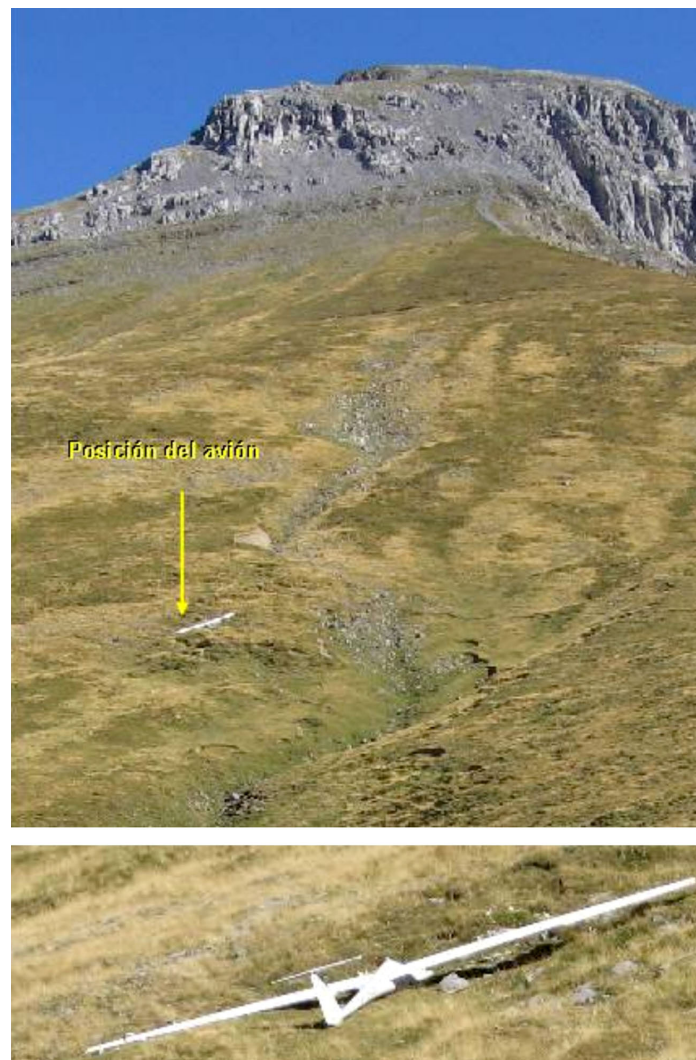
Figure 1. Accident site and view of airplane

The debris field was very compact. The plastic cockpit canopy was found underneath the left wing, near the tip.

The aircraft was damaged considerably. The most affected part was the front area, especially the cockpit, which was completely destroyed. The wings and fuselage showed minor damage. The latter had an opening along its top part, the right wing lower surface had been fractured by an impact with a rock, and there was a fold in the middle of the left wing's leading edge. The tail cone assembly was undamaged.

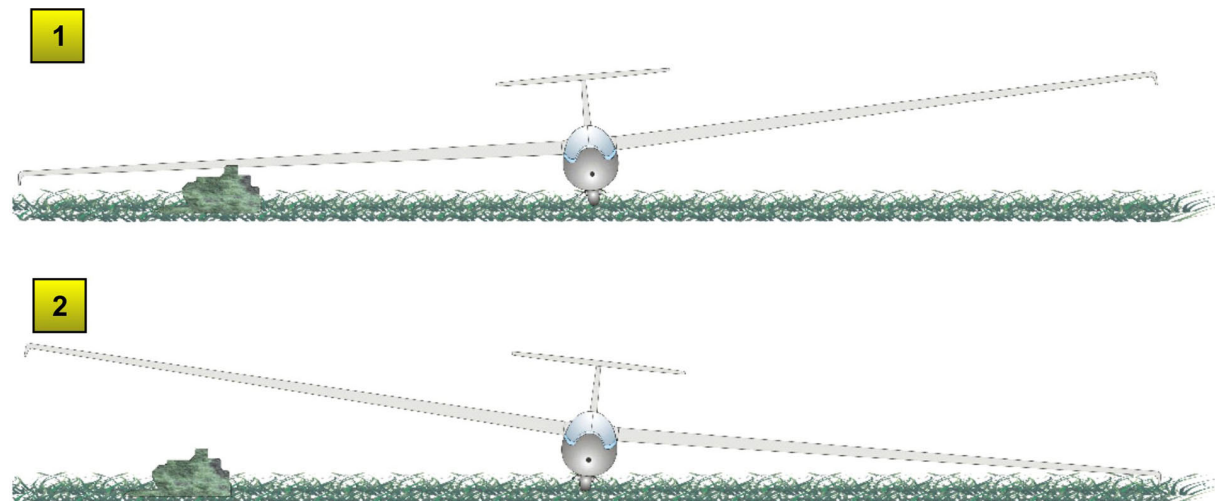
There were no visible drag marks at the impact site. The aircraft initially impacted the ground with its front part while turning left. Almost simultaneously the right lower wing surface struck a rock (see sketch, Figure 4). The left wingtip was next to hit, at which point the aircraft turned approximately 30° to the left, ending up with its longitudinal axis facing north. The part housing the cockpit, however, was slightly turned to the

Figure 4. Head-on view of the impact

northeast (toward the summit). There was a distance of 2.5 m between the initial impact point with the ground and the aircraft's final resting place.

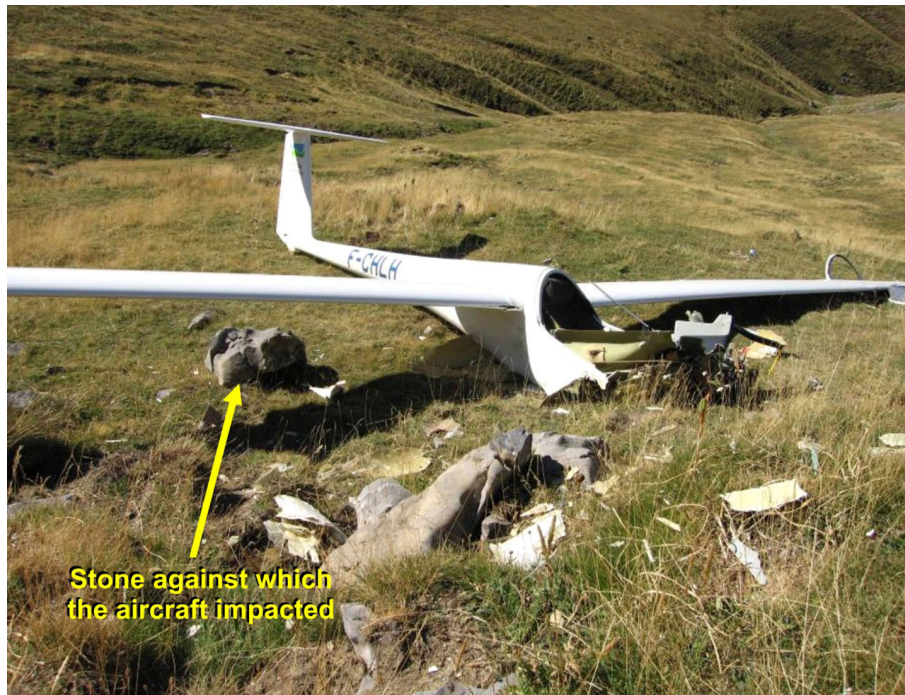
The entire front part of the aircraft, including the cockpit, was destroyed. The pilot compartment was warped.

The right wing had an impact mark on its lower side one-third of the way to the wingtip caused by hitting a rock, which resulted in the loss of material from the surface but without perforating it. There was also a tear in the leading edge near the root.

The left wing had an impact mark in the leading edge near the middle, which caused a buckle and a considerable scratch that extended backward along the upper surface. In close proximity, and nearer the tip, the aileron also exhibited a gash along the trailing edge and parallel to the chord. The trailing edge of the wing tip was slightly dented.

Figure 5. Condition of the aircraft

In the center top part of the fuselage, level with the trailing edge of the wings, a mark was found parallel to the longitudinal axis of the aircraft, the rear part of which extended transversally toward the left side of the fuselage along its perimeter, creating a small fold.

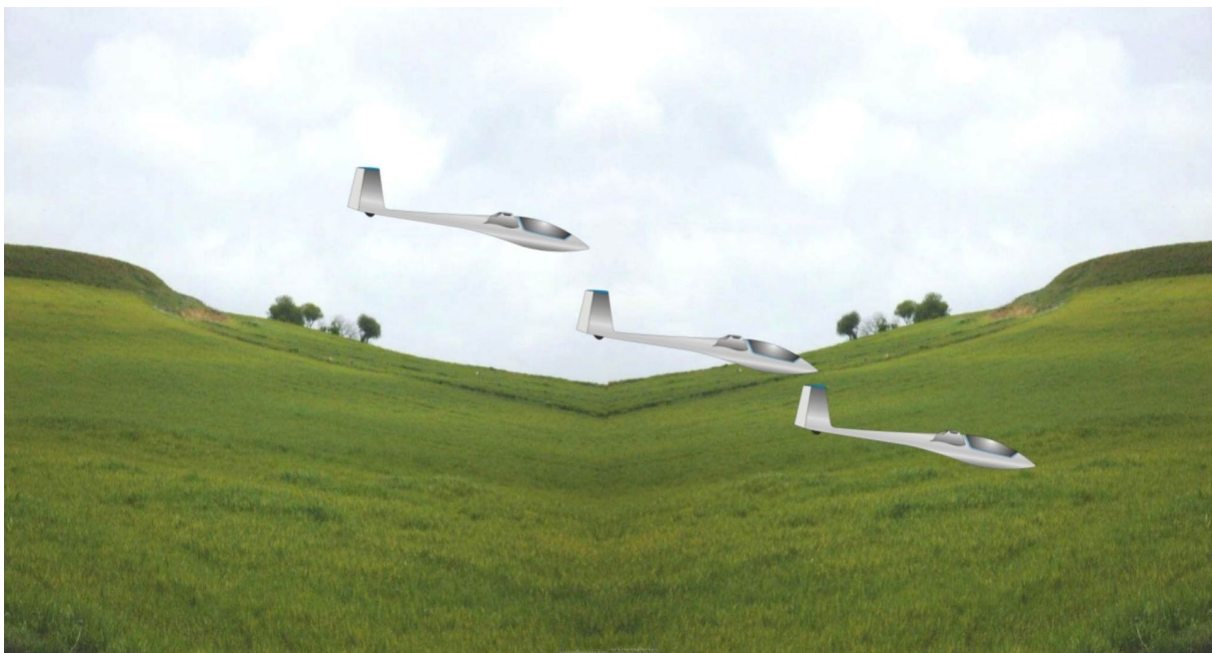
Another factor to keep in mind is that even though the wind was weak, it was blowing from a different direction at lower elevations (west) as compared to the higher areas (north), which could have caused the pilot to misjudge the direction of the wind. What can be stated with certainty is that the area in which he was flying when the impact occurred was the leeward side of Peak Bisaurín, which was the nearest mountain. It is in these areas near the hillside where turbulence is often found that gives rise to the most severe downdrafts. Everything seems to indicate, then, that he was caught off guard by a downdraft that propelled him to the ground. The aircraft's final position, with its longitudinal axis oriented northward, the types of fractures found and the absence of drag marks indicate that the impact took place pitch down, with barely any horizontal speed component, which would have been consistent with having been

Figure 6. Simulated diagram of impact

caught in a downdraft that pushed him to the ground while flying at a low altitude without giving the pilot time to react and to steer the airplane toward the valley and away from the hillside.

The possible cause of the accident was encountering a downdraft that pushed the glider to the ground from a low altitude while flying over a steep hillside that was leeward of the nearest mountain.
