DATA SUMMARY

Registration	G-BYIC
Type and model	CESSNA TU206G
Operator	Private

Type and model	TELEDYNE CONTINENTAL MOTORS TSIO 520 M7
Number	1

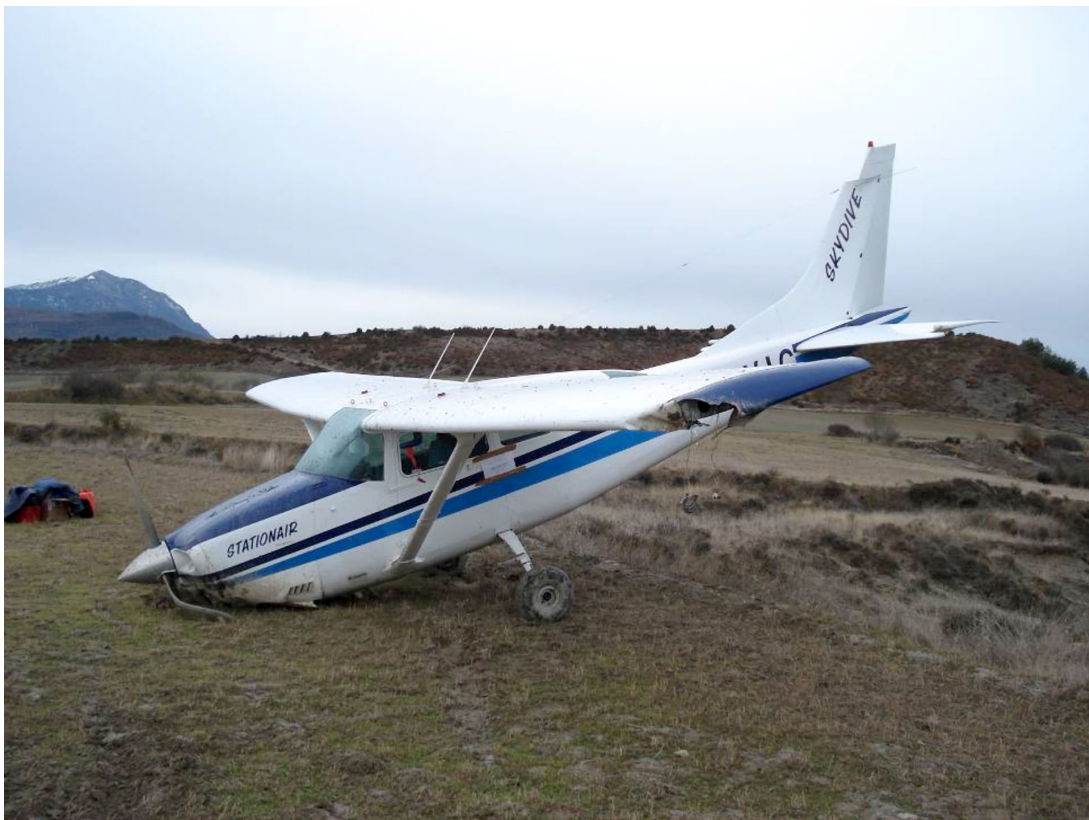
Figure 1. Final aircraft position

The aircraft landed in a muddy area west of Abay, a town near Jaca. The nose gear detached during the landing, leaving the aircraft resting on the propeller blades, the bottom engine cowl and the main gear. The coordinates of the aircraft's stopping point were 42°34'18.6"N 000°37'14.16"W.

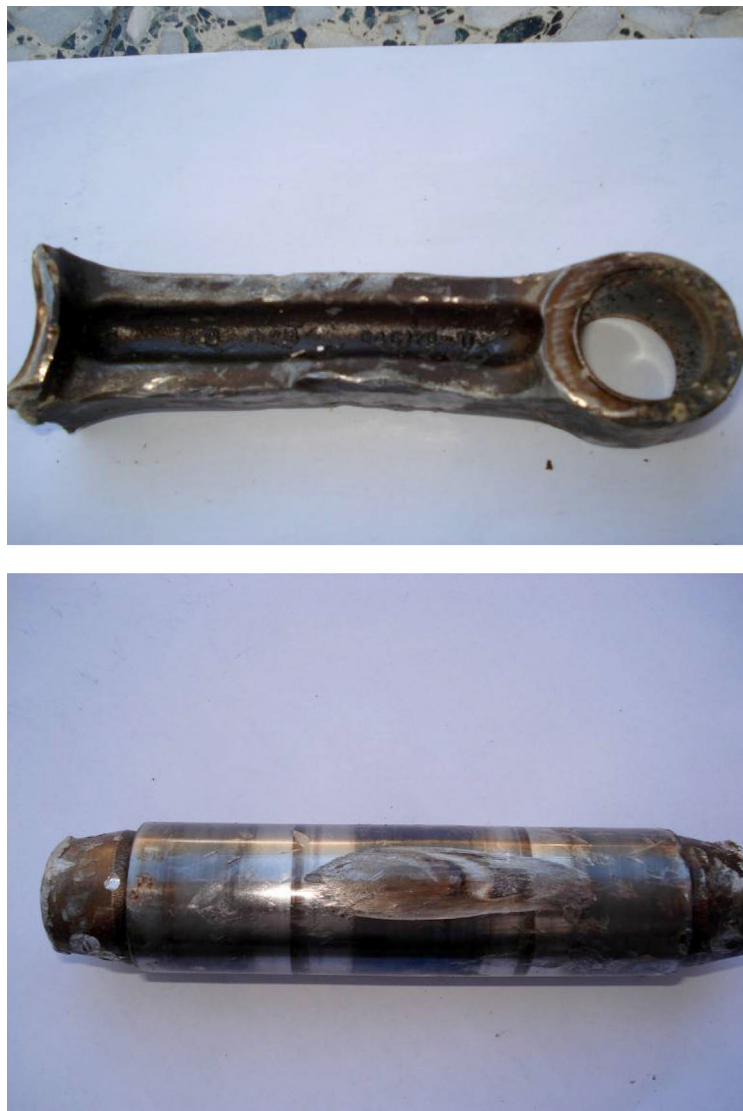
Part of a connecting rod (Figure 4) was found 154 m into the landing run, and some 8 meters further, the pin that attached the rod to the piston. Both components were from the no. 4 cylinder.

The connecting rod had broken where the yoke arms join the body of the connecting rod and was missing the head and cover. It had also been deformed by what must have been impacts against the crankshaft before being ejected from the engine.

There were impact marks on the ends of the pin, also produced before being ejected from the engine, and in the center.

Figure 4. Connecting rod and pin found along the landing run

The no. 4 cylinder connecting rod and piston were subjected to a metallurgical study, which showed that the material possessed the strength requirements specified and that the fractures present had resulted from an overload.

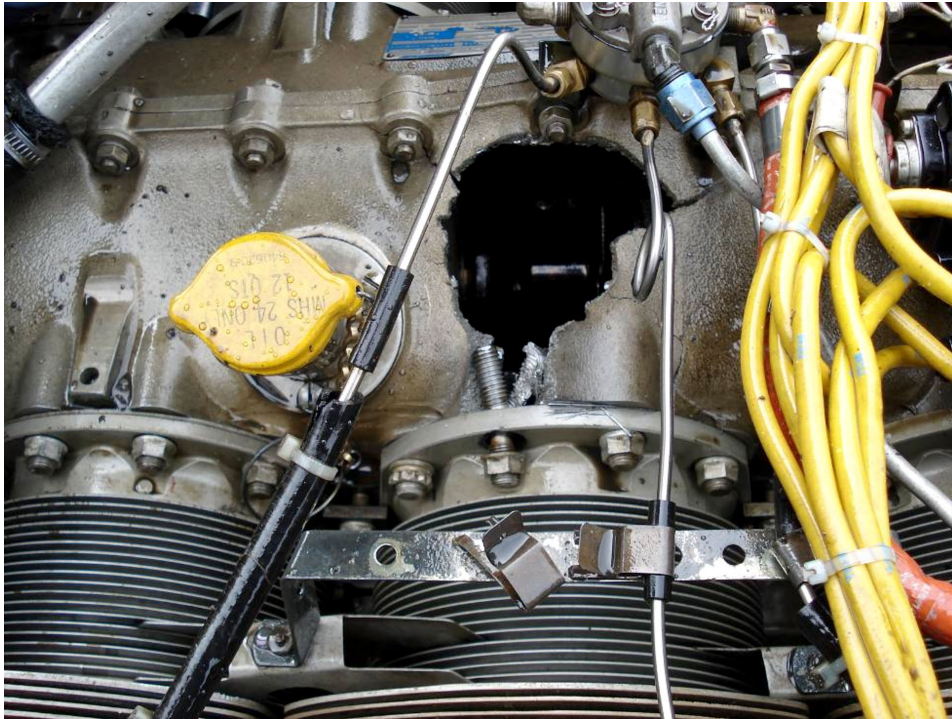
The aircraft did not exhibit any outward structural damage of any significance. Only the damage to the bottom of the fuselage, the left wing tip, the propeller blades and the fracture of the nose gear were visible. A loss of oil was noted from the top and bottom engine cowls. There was also a hole measuring about 10 × 10 cm at the top left of the crankcase, in the area of the no. 4 cylinder, through which the piece of connecting rod and pin mentioned above must have been ejected.

Figure 5. Damage to the left side of the crankcase

- The two crankcase halves, in addition to the 10 × 10 cm hole in the area of the no. 4 cylinder, showed impact marks and mechanical damage in that area, but the crankshaft support diameters were in good condition, without existing signs of bearing movement or rotation. The oil galleys and passages in the crankcase halves were intact clear and unrestricted.

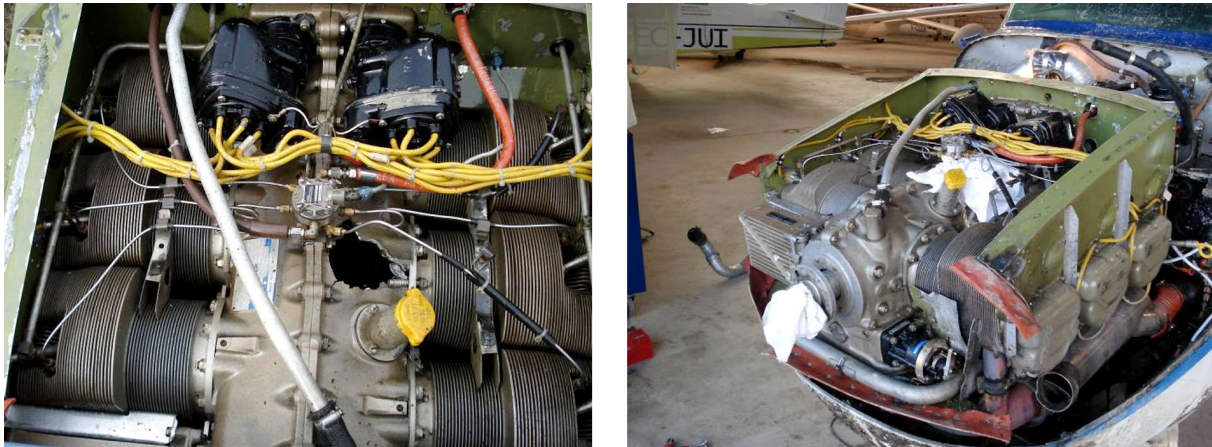
The engine was removed with help from a representative of the engine manufacturer. An analysis of the zinc chromate primer on the fixed metal part of the deflectors or bafflers (metal and rubber diffusers located in the engine nacelle to direct airflow and optimize cooling of the engine cylinders) revealed that friction had worn away the primer from the right part of the engine (nos. 1, 3 and 5 cylinders), whereas the primer on the left side (nos. 2, 4 and 6 cylinders) did not show any signs of friction.

Figure 6. Marks on the zinc primer caused by the defectors

It was also discovered that the left-side engine bafflers were not properly adjusted, since the zinc primer had not worn like on the right side, which resulted in air leaks that gave rise to improper cooling of the cylinders, especially those on the left side.

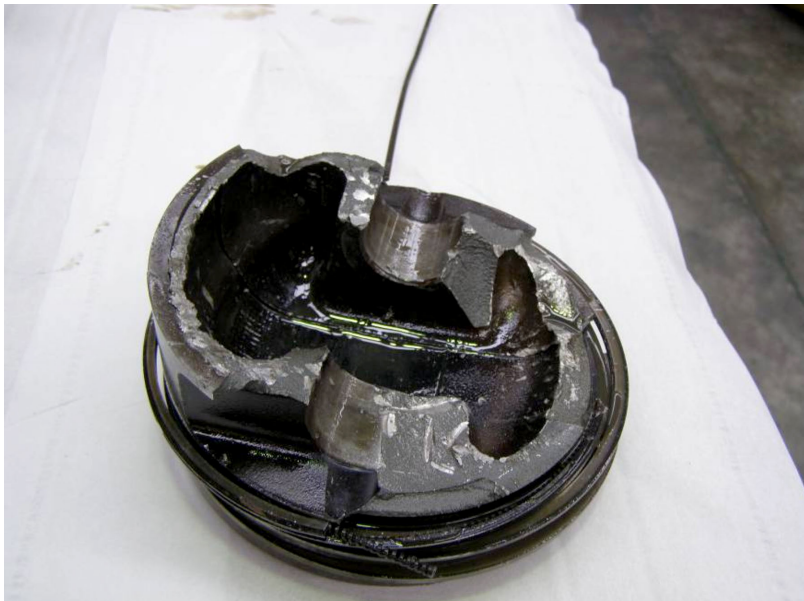
The main damage to the engine was to the no. 4 cylinder and its piston. The connecting rod and pin that joins the rod to the piston were not in the engine, since they had been ejected through the hole found in the crankcase. The edges of this cylinder's liner were damaged and although signs of friction were evident, the piston was not jammed. The piston had broken below the segments. Pieces from connecting rod and its bushings were found in the crankcase.

Figure 7. No. 4 cylinder piston

- The pistons and connecting rods were in good overall condition. The connecting rod ends assemblies were intact and secured. The no. 4 cylinder connecting rod, as already mentioned, had broken at the yoke arms and the corresponding piston had broken below the segments.

The fracture process probably started in the connecting rod, which would have been followed by the break of the no. 4 cylinder piston, which allowed the connecting rod and the pin to move inside the crankcase, hitting various engine components and the crankcase, until they exited via the hole that was made in the crankcase.

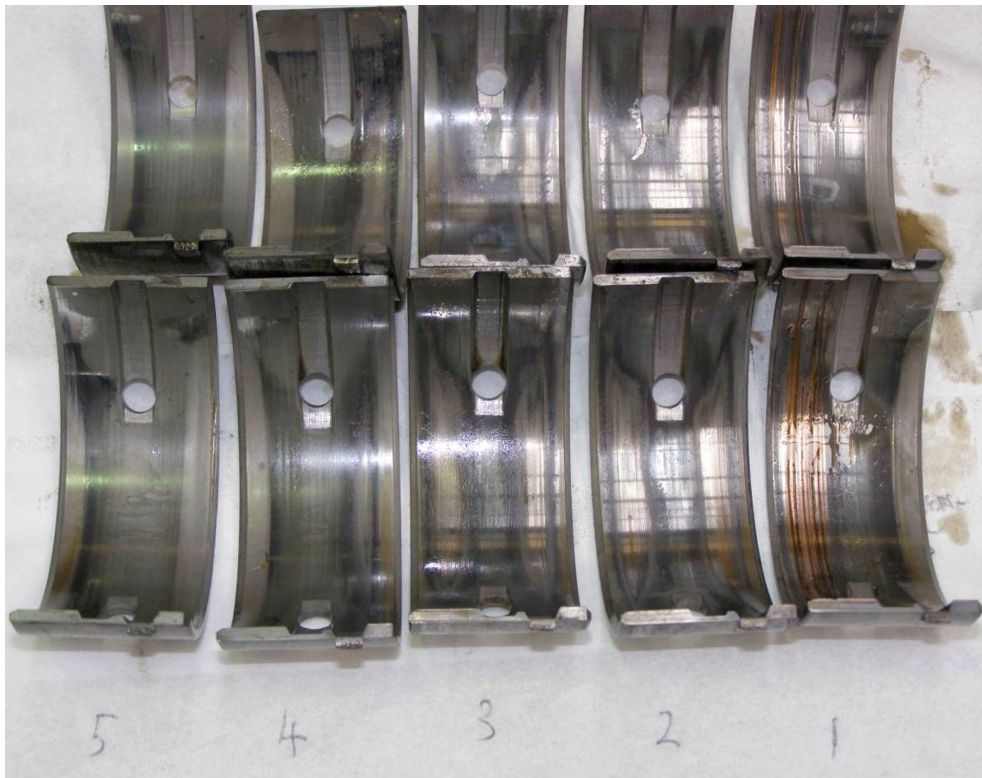
When the crankshaft was removed, its main bearings and one of the connecting rod cap were found to have suffered from a lack of lubrication, as shown in the figures.

Figure 8. Crankshaft main bearings

The condition of the crankshaft main bearings, and in particular of the connecting rod bearings, showed warping and even a lack of material, indicative of having withstood temperatures that were high enough to cause local melting of the metal. This points to a lack of lubrication in that area.

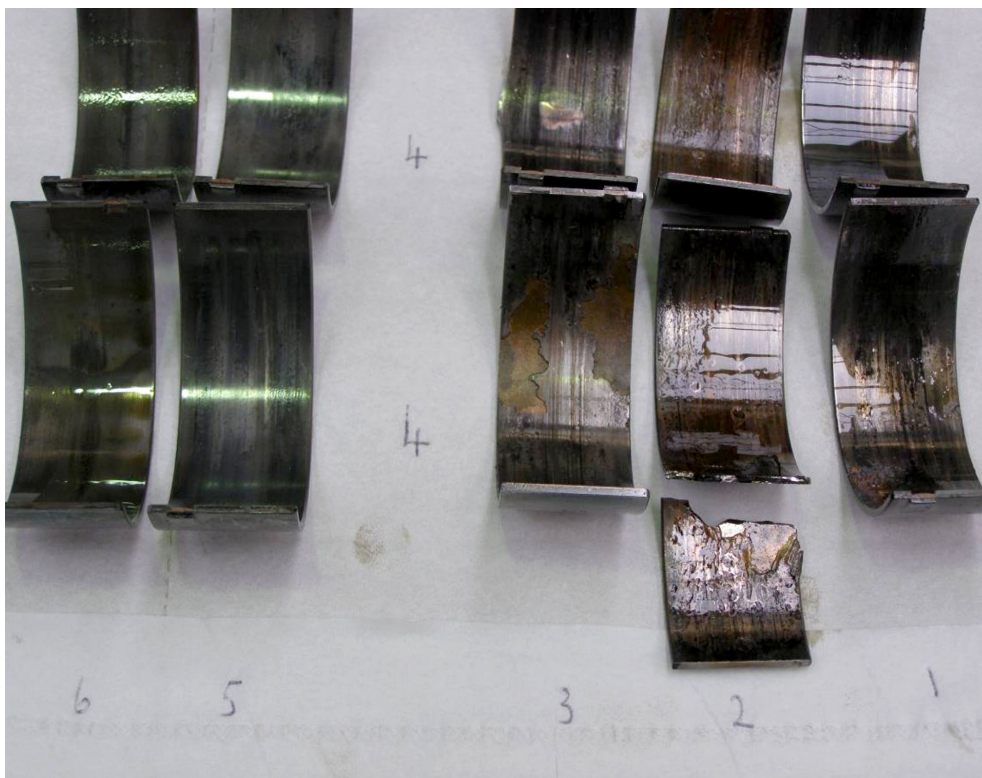
Figure 9. Conecting rod cap bearings

The bearing for the no. 4 connecting rod was not found, though parts from it were recovered from the crankcase. The remaining connecting rod bearing were bent and showed signs of rubbing from a lack of lubrication.

The engine failed due to the fracture of the no. 4 connecting rod cap as the result of inadequate lubrication of the connecting rod bearings, which caused it to overheat, eventually prompting the connecting rod to fail.
