**DATA SUMMARY**

Date and time	<b>Sunday, 2 March 2008; 16:30 UTC<sup>1</sup></b>
Site	<b>Anglesola (Lleida)</b>

Registration	<b>EC-JLQ</b>
Type and model	<b>TECNAM P2002-JF</b>
Operator	<b>Private</b>

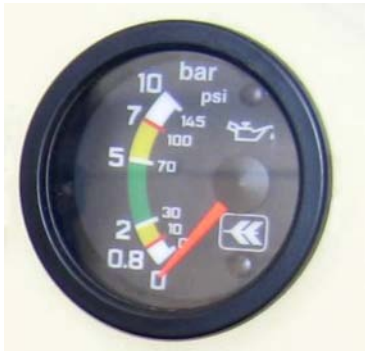
On 2 March 2008, the pilot was flying from Sabadell to Pamplona to Sabadell (LELL-LEPP-LELL) onboard aircraft TECNAM P2002-JF, registration EC-JLQ. It was the aircraft's first flight of the day and, as reported by the pilot, the pre-flight inspection and engine test had been satisfactory and the flight to Pamplona had been uneventful. Once in Pamplona, both the pre-flight inspection and the engine test were again satisfactory, the only difference being that the oil level dipstick indicated 1/4 instead of 1/2 (as found on the pre-flight inspection at the aerodrome of origin), as a result of which the pilot filled the oil tank. About an hour into the return flight to Sabadell, the oil pressure started to drop until the oil pressure reading was at the lower threshold of the green region (2 bars) (see Figure 1). The remaining parameters were within limits. A few minutes later, the engine

Figure 1. Cockpit oil pressure indicator

started to sputter and lose power. The oil pressure reading dropped below 2 bars (upper threshold of yellow region). According to his statement, the pilot then performed the emergency procedure<sup>2</sup>, but the engine did not regain power; instead, the propeller stopped completely two minutes later. Unable to restart the engine, the pilot declared the emergency to the Barcelona Control Center (BCN), selected an emergency frequency on the transponder and then conducted an emergency landing west of Tárrega (Lleida).

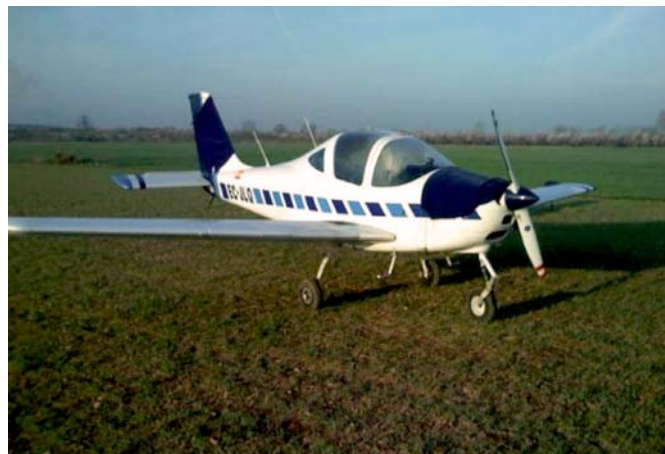
The pilot was uninjured and the aircraft, except for the engine, was undamaged.

Figure 2. Final position of aircraft in field where it landed

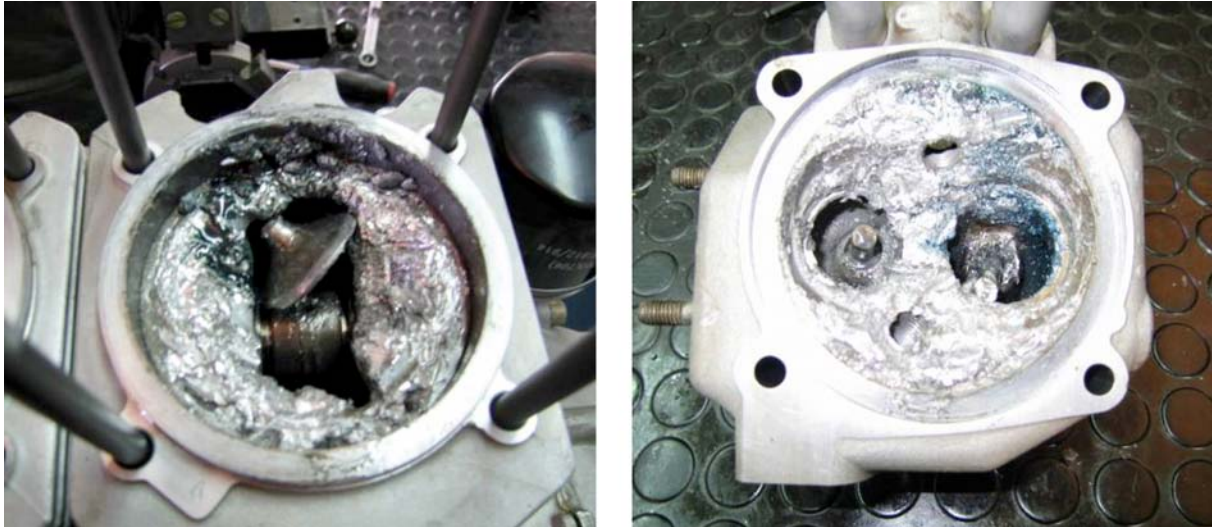
The engine was disassembled as part of the investigation. During the inspection it was noted that the intake and exhaust valves on the number 2 cylinder (front left, as seen from the cockpit) had fractured, perforating the piston and damaging said cylinder's head (see Figure 3).

Figure 3. Condition of piston and no. 2 cylinder head

Both valves were fractured where the stem joins the valve head.

foreign element must have been present in the space between the piston and cylinder head that could have interfered with the movement of the elements comprising the cylinder-piston assembly. After analyzing the different parts sent for inspection, this foreign element was determined to have belonged to either an exhaust valve or the seat of said valve, and which lodged in the cylinder head. Said element would eventually also have caused the exhaust valve to fracture.

Both valves fractured in the area where the stem joins the valve head. Based on the results of the laboratory findings following its analyses, and due to the fact that two minutes (as stated by the pilot) elapsed between the time the engine started to sputter

and its stopping, the valve that fractured first could have been the exhaust valve on the no. 2 cylinder. This would have allowed the engine to continue running, though at reduced power, while the detached valve head interfered with the piston's movement against the cylinder head and against the other valve, which resulted in the fracture of the latter and the eventual failure of the engine.

The incident is thus believed to have been caused by the fracture of one of the valves in the no. 2 cylinder, which led to the subsequent fracture of the second valve and the final failure of the engine.

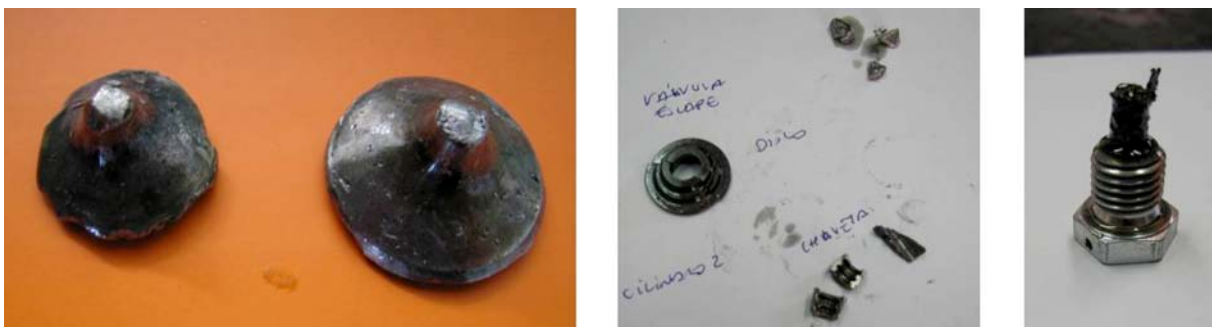
Figure 4.

Dents were also observed inside the intake manifold for the numbered cylinders. The top plate (spring retainer) was also broken on the exhaust valve and there were metal shavings on the magnetic plug in the sump (see Figure 4).
