DATA SUMMARY

| Registration | EC-FHZ |
| Type and model | PIPER PA-28R-200 |

REPORT

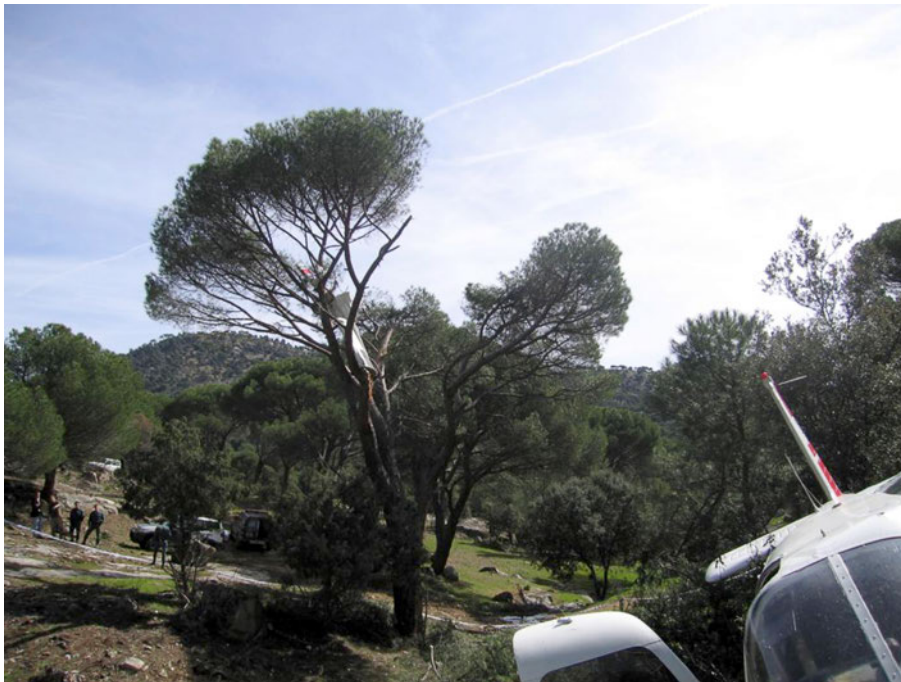
Figure 1. View of wreckage

The wreckage did not scatter. The right horizontal stabilizer was damaged, part of the right wing’s lower surface was missing (it had become lodged in the tree) and the wing roots had broken.

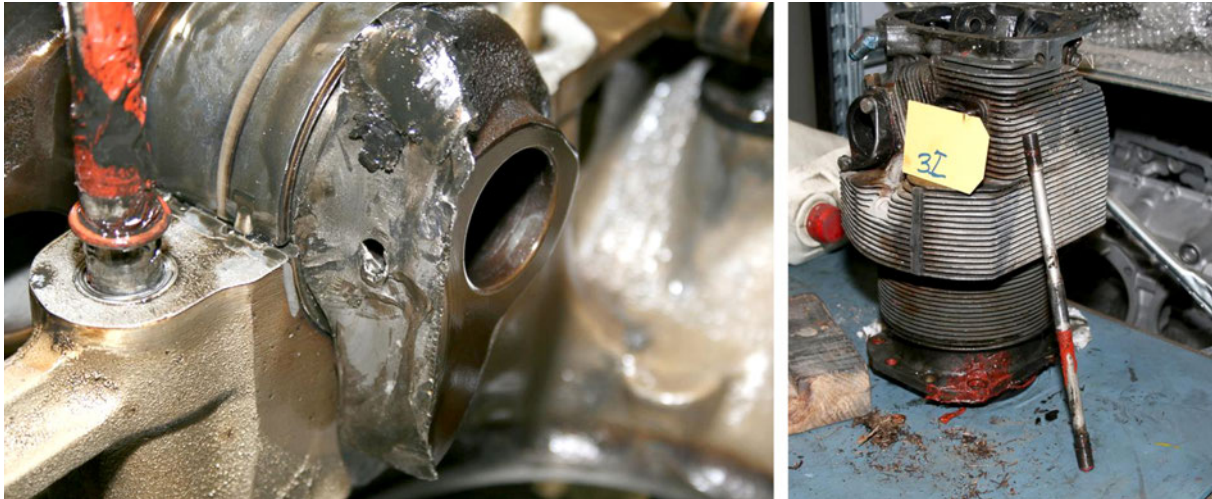
Figure 2. Engine and the no. 3 cylinder

- the central supports of the main crankcases exhibited fretting¹
- there was an orange coating on the through-studs for the central mount (like a plastic sealant)
- the base of the no. 3 cylinder was covered in a layer similar to that found on the through-studs,
- improper lubricant residue on the crankshaft central support,
- the half bearings from the crankshaft central support were worn from overloading (they were burred),
- the crankcase central support exhibited pile-up² due to overloading,
- of the engine's four pistons, the one installed in the no. 3 cylinder was different from the rest and did not correspond to the one installed during the engine's overhaul.

The post-accident inspection of the engine revealed the presence of abundant sealing material (see Figure 2) in the through-studs and at the base of the no. 3 cylinder (see Figure 3). It was also noted that the new cylinder installed in this position was subsequently replaced by another.

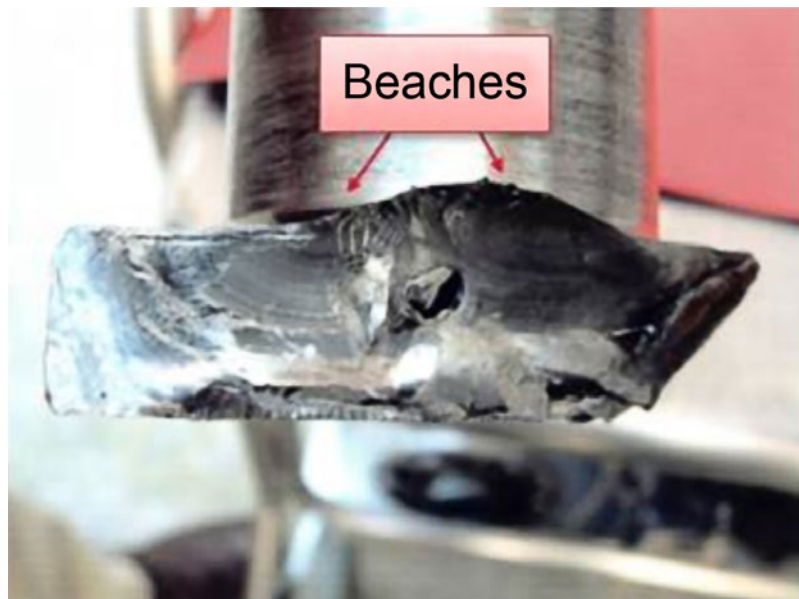
- the crankshaft fractured as a result of a simultaneous fatigue process in two areas of the same fracture surface (see Figure 3),
- the presence of several developing fatigue cracks in different sections of the crankshaft,

Figure 3. Crankshaft fracture area

The results of the study show that the crankshaft broke as the result of excessive bending loads originating in the central half bearing, which was mounted outside of its positioning tabs, specifically, toward the front of the engine. This, in turn, resulted in the greasing stub becoming lodged in the surface of the central half bearing.

As a consequence, the crankshaft journal, which is alongside the central support, shifted, leading to its misalignment with respect to the other two supports, causing increased bending loads on the crankshaft. The additional loads, then, in conjunction with the probable appearance of vibrations and increased loads on the half casing mounts, incubated the various cracks discovered during the inspection.

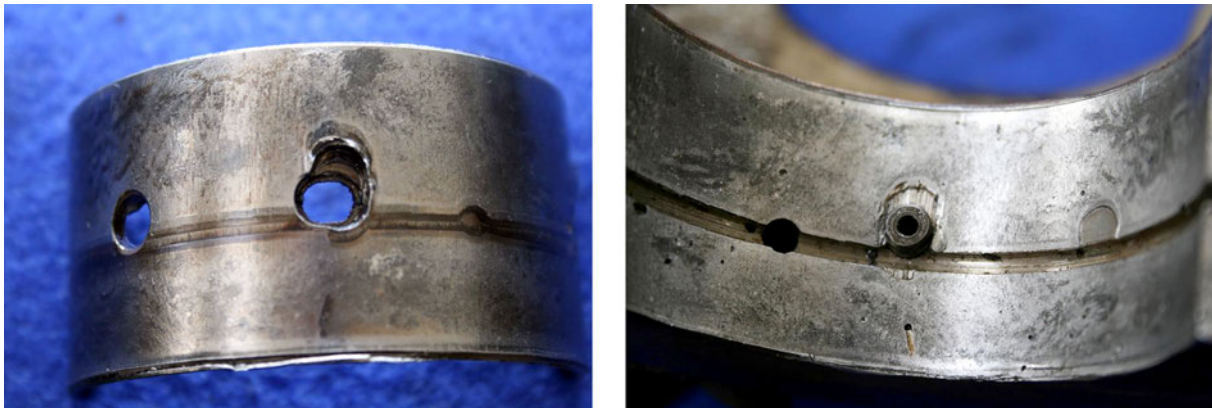
- the high loading to which the crankshaft had been subjected was evidenced in the deformations found in the crankshaft's central support and in its half bearings, as shown by:
 - erosion and deformation in the greasing ports, see Figures 4 and 5,

Figures 4 & 5. Deformations in the central half bearing and half casing

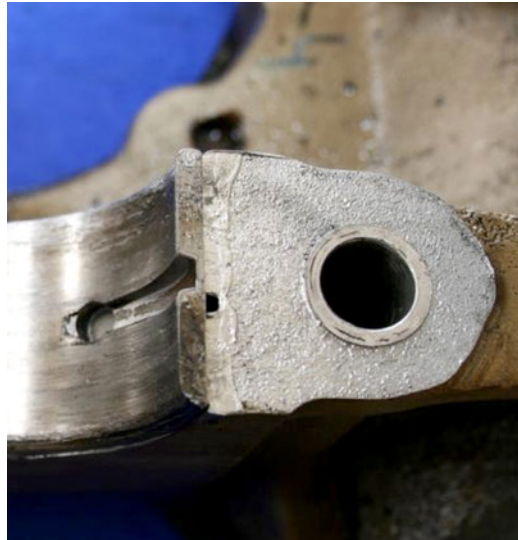
- fretting in the contact area between the two half casings near the central support resulting from repeated relative motion of the contact surfaces under load, see Figure 6,
- edging on the side surface of the crankcase's central support and on one of the central half bearings.

Figure 6. Close-up of surface on central support
