Report A-015/2008

Accident involving a Cessna
T310 aircraft, registration
EC-DZV, in the vicinity of the
Cuatro Vientos Aerodrome
(Madrid), on 29 April 2008

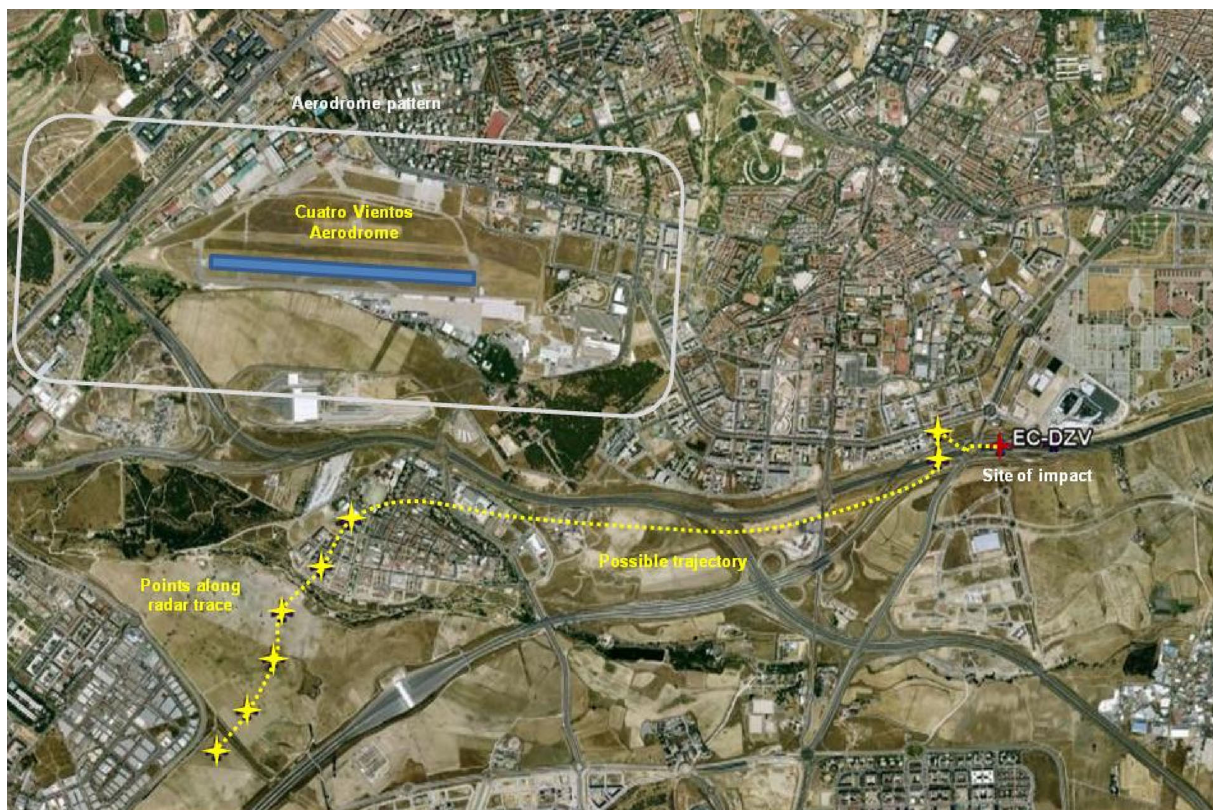
At about 08:59, aircraft EC-DZV reported that it was over point S³ at the entrance to the field, and at about 09:02 it reported that it was entering the left downwind leg for runway 28. At 09:04, the preceding aircraft, which had just landed, reported on the ground frequency that it had seen an airplane "doing strange things on downwind". The controllers looked for the airplane visually but could not find it, after which they started calling it on the clearance frequency. They received no reply, and proceeded to notify emergency services. At 09:14 another aircraft in the aerodrome pattern reported that an airplane had crashed next to the M-40. At 09:22, a SUMMA helicopter reported that there were no survivors.

Figure 1. Radar positions (dots) for aircraft prior to impact

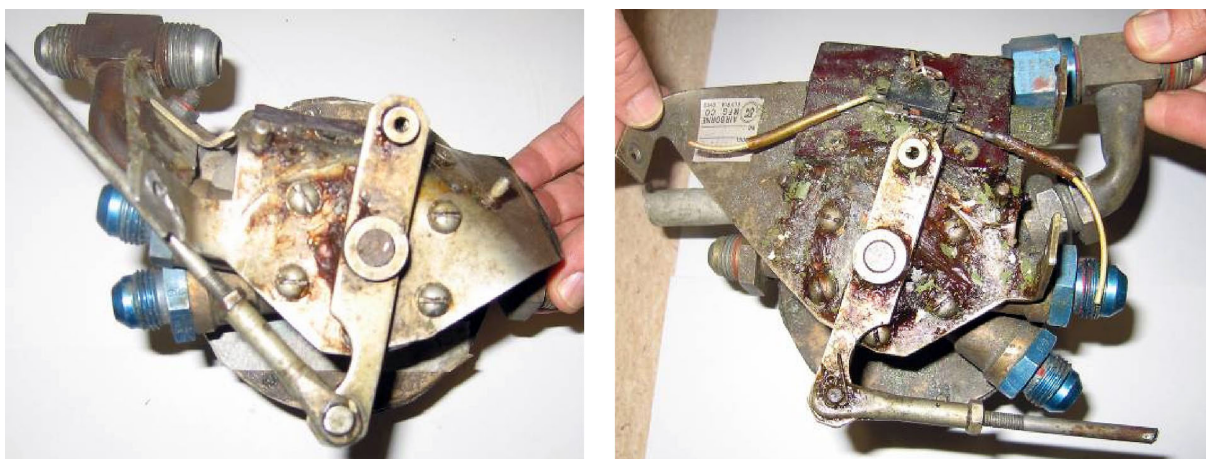
Figure 4. Fuel selectors inside the wings of the accident aircraft

A more detailed inspection of the fuel system and all of its components was conducted. The piping and the selectors barely had any fuel. The main fuel tanks were then examined. The inlet to the right tank transfer pump was blocked by deposits from the fuel tank. The left tank transfer pump was not blocked. No internal anomalies were detected that would have resulted in an improper operation of the pumps, though the sealing joints in both pumps were not approved. There were no signs, however, of any leakage. The auxiliary pumps were sent to the manufacturer for their inspection and disassembling to check their condition and operation. An operational test was conducted to check flow rates and electric current draw in the pump motors. The pumps were then disassembled. The results of this inspection confirmed that the auxiliary pumps satisfied the requirements of the operational test, save for a slight increase in the current drawn by the left tank pump. During the internal inspection a swelling of the potting was noted. Normally, such swelling appears in pumps that are running dry (without fuel) for a certain period of time. Without a flow of fuel to cool the armature, the wires will expand, pushing out the potting and resulting in greater friction and resistance to rotation, meaning more current is required to maintain the fuel flow to the engine.

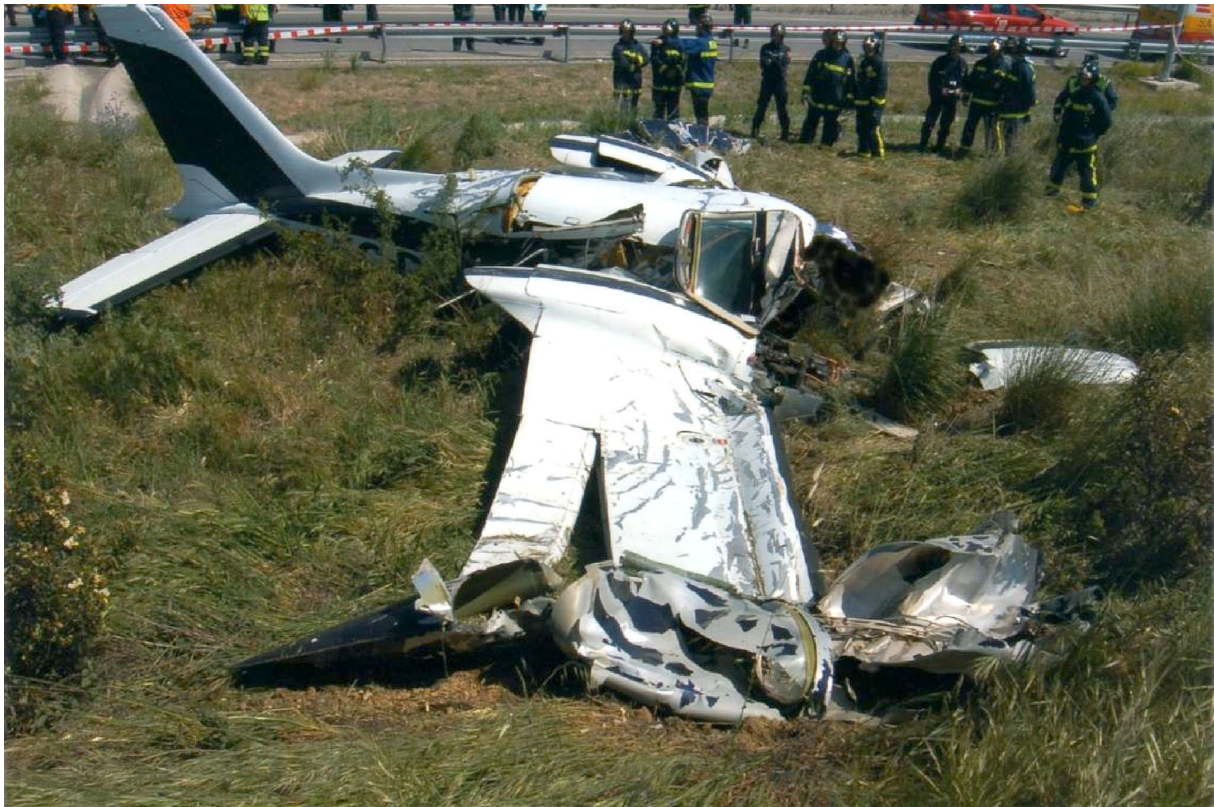
The aircraft was found on a small field flanked by the R-5 and the on-ramp to said motorway from the M-40. The wreckage was confined to a small area. The aircraft showed signs of having impacted at a high angle with respect to the horizontal. Neither the nose of the aircraft nor the cockpit were visible. The remaining airframe and the tail section did not show any signs of an impact and there were no drag marks on the ground. The nose was oriented toward 130° (see Figure 6).

Figure 6. Condition of the aircraft after the impact

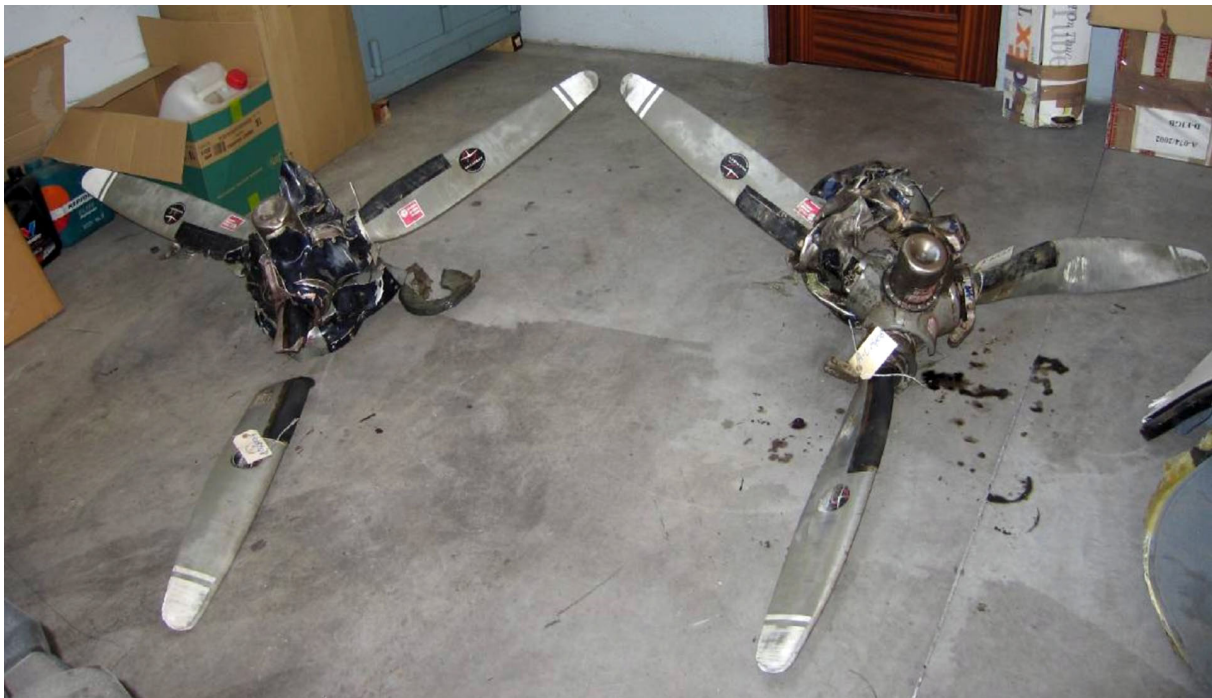
One of the firemen who took part in extracting the bodies and who had a knowledge of aviation reported smelling barely any fuel when he arrived at the scene. The main tanks were destroyed. Only beneath the left wing was some moisture noticeable on the ground under the main tank. The landing gear was deployed and the flaps were extended to about 15°. The propellers had dug into the ground and one blade on both sides was buried in the dirt. The buried blade on the left propeller was found torn from its hub, under the engine and facing backwards with respect to the rest of the aircraft. The buried blade on the right propeller had broken near its attachment to the hub. In general, none of the blades showed any signs of having impacted the ground at power and none were in a feathered position (see Figure 7).

Figura 7. General view of aircraft propellers

The condition of the propellers and the evidence found in the auxiliary pumps in both tanks points to a probable stoppage of both engines, one after the other.

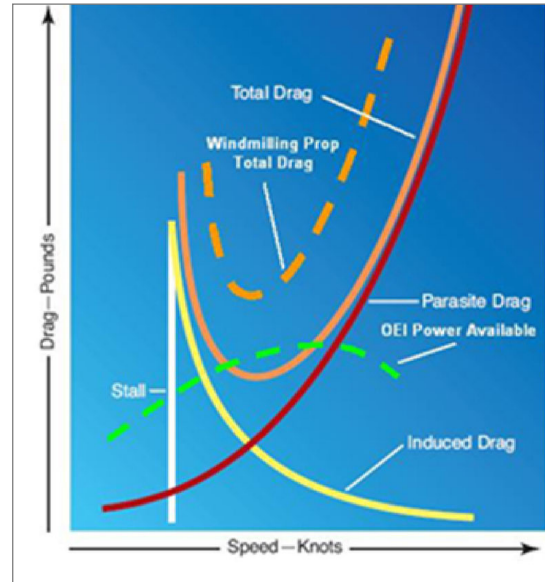
The inability to maintain level flight is exacerbated by a windmilling propeller, which generates large amounts of parasitic drag. In the case of a piston multi-engine airplane, the effect of a windmilling propeller is to increase the total drag of the airplane and induce an asymmetric drag about the yaw axis. The net result of a windmilling propeller is the aircraft total drag exceeds the power available, thus the aircraft is no longer able to sustain level flight.

Figure 10. Total drag with a windmilling propeller

As noted in Section 1.18.2, when faced with a one engine inoperative situation in a twin-engine aircraft, the inability to maintain level flight is exacerbated by a windmilling propeller on an inoperative engine, which generates large amounts of parasitic drag. In the case of a piston multi-engine aircraft, an un-feathered propeller would cause an increase in the total drag and induce an asymmetric drag about the yaw axis. The result of OEI with an un-feathered propeller is that the aircraft's total drag is greater than the power available, meaning the aircraft is no longer able to maintain level flight. In this case, we must add the fact that the airplane was in a "dirty" configuration with the gear down and the flaps deployed, which would have increased the parasitic drag even more.
