RESUMEN DE DATOS

Matrícula	EC-GCX
Tipo y modelo	CESSNA 177 RG «Cardinal»
Explotador	Privado

INFORME

1. INFORMACIÓN SOBRE LOS HECHOS

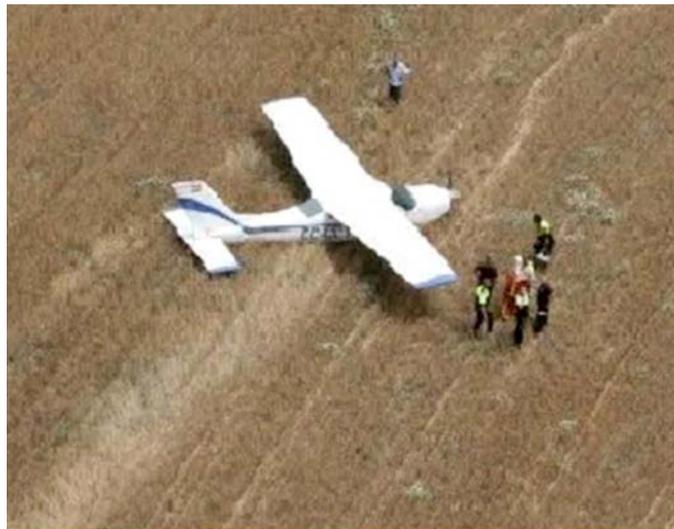
El aterrizaje de emergencia se había realizado con el tren de aterrizaje recogido. El contacto de la aeronave con el terreno había sido suave y esta había recorrido en tierra unos 70 m, terminando su trayectoria con un giro de 60° a la derecha. En la Figura 2 se presenta una vista aérea de la aeronave en su posición final.

Figura 2. Aeronave después del aterrizaje

La aeronave no sufrió daños estructurales significativos, presentando exclusivamente los producidos en la parte inferior del fuselaje durante el recorrido en tierra.

Además, la parte inferior del fuselaje estaba, también, impregnada de aceite de motor.

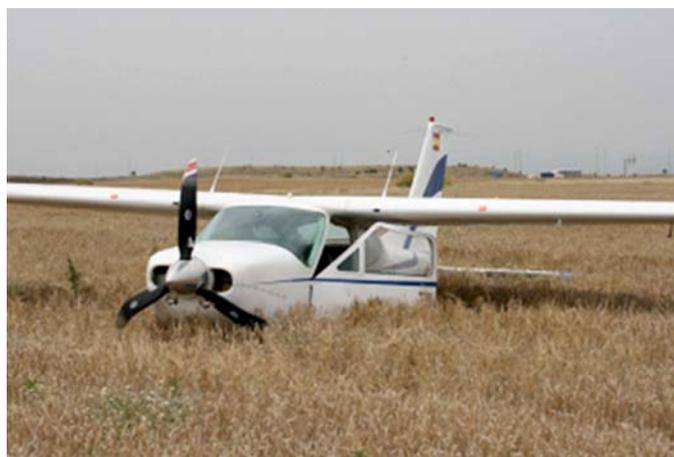
En lo que al grupo motopropulsor se refiere, el motor tenía el retén delantero del cigüeñal fuera de su alojamiento y desplazado hacia delante, y presentaba un orificio en la parte superior del cárter, a la altura del cilindro n.º 4; la hélice presentaba características de haber entrado en contacto con el terreno sin potencia aplicada, con las puntas de las palas dobladas hacia atrás y marcas de roce en ellas sensiblemente paralelas a la envergadura de las respectivas palas.

Figura 3. Restos de la aeronave

La hélice se desmontó del grupo sin dificultad y, previamente, se confirmó que las palas estaban en la posición de paso fino, y con las puntas rayadas y dobladas hacia atrás (véase Figura 3). Los daños en las palas demostraban que el contacto de la aeronave con tierra se había realizado sin tracción y a bajo régimen.

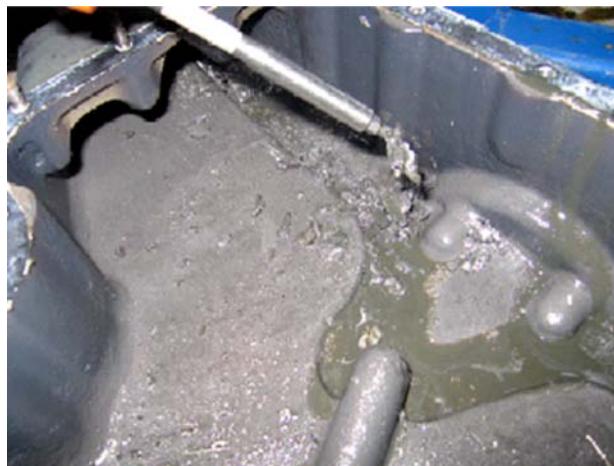
Al iniciar el despiece del motor, se detectaron abundantes virutas metálicas, tanto magnéticas como no magnéticas, en el cárter inferior (Fig. 4), y en los conductos de engrase, especialmente, en la malla del filtro de entrada a la bomba de aceite de motor. Al inspeccionar el interior de esta bomba, se comprobó que sus piezas estaban en buen estado, con señales de ligeros roces de los dientes de los engranajes con la carcasa. La bomba no tenía síntomas de haber funcionado sin aceite.

Figura 4. Partículas y virutas metálicas en el cárter

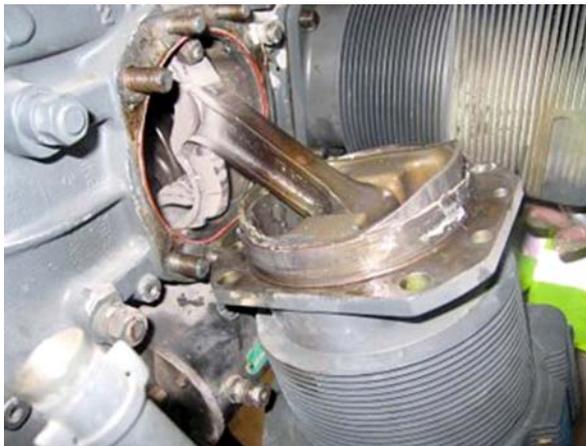
Seguidamente, se desmontaron los cilindros del cárter principal, encontrando que las bielas de los n.ºs 2, 3 y 4 se habían desprendido del cigüeñal y tenían señales de sobrecalentamiento severo que había llegado a producir fluencia del material en sentido longitudinal, especialmente en la del cilindro n.º 2 (Fig. 5). Asimismo, algunos de los cojinetes del cigüeñal habían roto y saltado permitiendo que la muñequilla se requemase (Fig. 6). Los daños en las piezas principales eran mayores cuanto más alejada era su situación de la bomba de aceite, así, la biela del cilindro n.º 1 permanecía cogida al cigüeñal y sus cojinetes, aunque también con huellas de alguna falta de engrase, no estaban recalentados.

Figura 5. Cilindro 2, semidesmontado, mostrando la rotura de la biela

No se encontraron características típicas de «gripado» del motor, en el que se producen, en general, roturas estáticas de bielas y cilindros sin deformaciones apreciables. En este caso, se encontraron fuertes deformaciones de tipo plástico, producidas por una tracción superior a la carga de fluencia del material a alta temperatura, aplicada durante cierto tiempo, típicamente causadas por un funcionamiento del motor a regímenes altos, incluso superiores al máximo permitido (sobrevelocidad) con una lubricación cada vez más insuficiente.

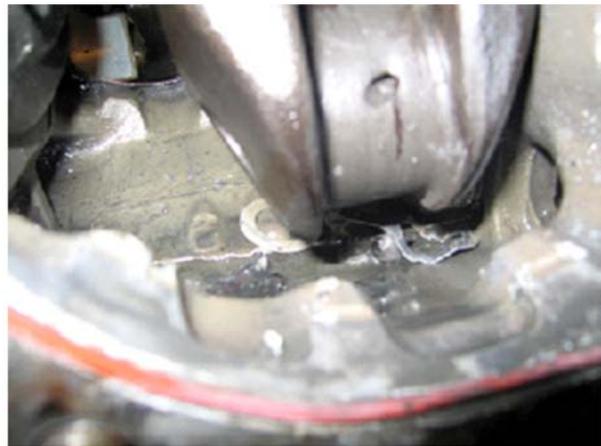
Figura 6. Muñequilla cigüeñal quemada y restos metálicos sueltos

En resumen, los daños observados son coherentes con un funcionamiento del motor a un régimen elevado, incluso con una posible sobrevelocidad, a la vez que se estaba produciendo una fuga de aceite que fue dificultando su lubricación y produciendo un excesivo calentamiento de las piezas móviles del motor.

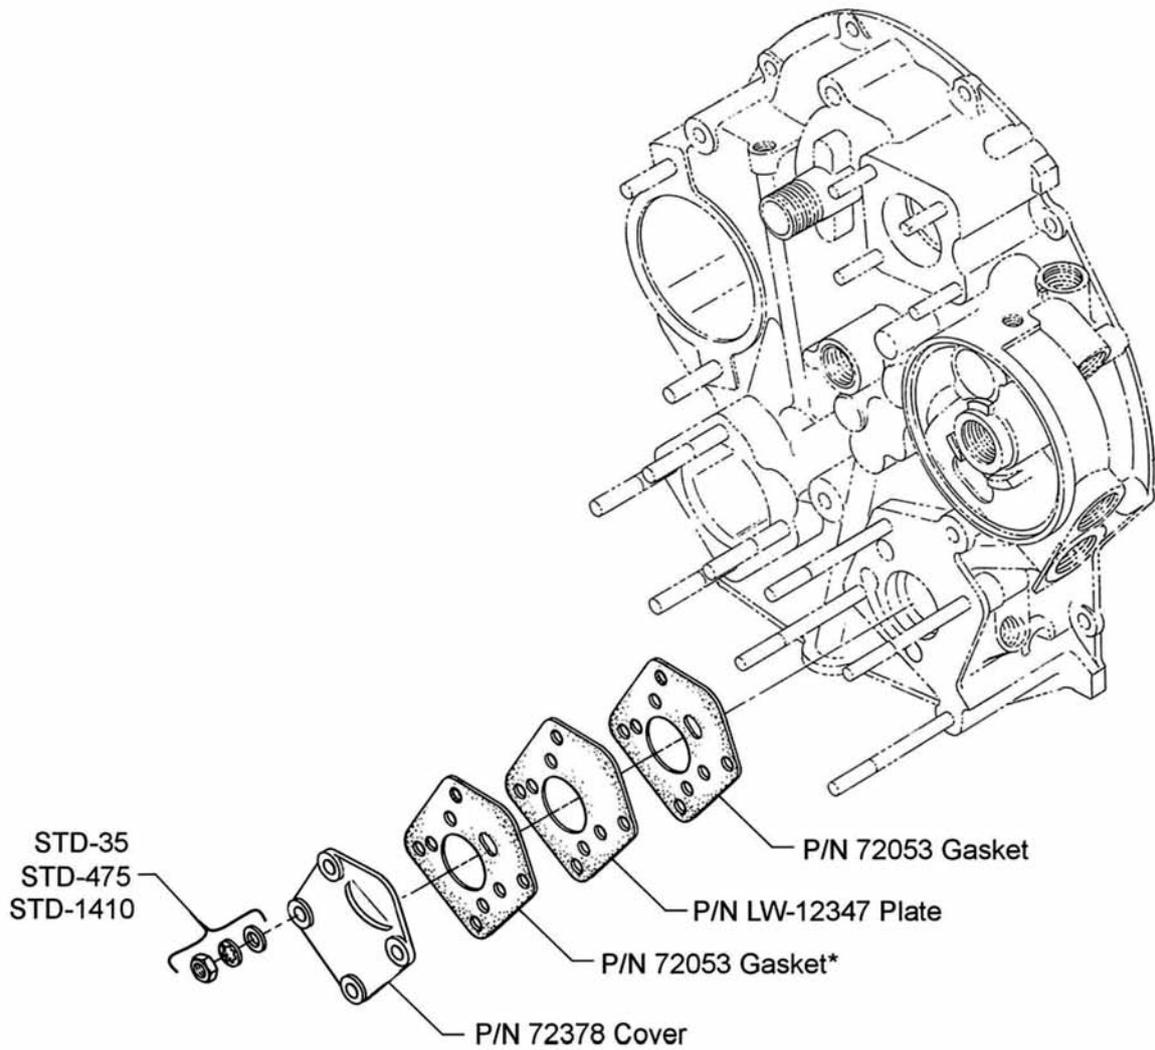
Propeller Governor Pad Plate and Gaskets

The use of a P/N LW-12347 propeller governor pad plate and two P/N 72053 gaskets on dual magneto engines with rear mounted propeller governor drives is necessary with some propeller governors to eliminate the possibility of oil leakage between the propeller governor and the accessory housing.

* Replaced by gasket specified by airframe or propeller governor manufacturer when propeller governor installed.

As a product improvement, to insure against oil leakage, the propeller governor pad plate and gaskets are being incorporated and will not effect operation with any propeller governor drive installed on the engines. See illustration.

WHEN INSTALLING THE PROPELLER GOVERNOR, THE P/N 72053 GASKET BETWEEN THE PROPELLER GOVERNOR PLATE AND THE COVER IS REPLACED BY A GASKET SPECIFIED BY THE AIRFRAME OR PROPELLER GOVERNOR MANUFACTURER. (REFER TO AIRFRAME IPC.) LYCOMING DOES NOT SUPPLY THIS GASKET; HOWEVER, IT MAY BE PURCHASED THROUGH THE AIRFRAME OR PROPELLER GOVERNOR MANUFACTURER.
