DATA SUMMARY

Date and time	Tuesday, 24 February 2009; 18:40 local time ¹
Site	Descending 55 NM south of the Santander Airport

Registration	EC-IKZ
Type and model	BOMBARDIER CL-600 2B19 (CRJ-200ER)
Operator	Air Nostrum

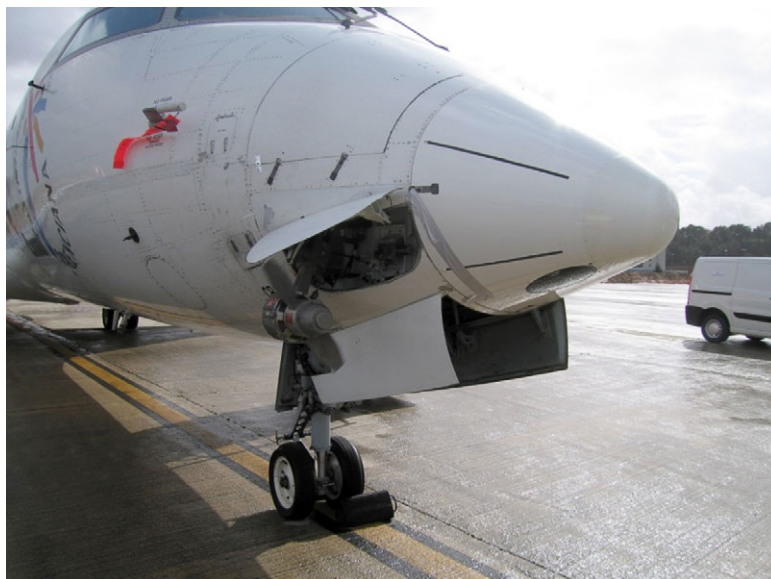
Figure 1. Aircraft after landing with the ADG deployed

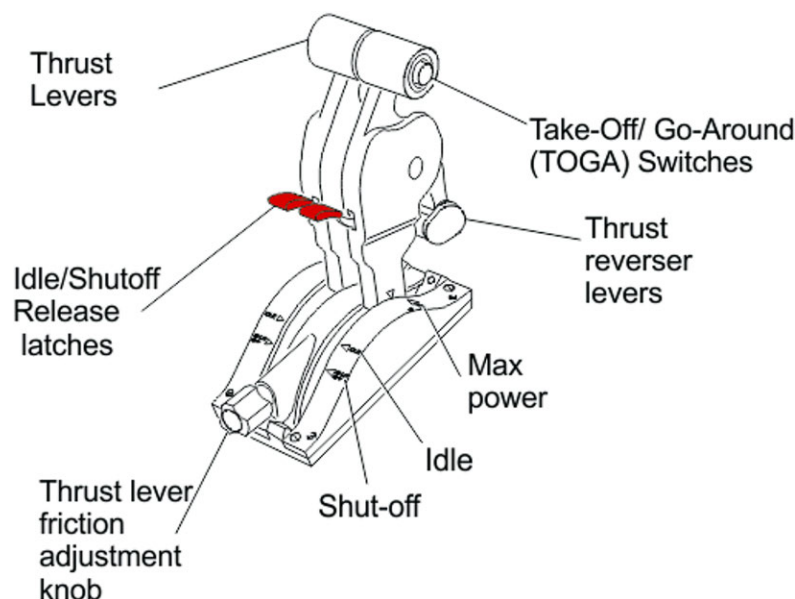
The thrust levers control the application of power in the forward thrust range, and the lever settings of SHUTOFF, IDLE and MAX POWER. There are two latches (shown in red) behind each thrust levers. These latches are used to release the mechanical stops that guard against inadvertent movement of the thrust levers to SHUT OFF.

Figure 2. Engine thrust control system

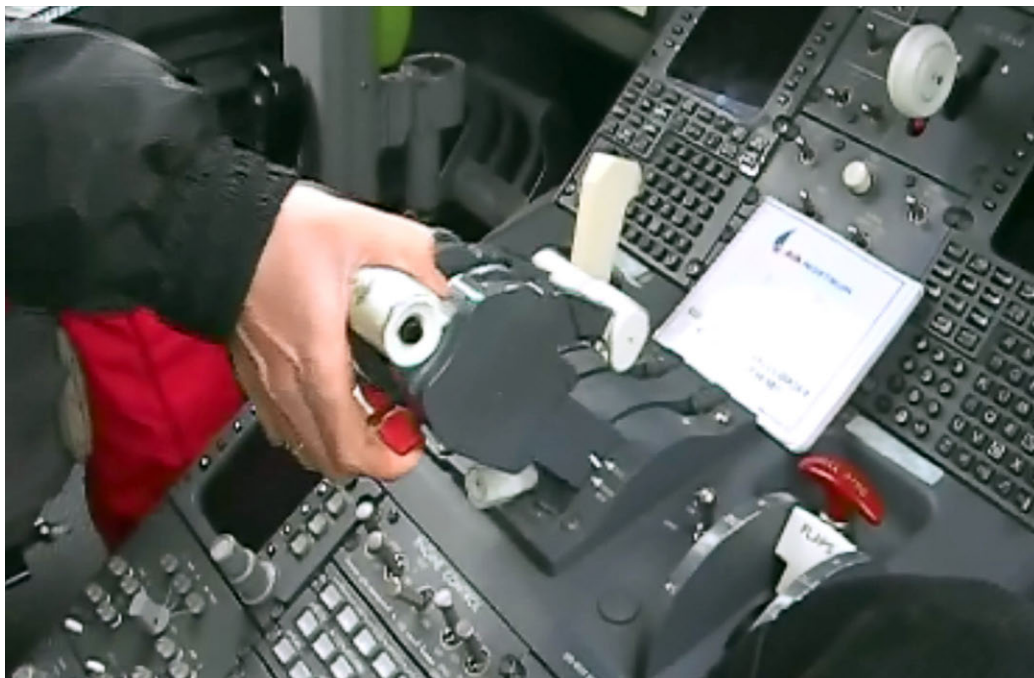
In addition, the thrust levers were verified to be working properly and in keeping with the specifications in the operations manual. Investigators confirmed that both engines could be stopped using just one hand. Lastly, it was shown that moving the release latches required placing the hand in a different position from that used during normal operations.

Figure 5. Positioning the lever from IDLE to SHUT OFF

The pilots taking part in the test noted that the engines never shut off at the SHUT OFF position, but somewhere between IDLE and SHUT OFF.

It was also noted that operating the release latches that allow the lever to go from IDLE to SHUT OFF is not easy using the same hand position that is normally kept on the thrust levers while in flight.

This information indicates that the engines were shutdown by placing the thrust levers below the IDLE position, an action that does not appear to have been unnoticed. It is also likely that shutting down both engines was involuntary, meaning that the captain did not intend to shut down the engines through his actions. As already noted in point 1, moving the levers below IDLE requires releasing safety latches to override the mechanical stops. To release these latches, the hand must be placed in a position that is not normally used in flight (see Figure 5).

REC 01/12. It is recommended that AIR NOSTRUM modify the company operations manual to explicitly state that placing the thrust levers in any position below IDLE mark, between IDLE and SHUT OFF, could shut down the engines even before the SHUT OFF mark is reached.

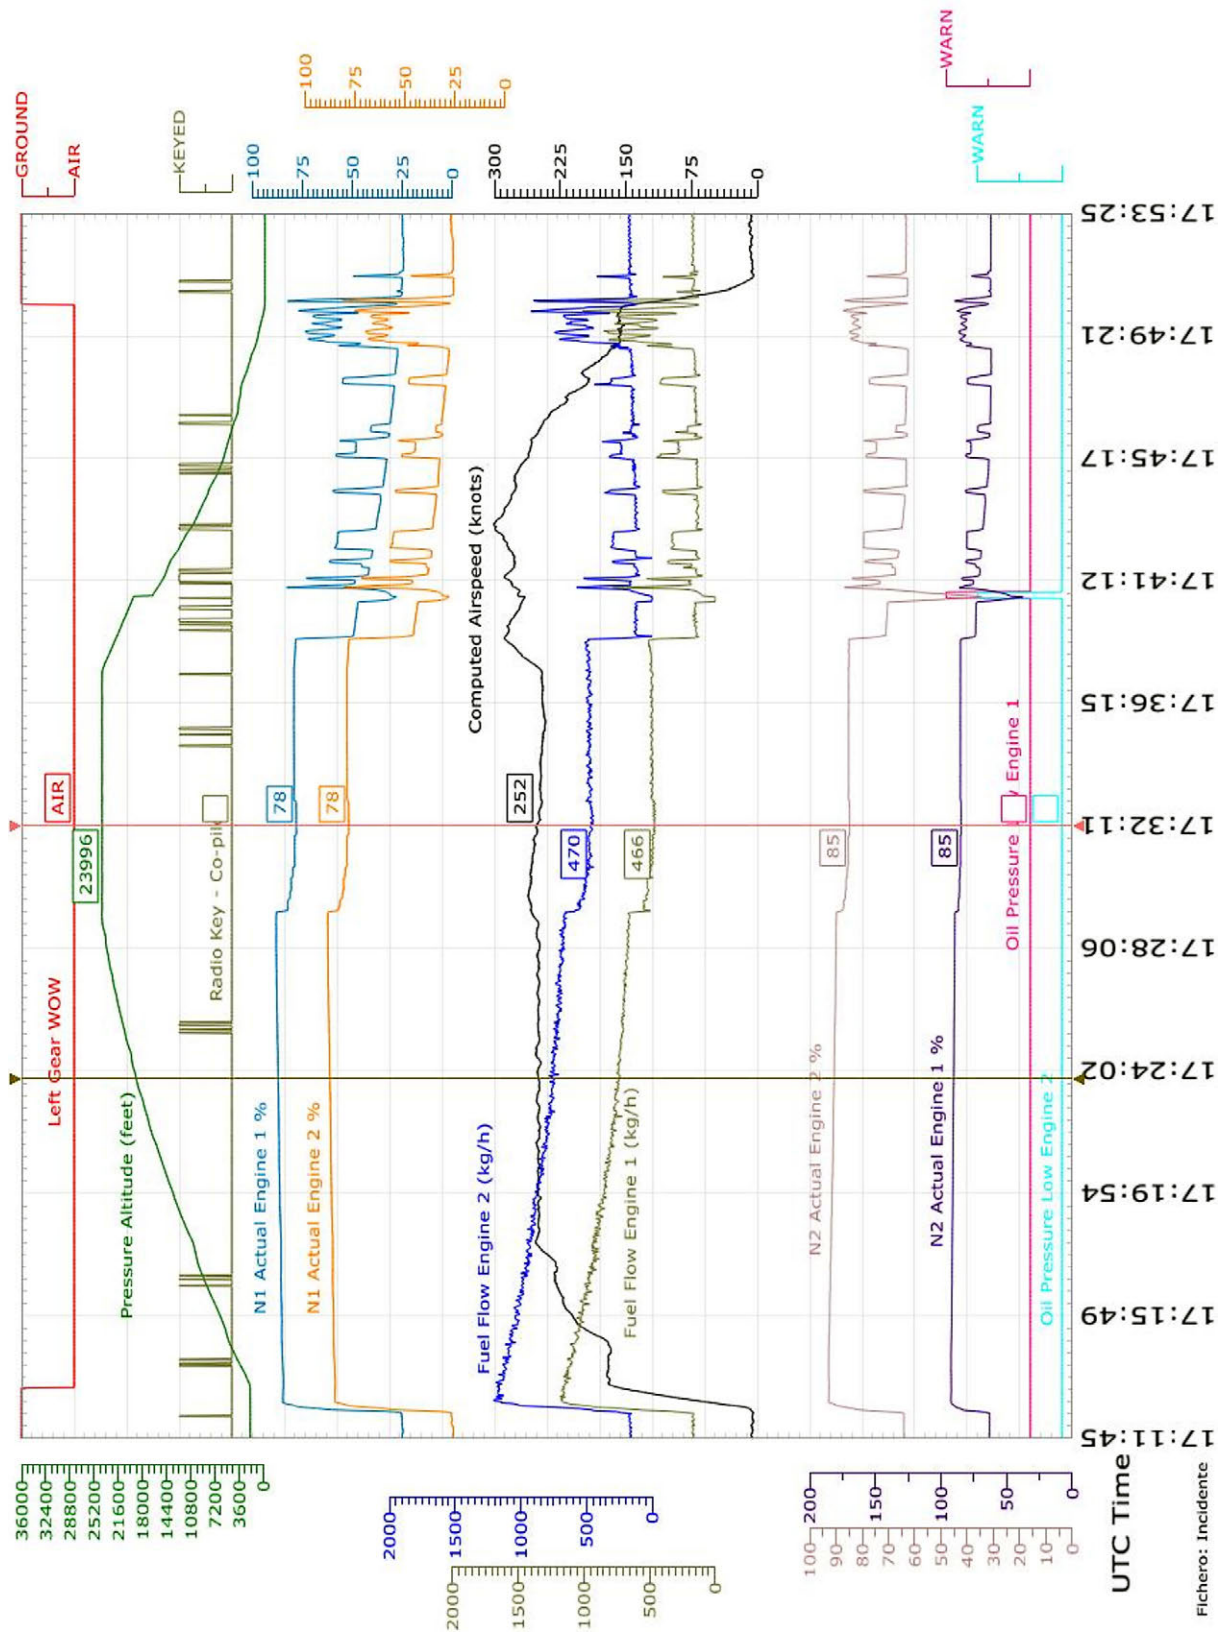
Engine data recorded on the DFDR

At 18:39:37 ATC asked if the aircraft could cross MOSCO established on flight level 80. The speed was 268 kt, the altitude 19,615 ft and the fuel flow to both engines was 0 kg/h. Ten seconds later the first of four "ENGINE OIL" warnings was heard in the cockpit. At that time the high-pressure compressor rpm's were at 42% in both engines.

The flight data recorder showed simultaneous low oil pressure warnings in both engines at 18:39:43.

At 18:40:44 the FDR resumed operation. The fuel flow readings were 109 kg/h in the left engine and 103 kg/h in the right.
