Report A-011/2009

Accident involving
a Eurocopter AS 350 B3,
registration EC-IOJ, in Mollet
del Vallés (Barcelona),
on 22 June 2009

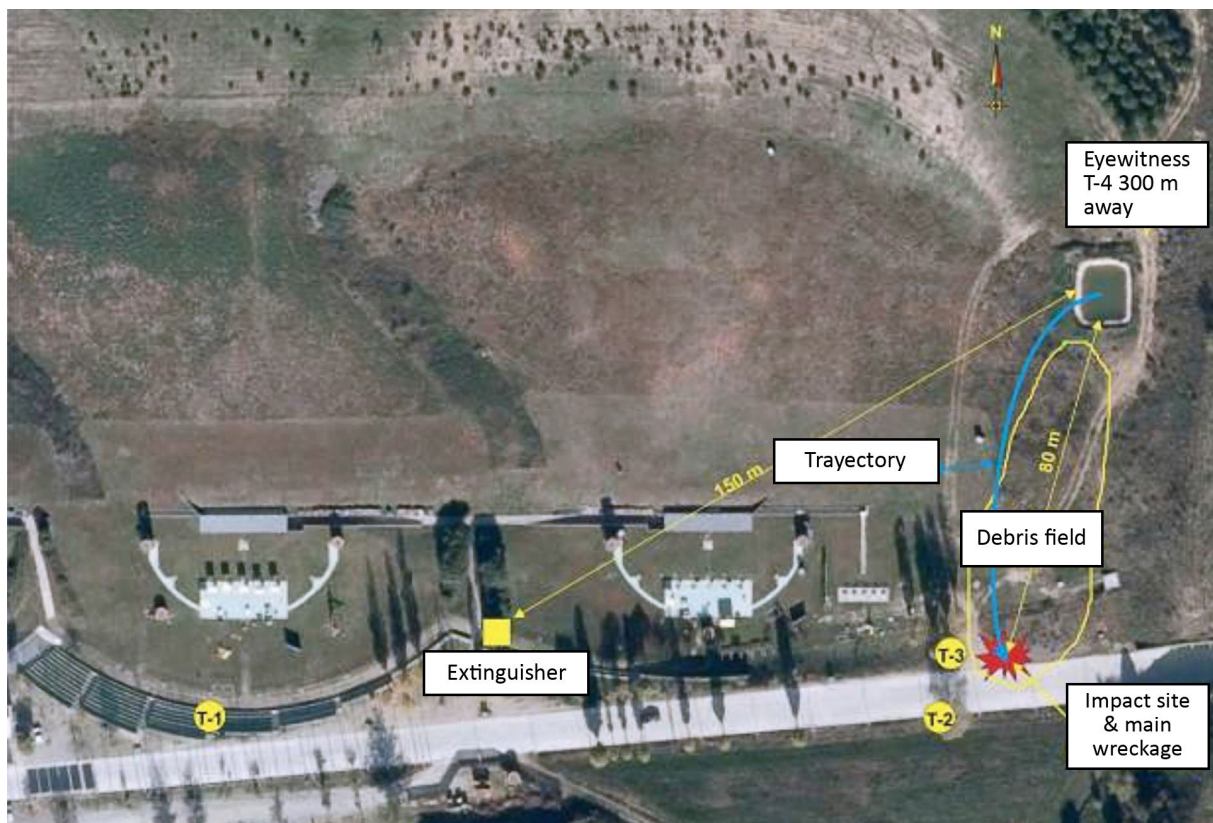
Figure 2. Location of wreckage and eyewitnesses

The main aircraft wreckage was concentrated in an area about one meter away from the right edge of the entrance road to the shooting range. A small amount of debris was found elsewhere (see Figure 2).

The extinguisher located in the helicopter was found some 110 m west of the impact point, between the first and second set of bleachers (see Figure 2). It was broken and bent such that a portion of its circumference along the midpoint was completely flat.

The accident was seen by four eyewitnesses situated at different locations, labeled T1, T2, T3 and T4 (see Figure 2), close to the impact site. Their statements revealed the following:

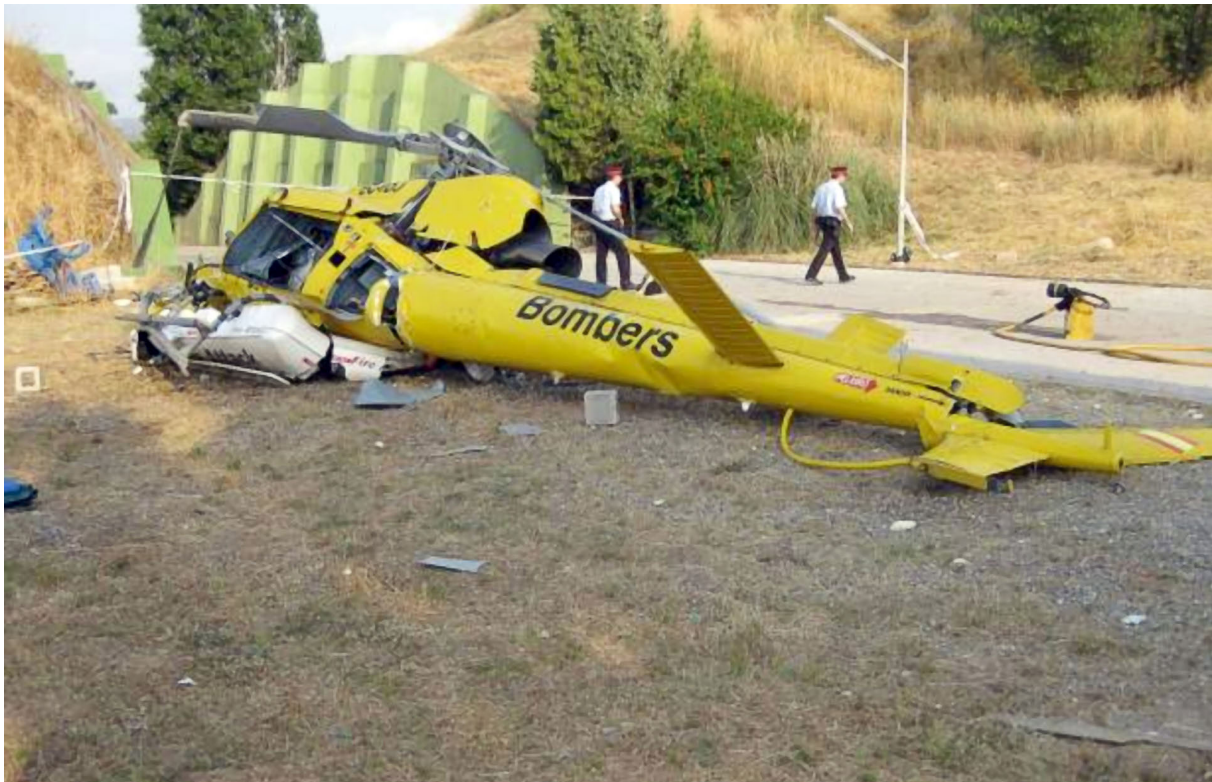
Figure 3. Main wreckage

The helicopter showed signs of having impacted at a high pitch angle and at a slight right bank angle. While the aircraft's nose and cabin exhibited severe damage, the rest of the airframe and the tail section showed no evidence of an impact, nor were there drag marks along the ground. The main aircraft wreckage was oriented on a heading of 130° (see Figure 3).

Based on the position in which the main wreckage was found, and as corroborated by various eyewitnesses, the helicopter impacted the ground at a high pitch angle and a slight right bank angle.

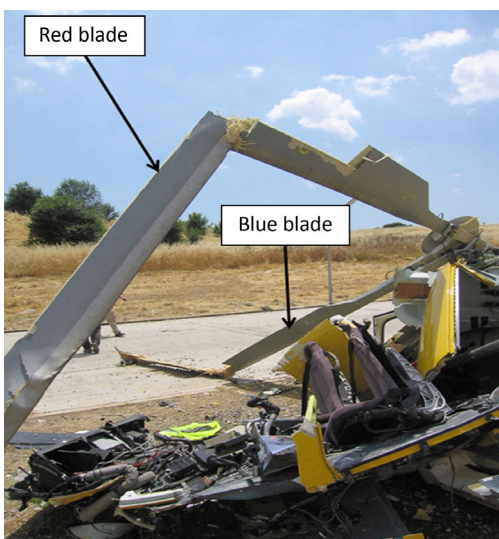
Figure 4. Condition of red and blue blades

The blades were severely damaged, though the only damage exhibited by the yellow blade was delamination at the tip. The other two —red and blue— had fractured and lost a large amount of material, showing signs of high impact damage.

There was red paint at a point 1.8-m away from the root on the leading edge and top surface of the blue main rotor blade, which was resting on the ground to the right side of the helicopter, and a broader patch of orange paint on the leading edge and lower surface. The blade had fractured 2.45-m away from the root with severe impact marks on the leading edge.

The red blade, which was toward the front part of the helicopter, was partially sheared 2.75-m away from the root due to an impact from its leading edge and to its side impacting the ground (see Figure 4). The counterweight that is located behind the leading edge in this area (see Figure 5) was ejected and found some 240 m west of the crash site.

There were red paint marks on the leading edge and top surface of the blue blade at a distance of 1.8 m from the root, corresponding to where this blade impacted the extinguisher, which was located to the right and below the pilot's seat and was ejected when the helicopter impacted the ground. The extinguisher was found some 110 m west of the impact point. It was broken and bent such that part of its circumference at the halfway point was completely flat, consistent with an impact with a flat surface such as the blade's. This same blade also had orange paint marks on the leading edge and bottom surface, evidence of an impact with the suction pump, possibly in the area of the spiral tubing, which has a lower strength than the part with the electric motor. This caused this area to break into several pieces, which were scattered over the ground. Moreover, the blade was broken at a point 2.45 m from the root, exhibiting irregular marks on the leading edge from a severe impact against a blunt object. The irregular shape of this impact area and the lack of orange paint rule out an impact against the suction pump, and seem to indicate that the blade could have

The red blade was also broken near its halfway point, with the outer part hanging vertically. The impact was extremely violent and resulted in a portion of the blade's counterweight detaching, this part being found 240 m west of the impact site. The deformation of the detached counterweight—it was round and matched the cylindrical shape of the suction pump housing perfectly—and the marks on said housing indicate that these two components impacted each other, leading to the fracture of the blade.

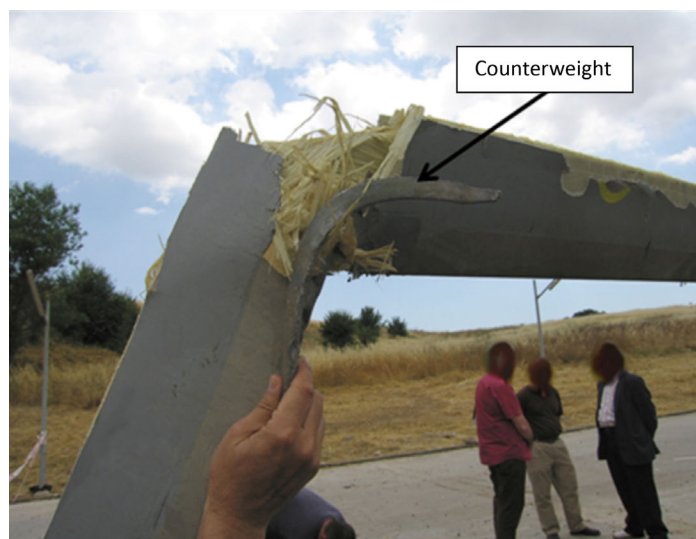
Figure 5. Red blade. Close-up of detached counterweight

The red blade violently struck the suction pump motor, resulting in the fracture and detachment of part of that blade's counterweight.

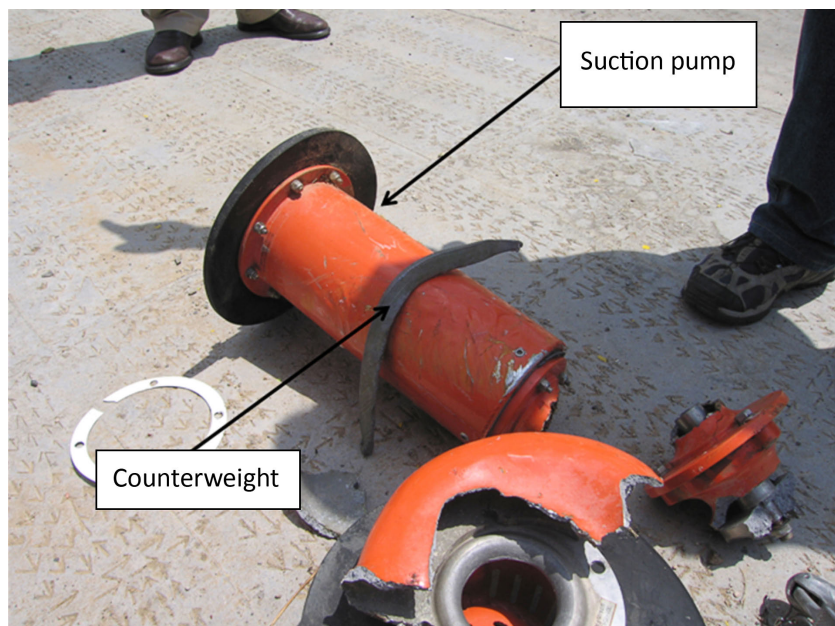
Figure 6. Parts of the suction pump and counterweight ejected from the red blade

Between the pond and the impact point there were debris with impact marks, belonging mainly to the suction pump —filter, guard, spiral tubing, electric motor assembly, protective housing— as well as components that had detached from the main rotor blades.

Scattered between the pond and the impact point were the remains of various suction pump components—filter, guard, spiral tubing, electric motor assembly and protective housing—all with impact marks. Also found in this area were pieces that had detached from the main rotor blades.

- REC 12/12.** It is recommended that SIMPLEX modify the design of the water-dropping system so that it can be detached from the aircraft in the event that the suction pump or hose on the system is inadvertently ensnared.
- REC 13/12.** It is recommended that the EASA and the FAA establish the mechanisms necessary to ensure that water-dropping system SIMPLEX 310 can be detached from a helicopter in the event that the suction pump or hose on the system is inadvertently ensnared.
