CIAIAC

Report A-012/2009

Accident involving a P-68
OBSERVER II aircraft,
registration EC-IPG, in Sant
Pere de Vilamajor (Barcelona),
on 23 June 2009

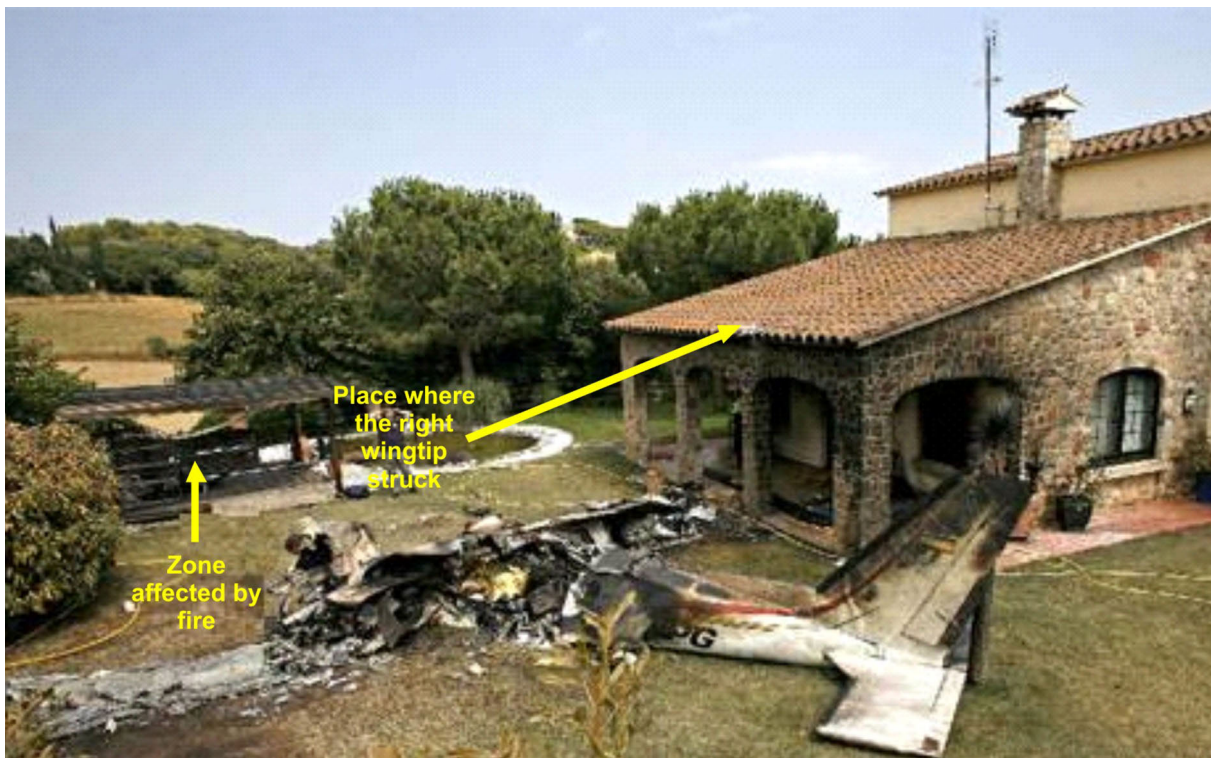
The front part of the aircraft showed significant impact damage. The cockpit, which was fully enclosed in glass, was practically destroyed.

There was considerable damage along the front half of the fuselage, affecting the underside. The rear half was mostly undamaged.

Figure 2. Photograph of the aircraft after the impact

The rear section of the airplane was resting on the ground. The horizontal stabilizer was touching a tree and did not show any significant impact damage.

The engines impacted the ground and were severely damaged. The blades on both propellers, however, were in one piece and were not significantly damaged.

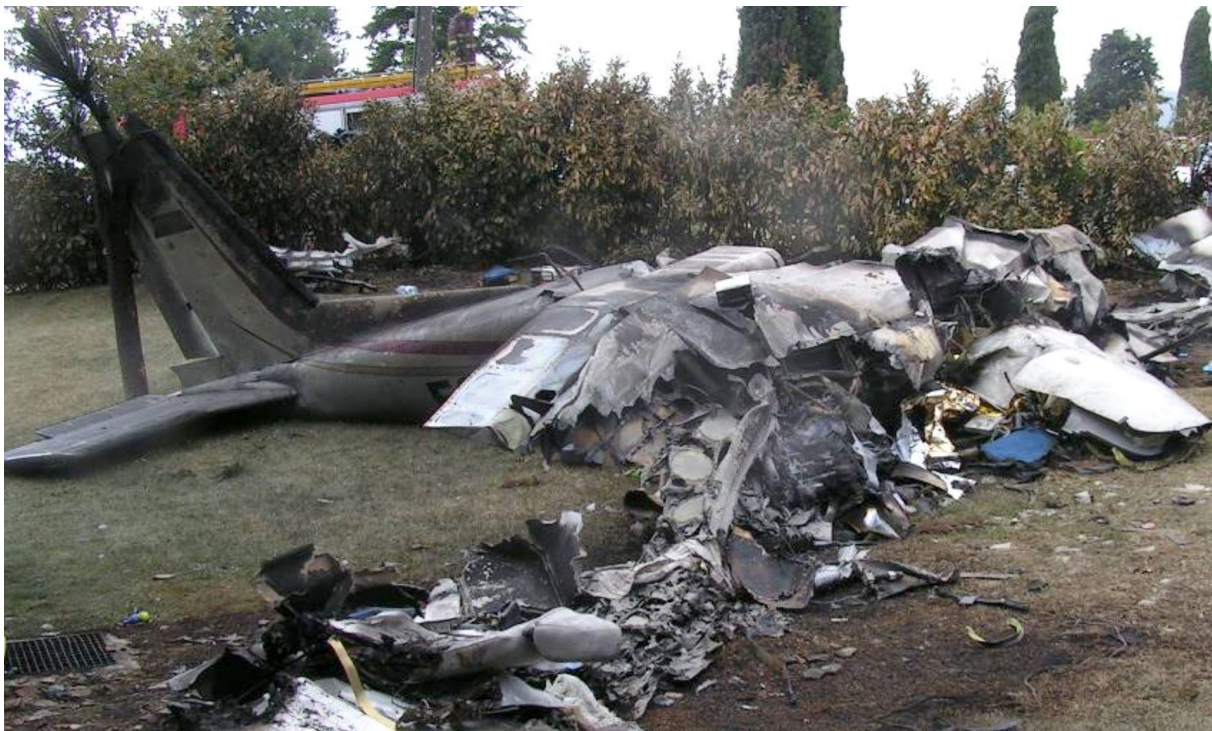
The cockpit was completely destroyed on impact. The instrument panel was heavily damaged. Only the two navigation and communications units retained a certain degree of integrity.

The wing was practically destroyed by the fire. The few remaining parts showed accordion-shaped folds from the leading edge back, resulting from the compression stress of the impact. The flap on the right wing was almost intact and was deployed 15°. The aileron was destroyed in the fire. The aileron on the left wing was preserved, but the flap area nearest the aileron was charred over 70% of its surface.

Figure 7. Condition of the wreckage

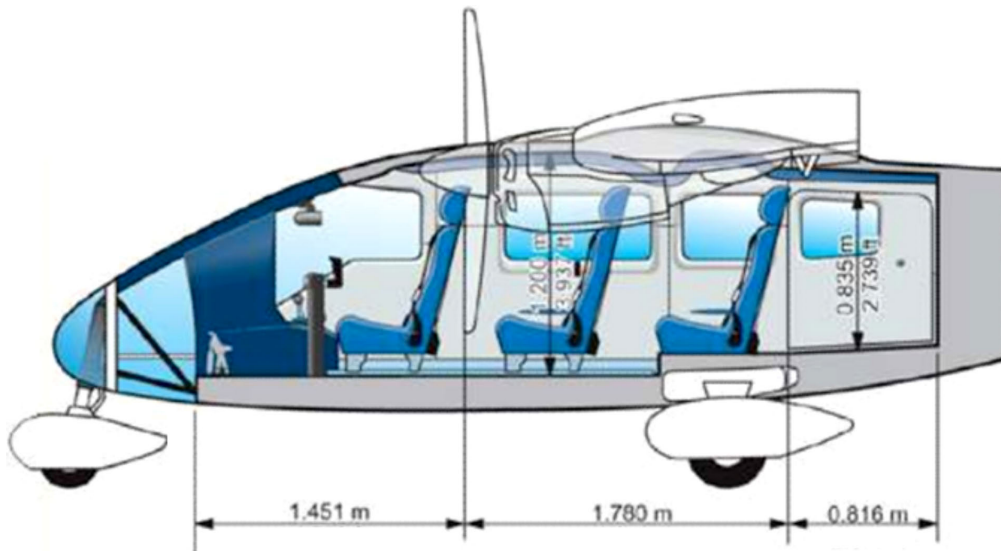
A fire broke out after the impact, which spread over the length of the wing and fuselage, affecting mainly the entire cockpit area and, to a lesser extent, the rest of the fuselage and the aft portion, which only suffered minor smoke damage.

Figure 8. Area affected by the fire

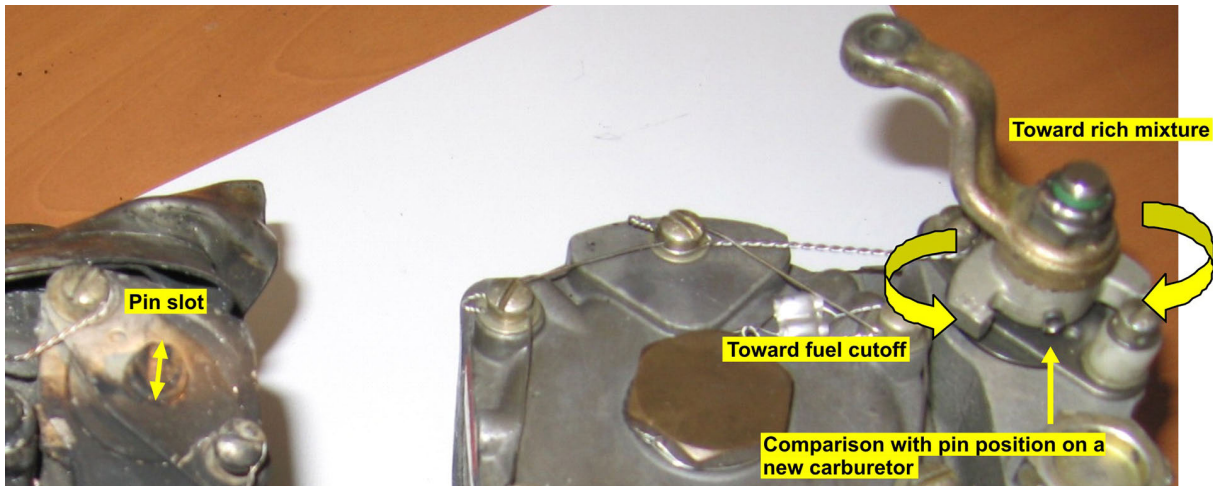
A similar effort was made to attempt to determine the status of the mixture controls, checking the position of the slot that house the pins on the servo mechanism. The slot on the left carburetor was in a position that indicated that the mixture was close to its "rich mixture" setting. The servo mechanism had detached following the impact, however, so its position may have shifted after detaching.

Figure 9. Condition of mixture in left carburetor

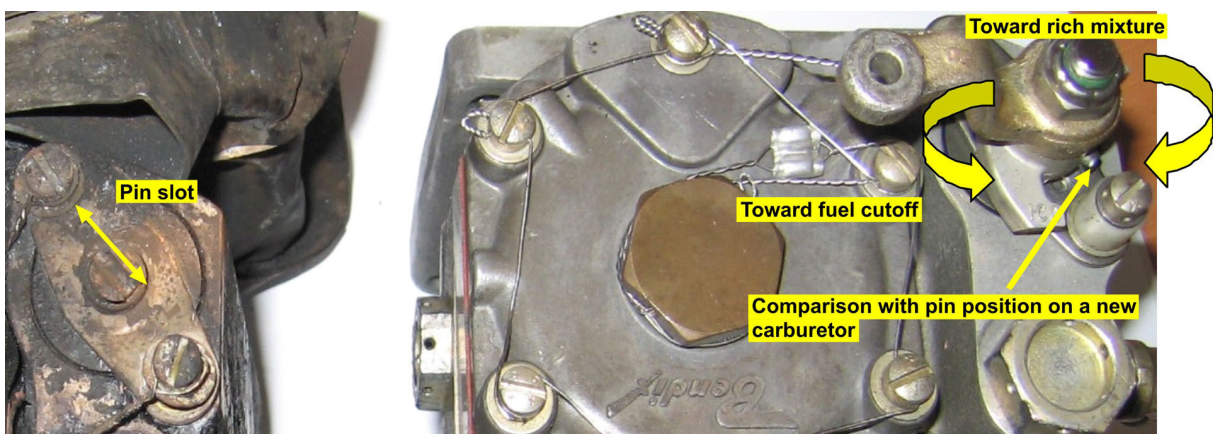
In the right engine carburetor, the pin slot was in a more intermediate position, but closer to the cutoff position. The servo mechanism had also broken off, meaning that, as in the left carburetor, it is impossible to say with any certainty what its position was prior to impact.

Figure 10. Condition of mixture in right carburetor

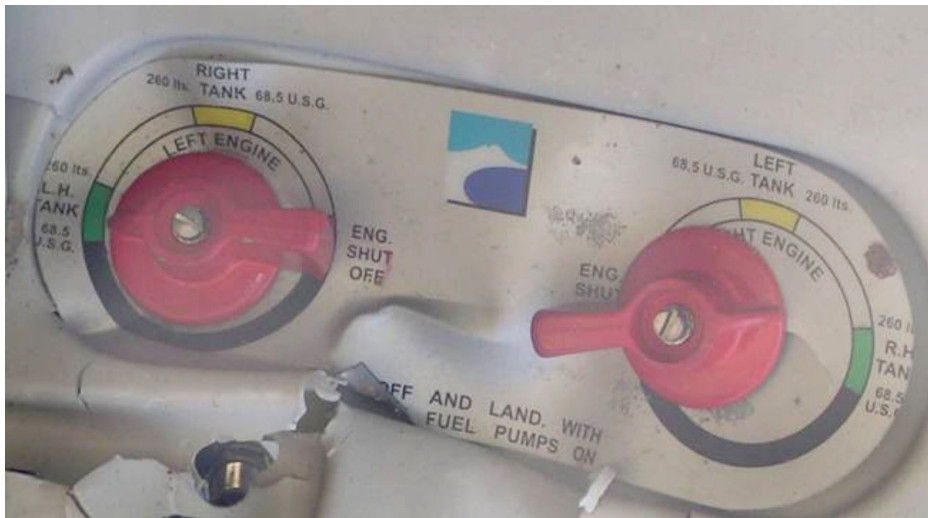
The overhead area of the cockpit that housed the fuel selector knobs was slightly damaged by the impact. The left engine flow valve was selected to its normal position (left tank feeding the left engine) and the right was in an intermediate position between normal (right tank feeding right engine) and crossfeed (left tank feeding right engine).

Figure 11. Fuel selector knobs

One explanation for this fact is that the area where the knobs are located in the cockpit had been slightly damaged by the impact, especially in the vicinity of the knob for the right engine, such that the position indicated by this knob was not reliable. The position of the knob for the left engine (normal) is considered reliable.

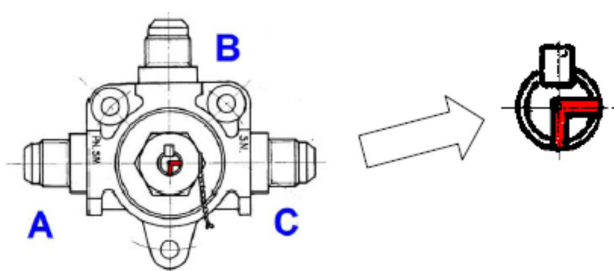
The rotating spindle on both valves was in the same position (see Figures 12 and 13), which would correspond to the fuel cutoff position in the right valve and with none of the three allowed positions for the left.

Figure 12. Position of valve shaft

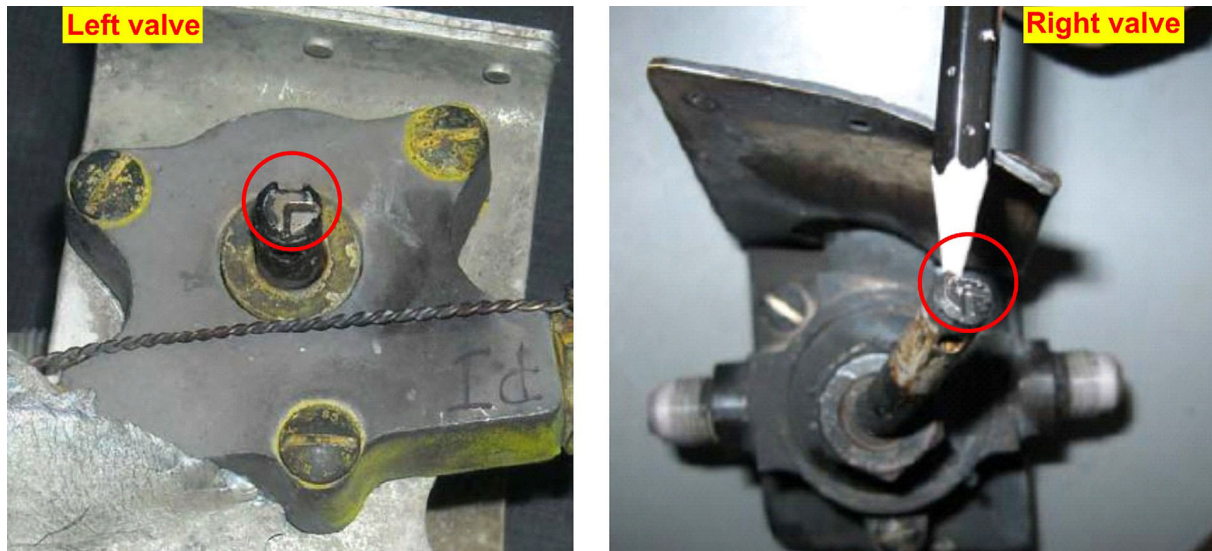
The disassembly of the left valve showed that it had been greatly affected by the fire, particularly the gaskets. It was also noted that the internal ring was burned and that fragments had detached from it. The control cable was also burned and scratched. Some of the gear teeth were broken.

Figure 13. Photographs of the valves, as seen from behind

The right valve was also disassembled. The threaded parts were loose, probably as a result of the high temperatures reached in the post-accident fire. All of the internal components were in good condition.

The analysis confirmed that the position of both valves' rotating spindles was as described above. It also concluded that the spindle on the left valve had become stuck and that the gasket had moved out of the selected position as a consequence of the sharp pull on the control cable during the impact, which would explain why it was found in a position that was not selectable under normal operations.

With regard to the right valve, it was confirmed that it was in the fuel cutoff position, and that the discrepancy between this position and that selected in the cockpit was probably due to the damage caused by the impact to the part of the cockpit where the selector knob was located.

As for the valves, the one for the right engine showed no external or internal damage, meaning that its position (cutoff) was as determined by the laboratory analysis. The interior of the left valve, however, especially the gaskets, was significantly damaged by the impact, meaning that its position, which did not agree with any of the three possible settings, had resulted from the fracture of the spindle housed in its interior. This could also explain the partial flow noted between the different ports on the valve during some of the tests that were conducted.
