## DATA SUMMARY

Date and time	Thursday, 22 October 2009; 10:50 UTC
Site	Runway 25R at the Barcelona Airport (Spain)

Registration	PH-DXB
Type and model	DE HAVILLAND DHC-8-315
Operator	Air Nostrum (Operated by Denim Air)

Date of approval	19 <sup>th</sup> December 2012
------------------	--------------------------------

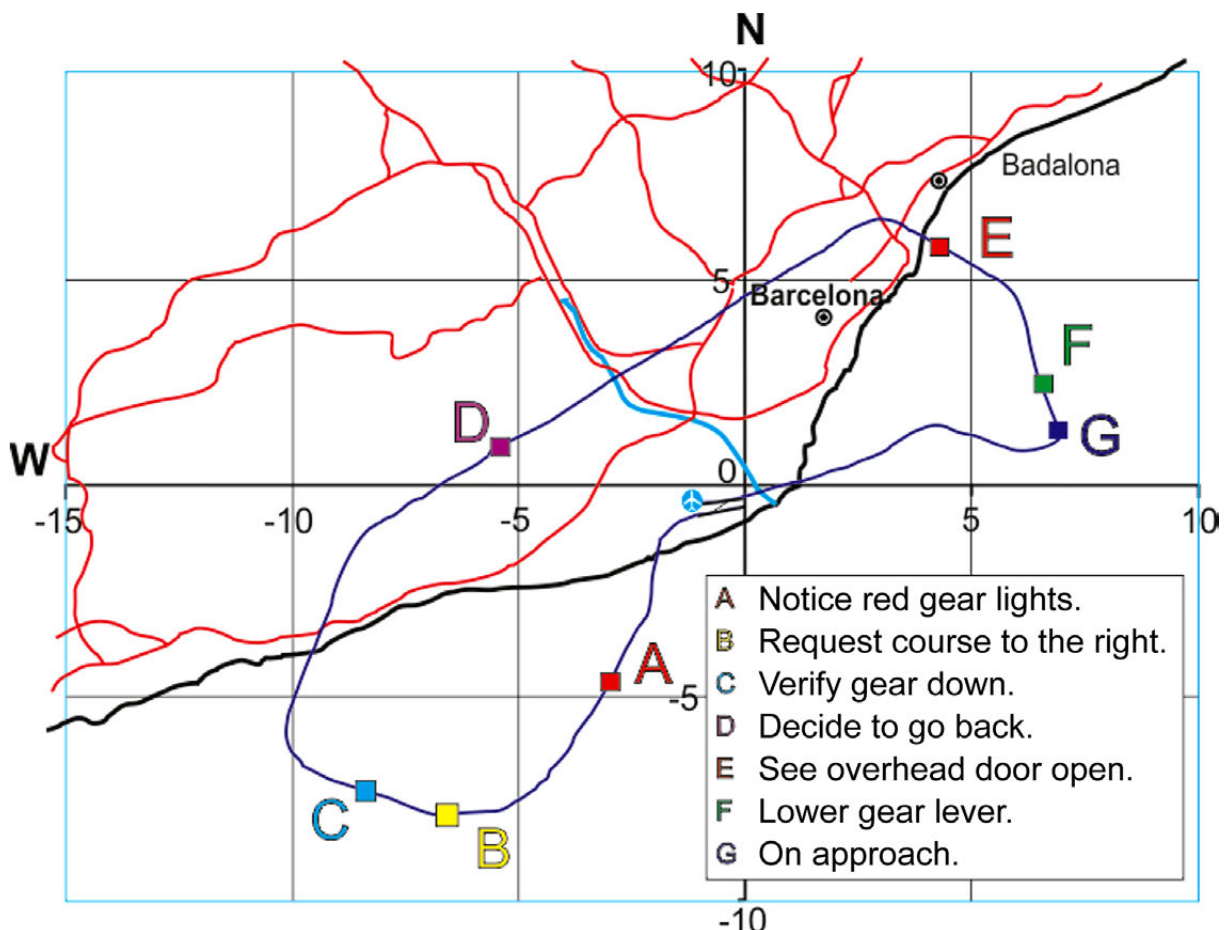
Figure 1. Flight path of the aircraft

Figure 1 shows the approximate flight path taken by the aircraft. This path was determined by integrating the TAS deduced from the IAS and using the magnetic data recorded on the DFDR. Also taken into account was a constant 18-kt wind from the SSW that was blowing on the morning of the incident, according to the meteorological information. The most significant points are labeled on the diagram.

A greater focus on the flight conditions after taking off and selecting gear up would have alerted the crew to the fact that the gear had not retracted. As it was, it took the crew three minutes to notice the situation. The airplane continued to climb and accelerate to an IAS of 199 kt, in excess of the top speed allowed with the gear down.

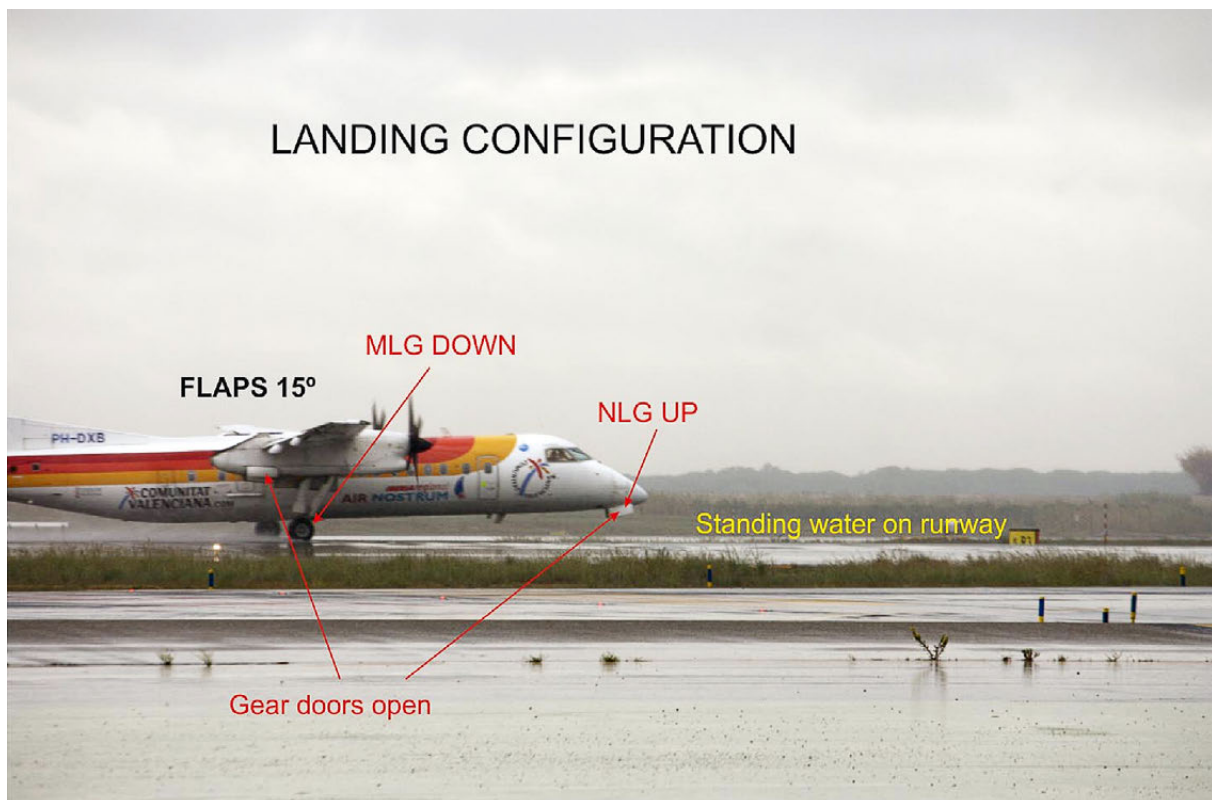
Figure 2. Photograph of the airplane during incident touchdown

Before landing, the crew noticed that they had two green lights for the main gear, one red light for the nose gear and three amber lights for the open doors on the three legs. On short final, assuming that the nose gear leg had not deployed, the crew declared an emergency and requested the presence of firefighters. They also notified the FA, who in turn informed the passengers. The aircraft landed on runway 25R at 10:48 after a 21:26-minute flight. The main gear was down and locked, the nose gear was up and the flaps were deployed 15°. The gear down not locked horn was sounding continuously and several GPWS warnings were received. The doors on all three legs were open (see Figure 2).

During the landing on the wet runway, the nose contacted the asphalt for about 12 seconds until the aircraft came to a complete stop, damaging the two nose gear doors. The passengers evacuated the aircraft under crew instructions, with two difficulties: getting the passengers to leave the aircraft and go into the rain, and many passengers did not obey the crew repeated instruction to leave hand baggage behind. Evacuation was aided by the firefighting service, which was on the scene.

- The gear indicating lights on the alternate system showed that the main gear was down and locked and the nose gear was unsafe and not locked.
- The landing was soft, which helped to minimize the damage, which was limited to the nose gear doors and scrapes in the fuselage in the area of the nose.

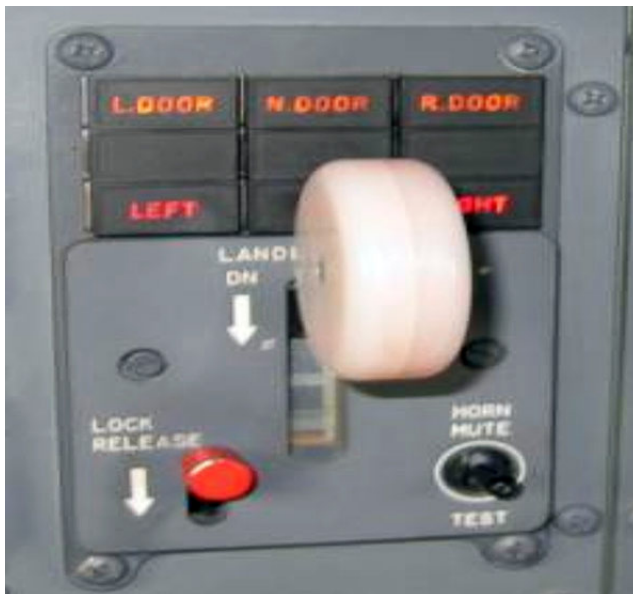
Figure 3. Gear lever and lights

The lever used to operate the gear also has an amber light. If it turns on at the same time as the red lights, this indicates that the gear is in transit. If it remains on after the gear is retracted, this means that the door sequence has failed. If this light remains on, the gear must be lowered using only the alternate method.

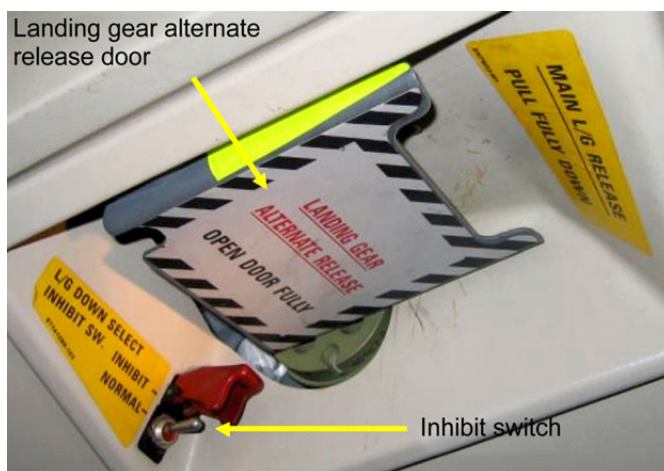
Figure 4. Gear inhibit switch

- An overhead door labeled "Landing Gear Alternate Release" (Fig. 4), behind which is a "T" type handle to open the main landing gear doors and release the main gear. Opening this door actuates a bypass valve in the hydraulic system used for the normal operation of the gear. Alongside this door is the gear "Inhibit Switch".

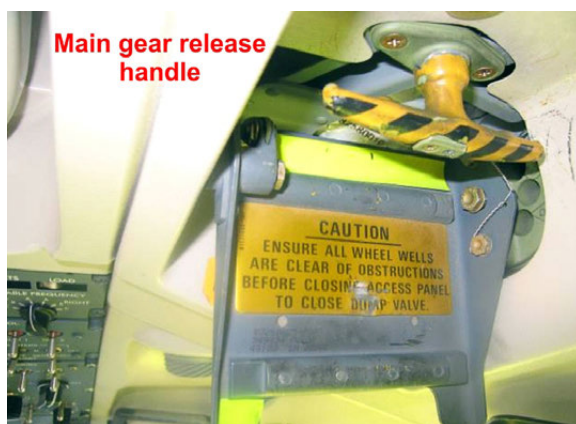
Figure 5. Overhead door

The “Landing Gear Alternate Release Door”, located in the overhead in the cockpit, was probably partially open when the crew reported to the airplane, but if so, this was not detected either by the CPT during her check of the cockpit or subsequently by either pilot at any time prior to takeoff. The airplane thus took off with this condition uncorrected.

Starting with the flight preparation, the normal pre-flight CL (checklist) has the pilots check the alternate gear extension controls. A careful check of the cockpit upon reporting to the airplane would have eliminated the cause that triggered the incident, namely the partially or fully open position of the overhead door.

The cause of the incident was the improper operation of the landing gear system by the crew that, due to both a lack of knowledge of said system and to deficiencies in the use of the available procedures, was unable to identify or correct the abnormal configuration of the Landing Gear Alternate Release Door.

- REC 92/12.** It is recommended that the manufacturer Bombardier Inc. (former De Haviland) and the operator DENIM AIR define and implement an operating procedure on requiring crew actions in the event of an unsafe gear indication that checks the position of the Landing Gear Alternate Release Door and of the Inhibit Switch on the landing gear hydraulic system.

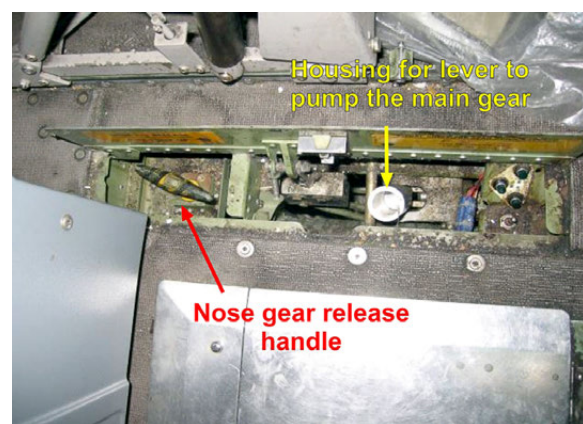
Figure 6. Floor door

- A door on the floor labeled "Landing Gear Alternate Extension" (Fig. 6), behind which is a "T" type handle to open the nose landing gear doors and unlock the nose gear, an alternate gear indication system and a fitting for inserting a pump handle used to operate the manual pump that uses the auxiliary cylinder to assist in locking the main gear. Opening this door actuates a valve that redirects hydraulic fluid to lower the main gear using the alternate method.

The noise from the PTU made the crew open the overhead door again, which reactivated the bypass of the hydraulic system. The floor door very likely remained open and thus the bypass of the alternate, or standby, hydraulic system remained closed. Under these conditions, the auxiliary cylinder cannot move, and thus cannot provide a hydraulic lock for the main legs regardless of their position. The main legs, therefore, did not move from the down position, nor would they unlock from said position.

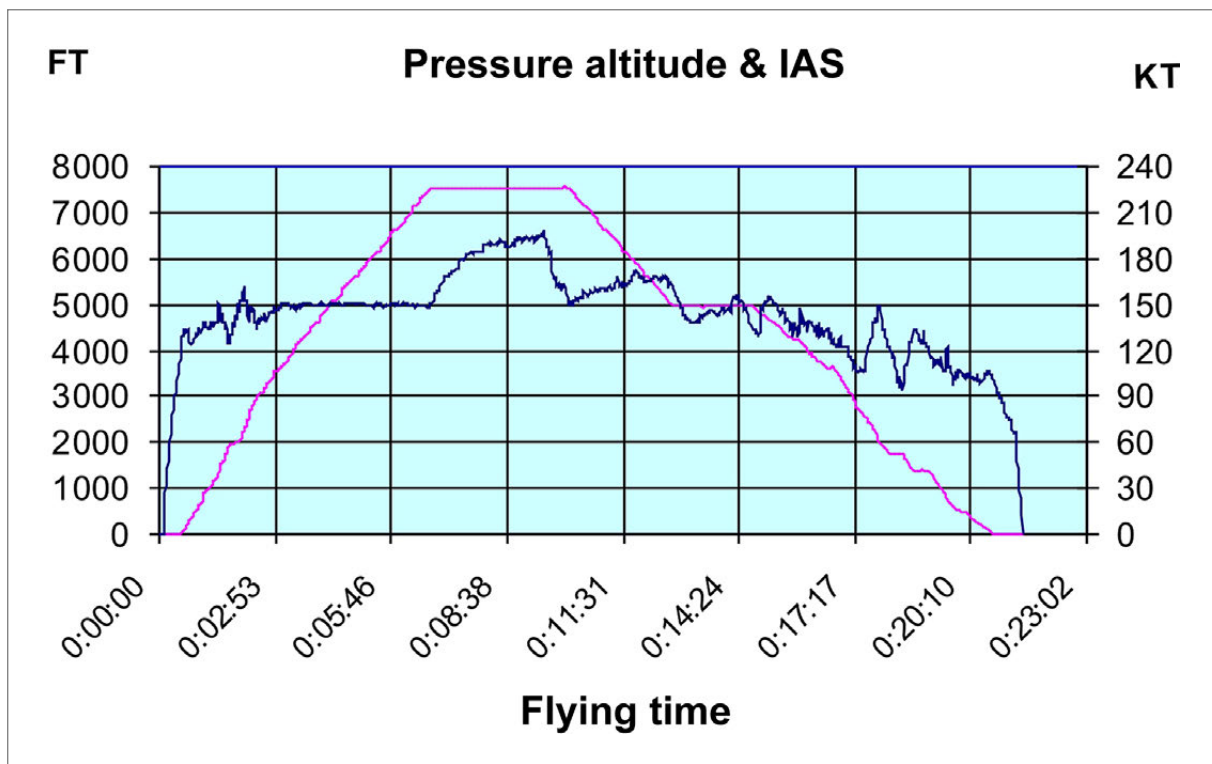
Figure 7. Graph of speed and altitude

The graph in Figure 7 shows the IAS (blue) and altitude (magenta) over the course of the flight.

The maximum vertical acceleration at touchdown was 1.33 g's. The longitudinal deceleration during the landing run was between -0.25 to -0.54 g's.
