DATA SUMMARY

Date and time	Thursday, 14 January 2010; 10:09 UTC
Site	Girona Airport (Girona, Spain)

Registration	EI-EBL	EI-DWT
Type and model	BOEING 737-800	BOEING 737-800
Operator	Ryanair	Ryanair

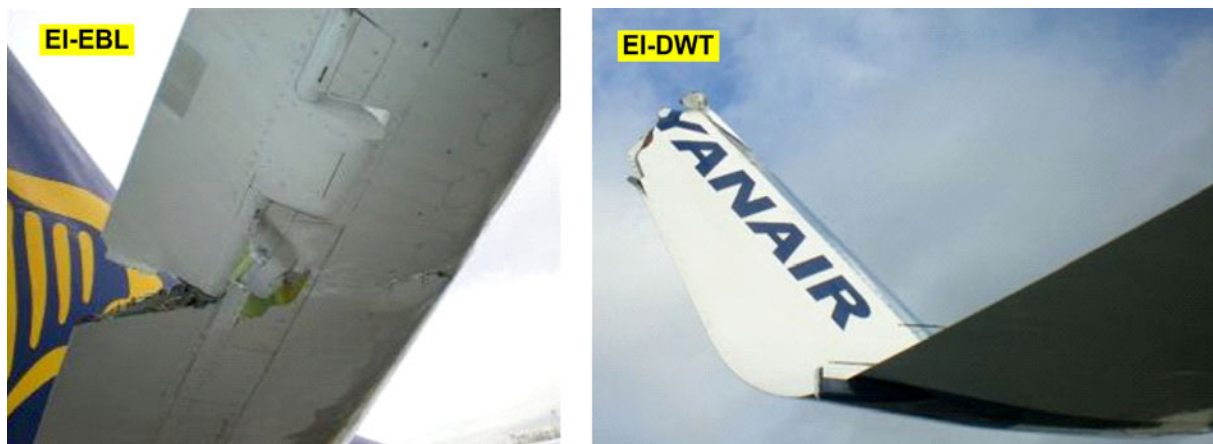
Figure 1. Damage to aircraft

As EI-DWT was overtaking EI-EBL, it struck the latter's horizontal stabilizer with its left winglet. Following the impact, the crew of aircraft EI-DWT reported it to both the control tower and to the other aircraft. The tower cleared both aircraft to return to parking via the runway. EI-EBL did so first, followed by EI-DWT.

Aircraft EI-EBL exhibited impact damage to the right part of the horizontal stabilizer along its trailing edge, some 1.42 m from the right edge. The damage affected both the fixed surface as well as the elevator. The damage to the other aircraft was limited to the fracture of the left winglet.

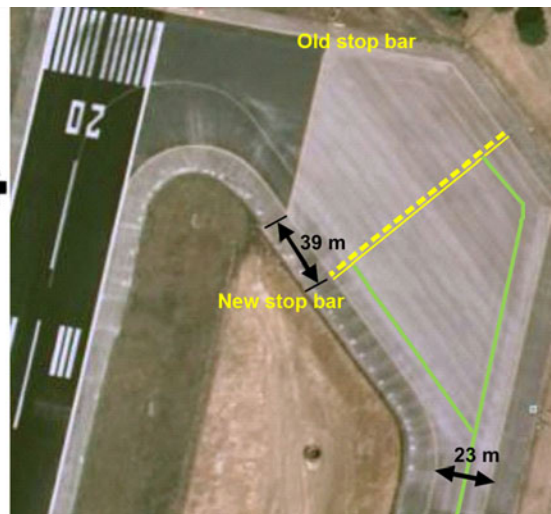
Figure 5. Stop bar

The aerodrome map for ground movements shown in the AIP on the day of the incident had the stop bar for runway 20 in a position different from its actual location. The same was true for the other threshold.

The airport reported that the location of the stop bar was changed in October 2009, when the ILS Cat II/III went into service, and that the information regarding the location of the stop bar was sent to the AIS (Aeronautical Information System) for publication in the AIP on 19 August 2009, though no NOTAM was published in this regard.

On the day of the incident the AIP still showed the position of the old stop bar. The position of the new bar was not reflected in the AIP ground movement chart until 29 July 2010. The information published in the AIP on the day of the incident did include the new ILS category (Cat II/III).

As a result of the above, the Commission believes a recommendation is in order for AENA to inform of changes to markings affecting airport operations as soon as possible via the method deemed most suitable, such as the issuing of a NOTAM, whenever the publication of the AIP that details said changes is delayed.

REC 05/11. It is recommended that AENA report changes to markings affecting airport operations, as well as of any possible consequences to aircraft operations, as soon as possible via the method deemed most suitable, such as the issuing of a NOTAM, whenever the publication of the AIP that details said changes is delayed.

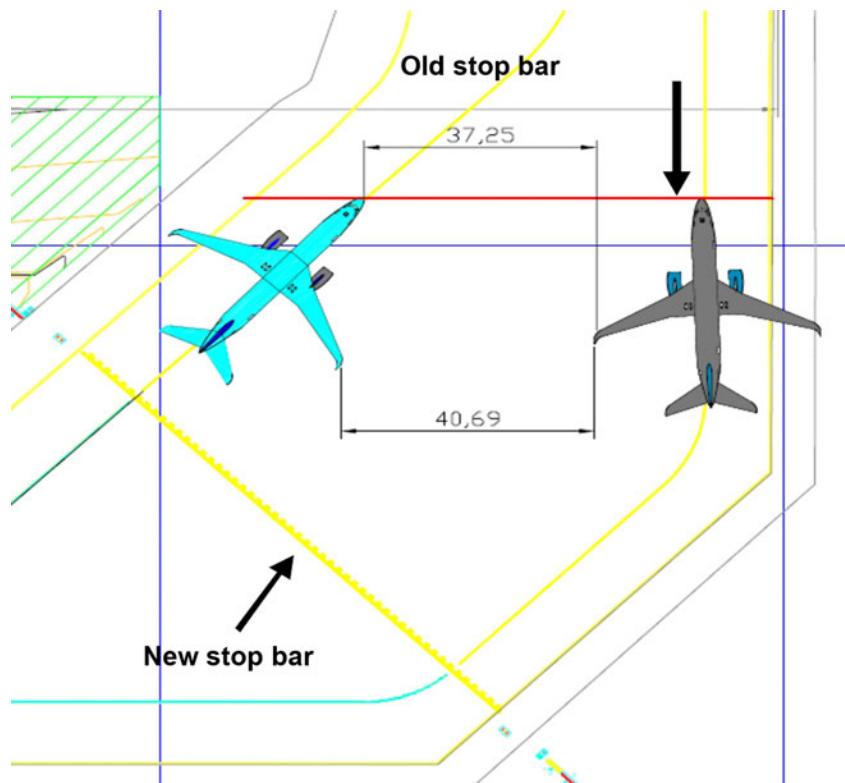
Figure 6. Positions at old stop bar

Figure 6 shows the clearances that existed for two airplanes of the same type as those involved this incident before the stop bar was moved.

The smallest clearance, 37.25 m, would have been between the nose of the airplane on the left and the left wingtip of the airplane on the right.

The minimum distance between their wings was 40.69 m. Based on the dimensions of the airplanes and on the values obtained from the measurements, the theoretical separation between the two airplanes during the overtake maneuver, that is, with the nose of EI-EBL situated above the stop bar and its longitudinal axis over the taxi line, and EI-DWT with its longitudinal axis likewise above the taxi line, was verified to have been 4.7 m. This is the distance that would have separated the left wingtip of the overtaking airplane (EI-DWT) and the right edge of the horizontal stabilizer on the stationary airplane (EI-EBL). See Figure 7.

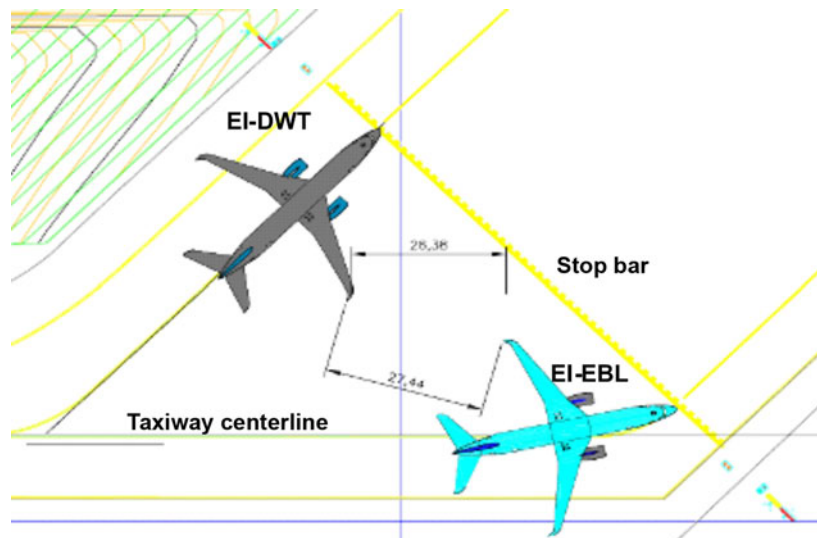
Figure 8. Another possible overtaking position

If airplane EI-EBL had stopped to the right of the stop bar, the margin for overtaking would have been greater, as shown in Figure 8.

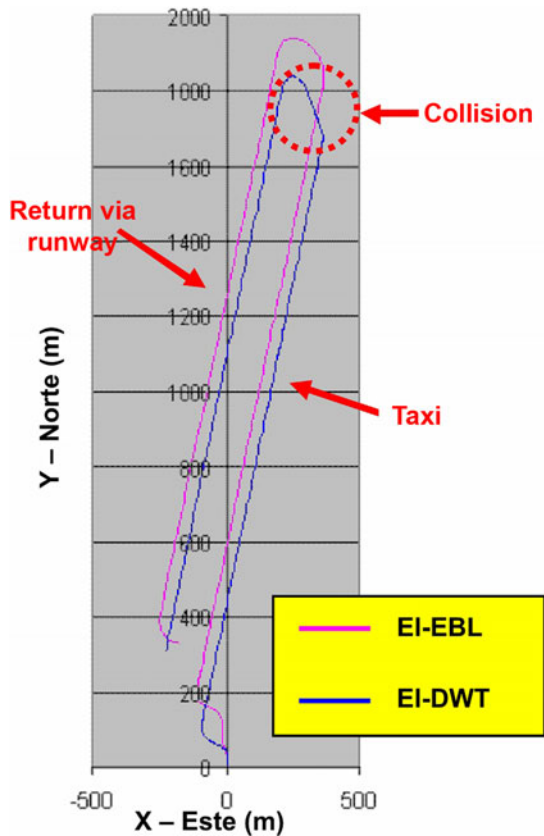
Figure 9. Diagram of trajectories

The airplane positional data for this report were obtained from the DFDR, which records this information based on data provided by the Inertial Reference Units (IRU). The IRUs measure, among other parameters, the airplane accelerations. Integrating the accelerations and speeds allowed investigators to obtain the paths for both airplanes over their entire trajectories, although the actual paths could not be determined accurately due to the accumulation of errors inherent to the inertial system as a data source. The diagram in Figure 9 shows the paths for the airplanes leaving the gates,

The exact position of the two aircraft at the time of impact could not be determined.

The coordinates obtained for aircraft EI-EBL were $41^\circ 54' 51.12''$ N - $2^\circ 46' 01.848''$ W, and $41^\circ 54' 48.6''$ N - $2^\circ 46' 01.848''$ W for aircraft EI-DWT. If these coordinates are overlaid on a map of the airport, the positions are inconsistent with the actual positions of the aircraft and yield a separation of 80 m between them, more than double the airplane's wingspan.

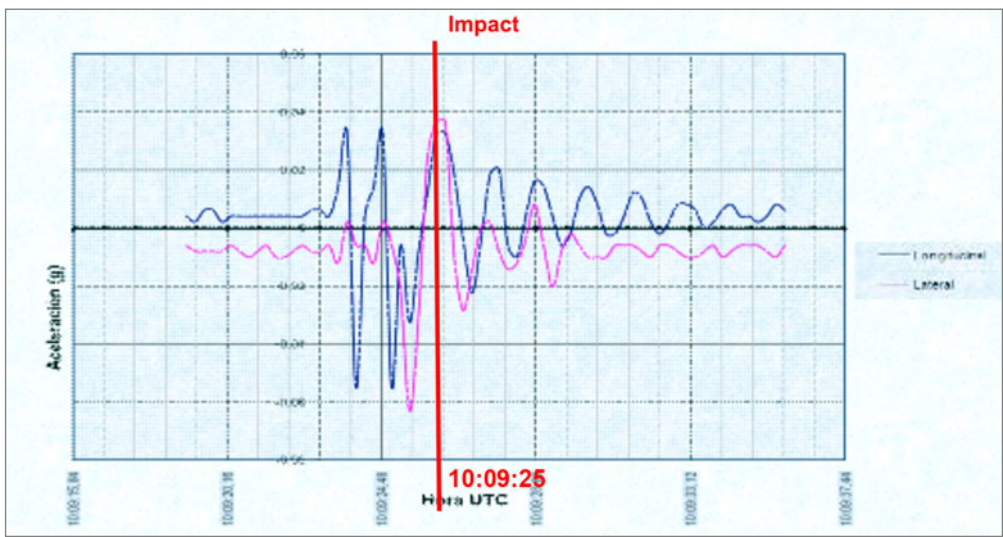
Figure 10. Longitudinal and lateral accelerations of EI-EBL

The graph in Figure 10 shows the longitudinal and lateral accelerations for the time interval between 10:09:19 and 10:09:35, which includes the period immediately before and after the impact. The variation in vertical acceleration was considerably less significant.

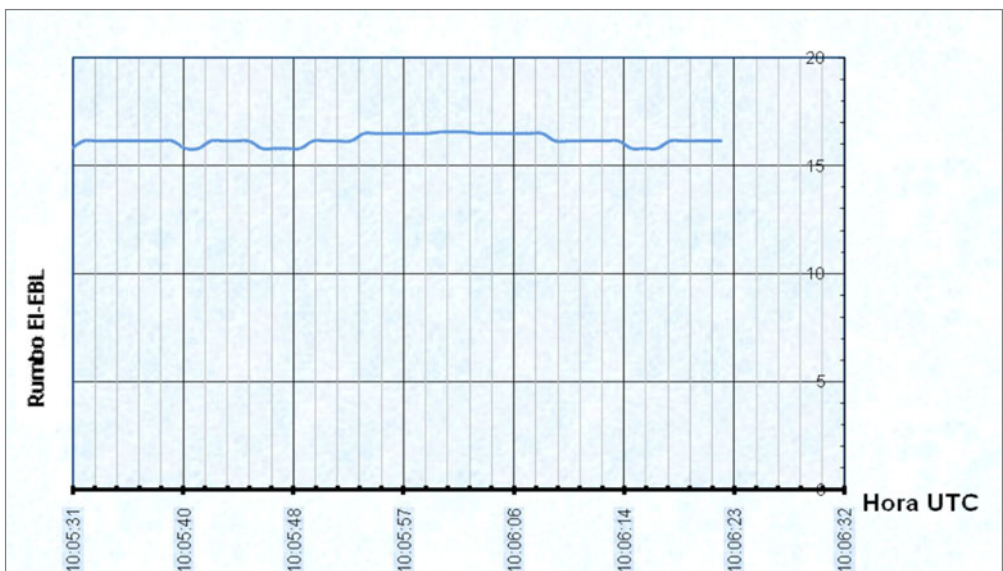
Figure 11. Heading of airplane EI-EBL on taxiway

longitudinal axis facing 331.523° . It remained in this position until the time of impact. Based on variations in the longitudinal and lateral accelerations, the time of impact was fixed at 10:09:25, at which moment the airplane's brake was set and exerting a pressure of 3,108.15 psi on the left brake and 3,080.14 psi on the right.

Figure 11 shows the airplane's heading as it taxied on the taxiway prior to coming to a halt at the stop bar.

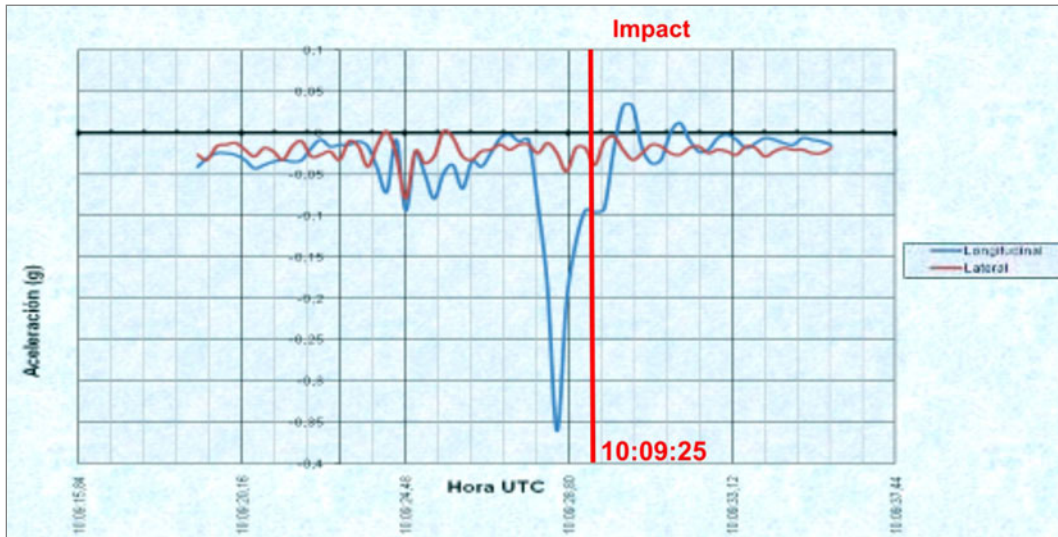
Figure 12. Longitudinal and lateral accelerations of EI-DWT

The graph in Figure 12 shows the longitudinal and lateral accelerations for the time period between 10:09:19 and 10:09:35, and includes the instants immediately before and after the impact. The change in the longitudinal acceleration was greater than that in the lateral acceleration.

As was the case with the stopped airplane, the variation in vertical acceleration was much lower.

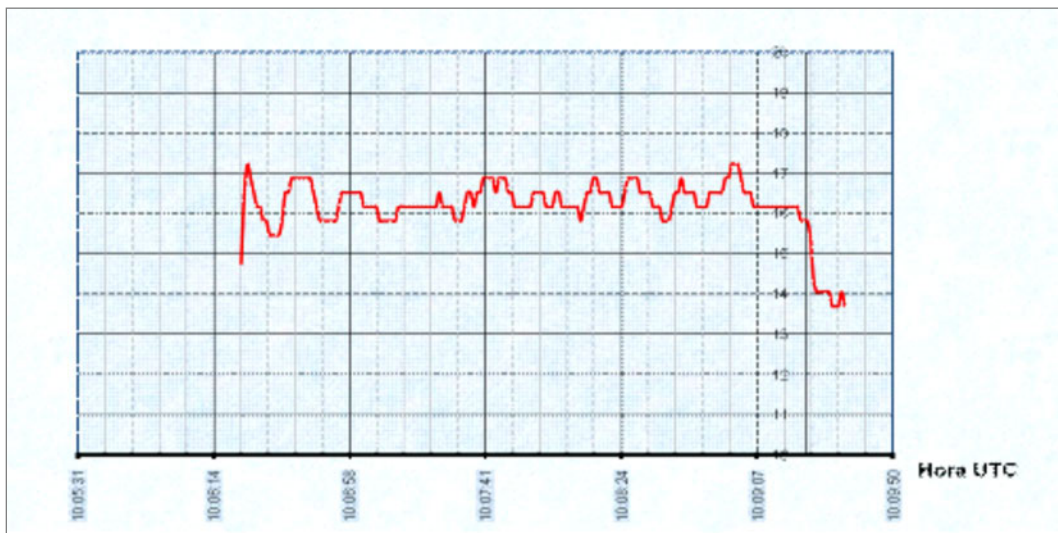
Figure 13. Heading of airplane EI-DWT on taxiway

The airplane entered the taxiway at around 10:06:23. During the time prior to the impact it was taxiing on a heading slightly to the left of the taxiway centerline (017°), except at two specific times, as shown in Figure 13.

The airplane was on a course of 14.0625° at the moment of impact, meaning it was 2.9375° left of the taxiway centerline, which is on a heading of 017°.

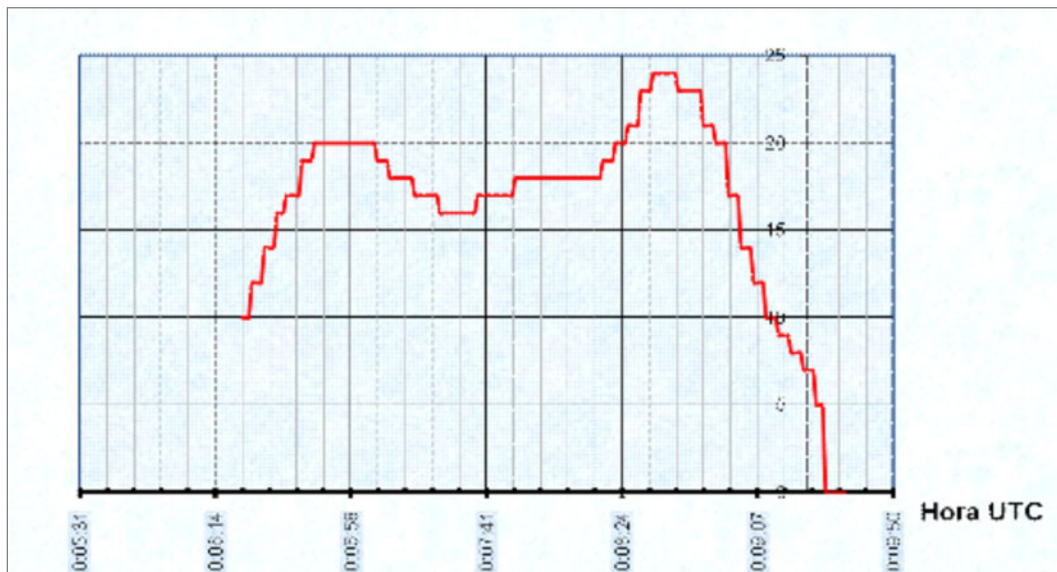
Figure 14. Speed of EI-DWT while taxiing

A study of the parameters revealed that at the time of impact, 10:09:25, the airplane was moving at a speed of 5.11 kt and that the top speed before the impact during the taxi phase had been 24 kt, between 10:08:35 and 10:08:39.

The graph in Figure 14 shows the speeds at which the airplane was moving while on the taxiway.

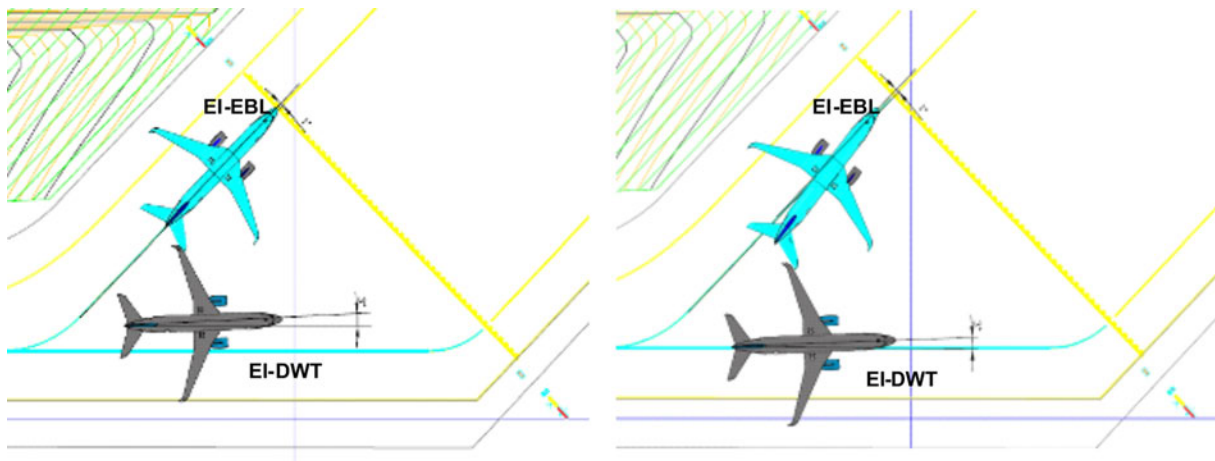
Figure 15. Relative positions of the airplanes

The left side of the figure shows airplane EI-EBL located atop the taxiway centerline with the nose over the stop bar and a heading practically equal to that which, in theory, it should have had. The other airplane, then, would have had to be outside of its required position. In contrast, the right side of the figure shows airplane EI-DWT over the taxiway centerline, which is the position where in theory it should have been, and 3° off course, meaning the other airplane would have had to be behind the stop bar.

Bearing in mind that both were slightly deviated from the course they should have taken (more so EI-DWT), the diagrams in Figure 15 show the most extreme cases from among many possible scenarios that could have occurred involving the likely positions of the two aircraft, namely that airplane EI-EBL was properly positioned and the other off the centerline (left), or that EI-DWT was over the centerline with EI-EBL well back from the stop bar (right).

These relative positions could have given rise to all types of situations with respect to that which, in theory, should have existed. At any rate, it seems clear that once airplane EI-EBL came to a stop, the crew of airplane EI-DWT misjudged the distance separating both aircraft.
