Report A-002/2010

Accident involving an
AgustaWestland AW139 helicoter,
registration EC-KYR, operated
by INAER HELICÓPTEROS
OFF-SHORE off the coast
of Almeria, on 21 January
2010 at 20:16 local time

**Accident involving an AgustaWestland AW139
helicopter, registration EC-KYR, operated
by INAER HELICÓPTEROS OFF-SHORE
off the coast of Almeria, on 21 January 2010
at 20:16 local time**

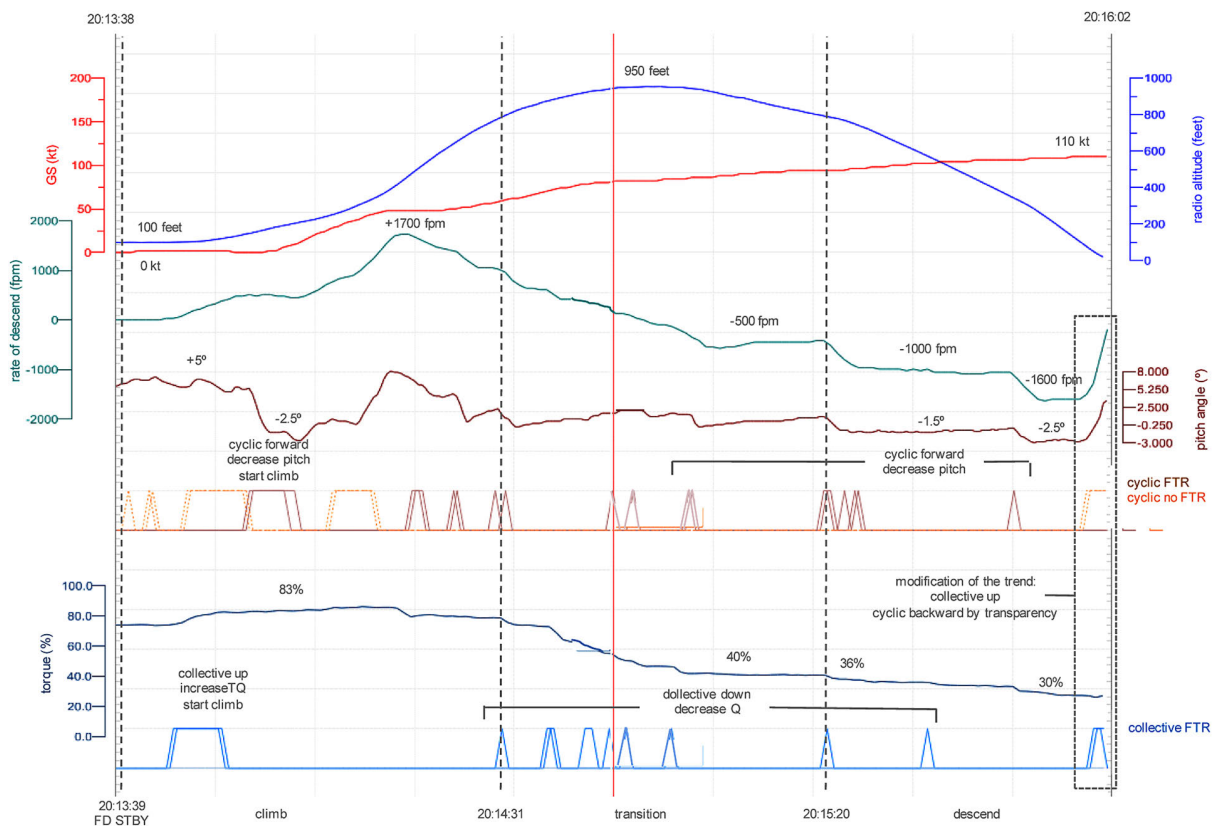
Figure 3. Return flight to Almeria. Flight profile and inputs to flight controls

At 750 ft, the captain started a series of six inputs to the collective FTR (decreasing torque to 40%) and to the cyclic FTR. These inputs were used to stop the climb and transition very gradually into the descent phase. The highest point reached in the trajectory was 950 ft at 20:14:59 h, with a GS of 90 kt. From that point until 780 ft, the helicopter descended at a rate of 500 ft/minute and increased speed.

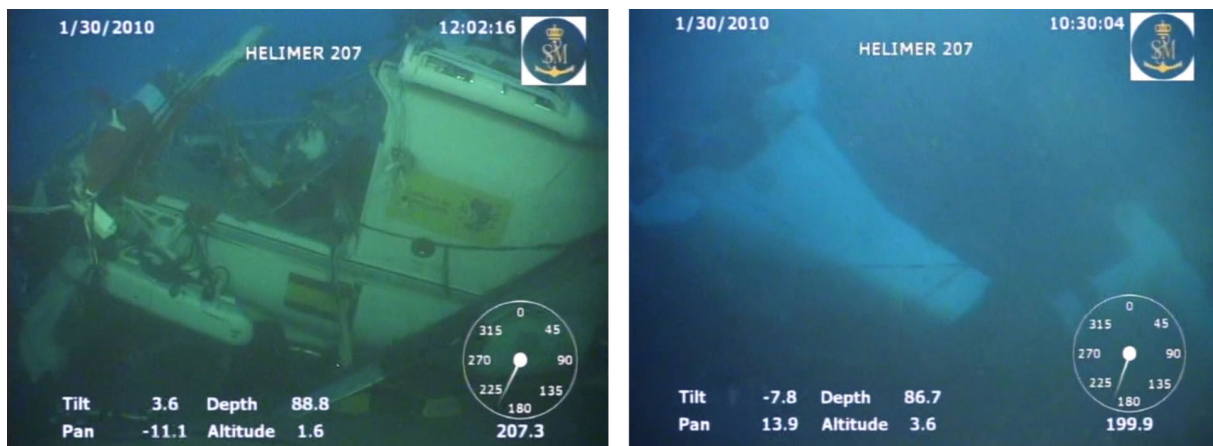
It was found upside down and slightly tilting to the right¹⁵. It was resting on the main rotor, on the area where the tail portion had fractured off and on one of the tail rotor blades. The nose and main fuselage (including the cockpit and passenger cabin) had detached and formed a tangled heap alongside the helicopter. The engines and rotors remained in their position and had not detached. The left engine cowling was open. The tail cone was still in its position and was bent in place at a 120° angle to the left. The main rotor was still attached to the fuselage though the blades were sheared and broken. The tail rotor blades were practically intact. The left horizontal stabilizer was broken, the landing gear was retracted, the emergency beacon had been ejected and the flotation system had not activated.

Figure 4. Condition of helicopter after impact. Images taken prior to recovery

entering the helicopter from the front toward the rear and then outward. The damage to the main rotor was consistent with the sudden stoppage of the rotor under power. The aft fuselage and the tail cone were bent upward and to the right, resulting from high inertial loading as a consequence of the impact and of the tail rotor.

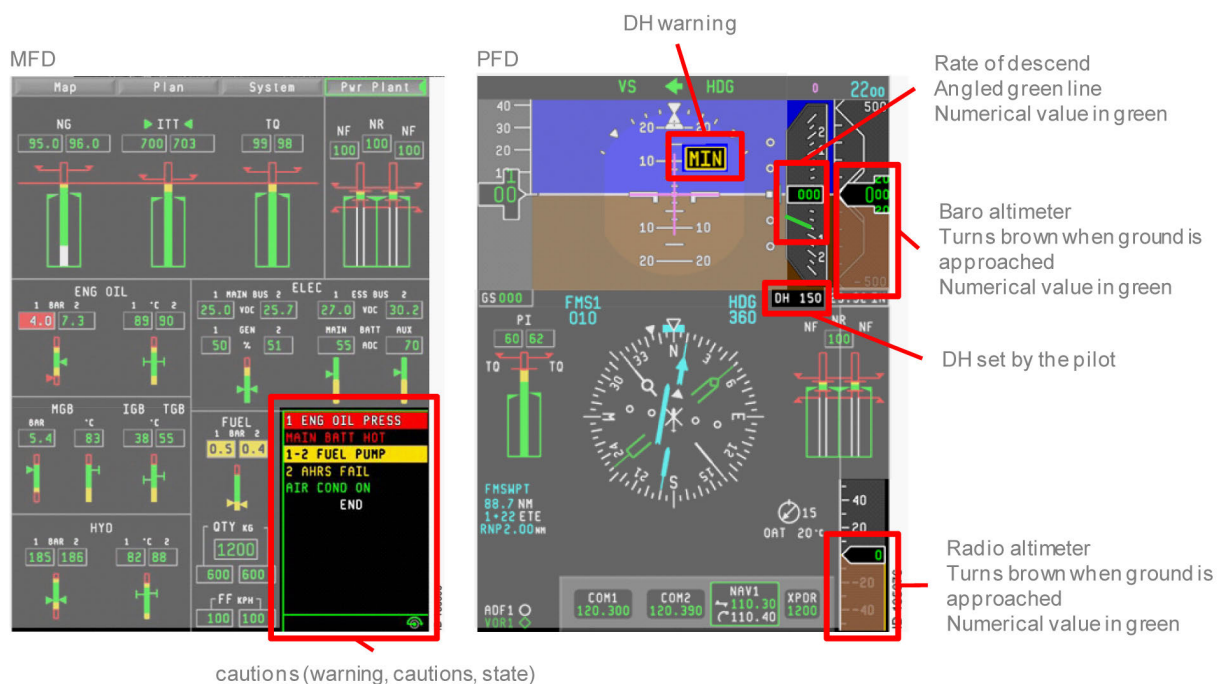
Figure 5. Display of altitude related warnings and information

– An aural CHECK HEIGHT warning when the helicopter is descending at or below DH. This warning is activated at the DH of the pilot flying. It is this warning that had been logged as inoperative since 20 November 2009 but which worked on the accident flight.

- Associated with an altitude of 150 ft:
 - An aural LANDING GEAR warning preceded by a dual chime sounds, is activated when the landing gear is not extended and the helicopter is descending through 150 ft. For the AW139, sounding the warning at this height allows the gear to be lowered before touchdown under normal speed and descent rate conditions (between 400 and 600 ft/minute).
 - A visual warning that displays the words LANDING GEAR on the MFD.
 - A master caution light (MCL), which is a yellow light above the flight displays.
 - An aural ONE FIFTY FEET warning³⁰ that sounds when the helicopter is at an altitude of 150 ft. The warning sounds even if the gear is down, providing the crew with an additional ground proximity alert. The LANDING GEAR warning has priority over the ONE FIFTY FEET warning.

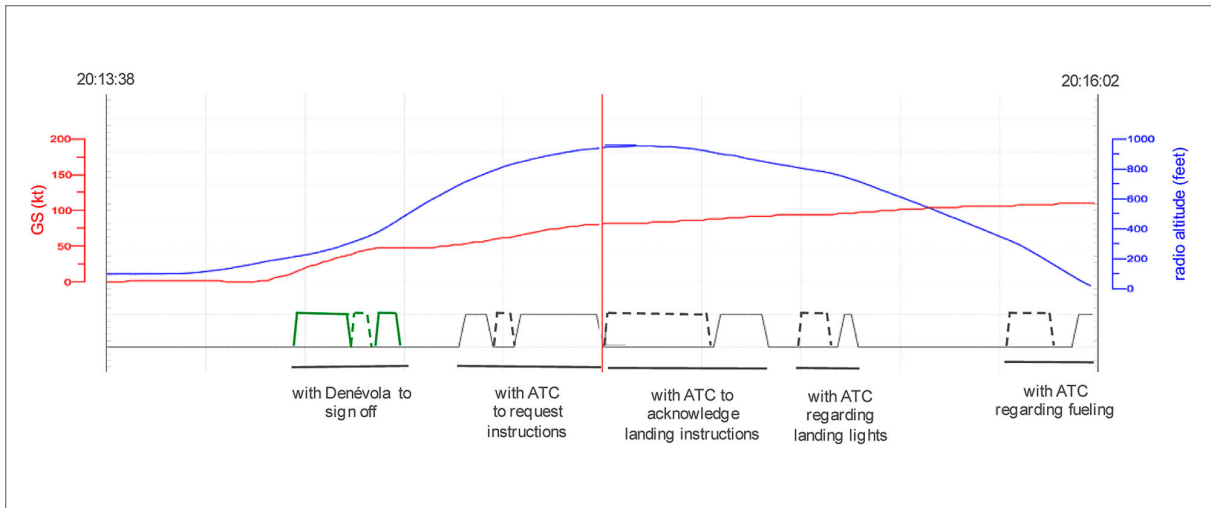
Figure 6 shows the amount of time devoted to communications on the return flight. Those with the Salvamar are shown in green and with ATC in gray. The solid lines are the copilot's transmissions and the dashed lines are the transmissions from the Salvamar and ATC to the aircraft.

Figure 6. Time devoted to communications during the return flight to Almeria
