DATA SUMMARY

Date and time	Thursday, 25 February 2010; 17:10 local time ¹
Site	Vigo Airport (Pontevedra)

Registration	EC-HPR
Type and model	CANADAI R CL-600-2B19
Operator	Air Nostrum

Operation	Commercial air transport – Scheduled – Domestic – Passenger
Phase of flight	Landing

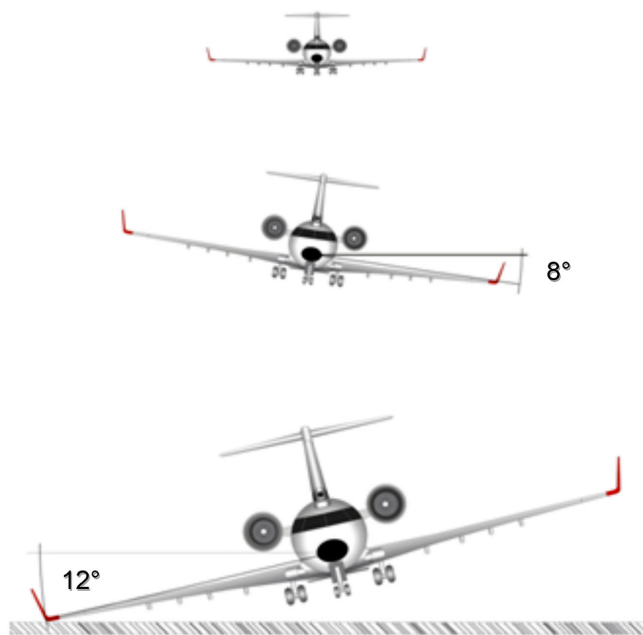
They established on the localizer once more and when they were 4 NM away the situation improved, though the turbulence persisted with 5-kt swings in IAS in either direction. These conditions persisted until they were on final. Since there were no windshear warnings, the Captain decided to land. He reported touching down gently but that they rose again about 0.5 m, at which time a gust of wind hit them from the right, causing the airplane to roll sharply to the left.

Both crewmembers reacted by turning their respective controls to the right to offset the roll. The airplane touched down with the right wheel first, followed by the left.

Figure 1. Diagram of landing

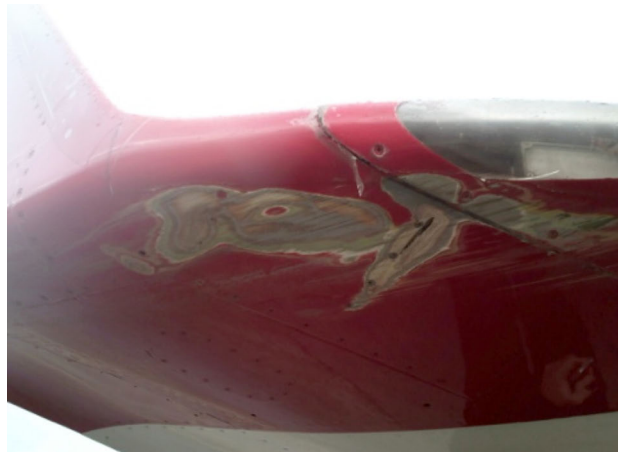
During the maneuver, the right wingtip hit the ground, resulting in minor damage to the underside of the wing (see Figure 2).

Figure 2. Damaged wingtip

The root cause of the incident is considered to be the brusque actions taken by both crewmembers to roll the airplane to the right in an effort to counteract a wind-induced roll to the left.

- The airplane exited the runway normally. It was not until later that the damage was discovered and repaired.

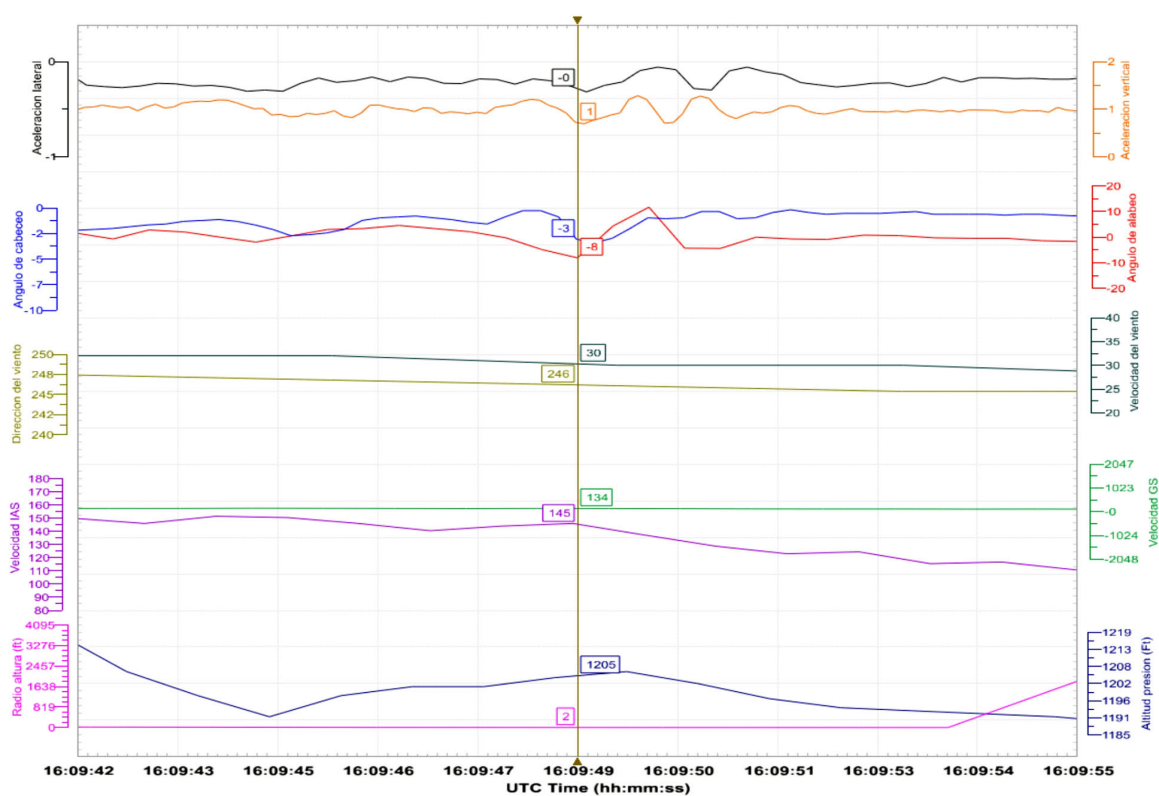
An analysis of the data reveals that at the instant when the airplane rolled left due to the wind, it was approximately 2 ft above the ground and was flying at an IAS of 146 kt. The wind was from 247° at 32 kt.

Figure 6. General parameters during roll to left

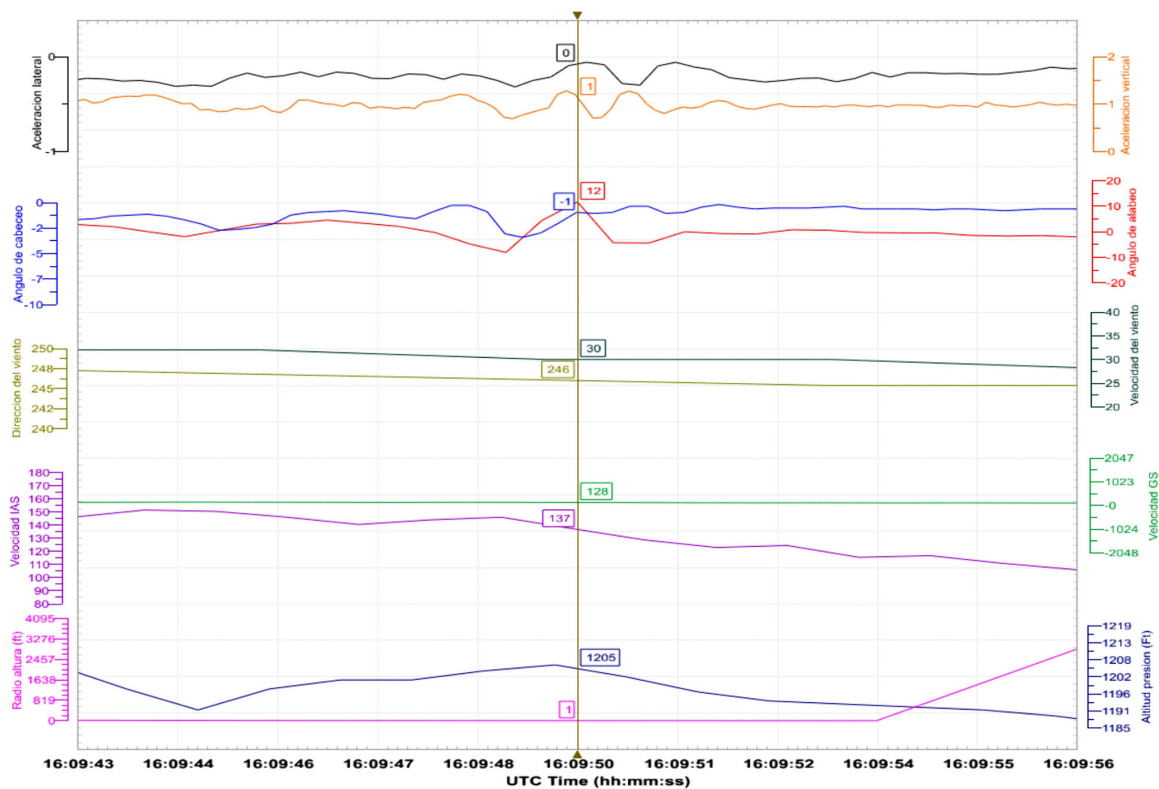
When the crew commanded a roll to the right immediately following the gust to correct for the roll induced by the wind, the aircraft was at practically the same altitude and the IAS was 137 kt (9 kt lower).

Figure 7. General parameters during roll to right

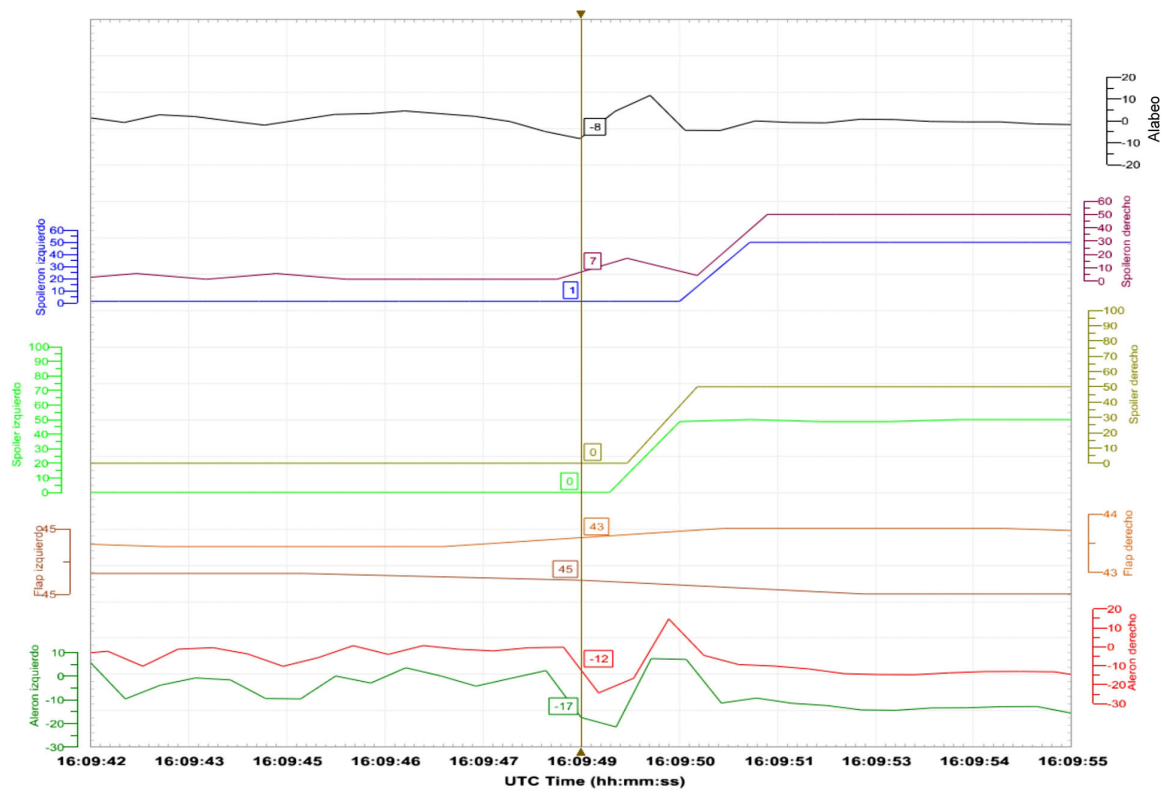
The position of the flight controls over the same interval shows that at 17:09:48, when the airplane was at a height of 2 ft (60 cm), its roll angle went from 8° left to 12° right in 1 s.

The ailerons went from having a negative angle before the impact to having a positive angle. The spoilers were retracted prior to impact and started to deploy 2 s later of impact, as did the spoilerons.

Figure 8. Flight controls during roll to left

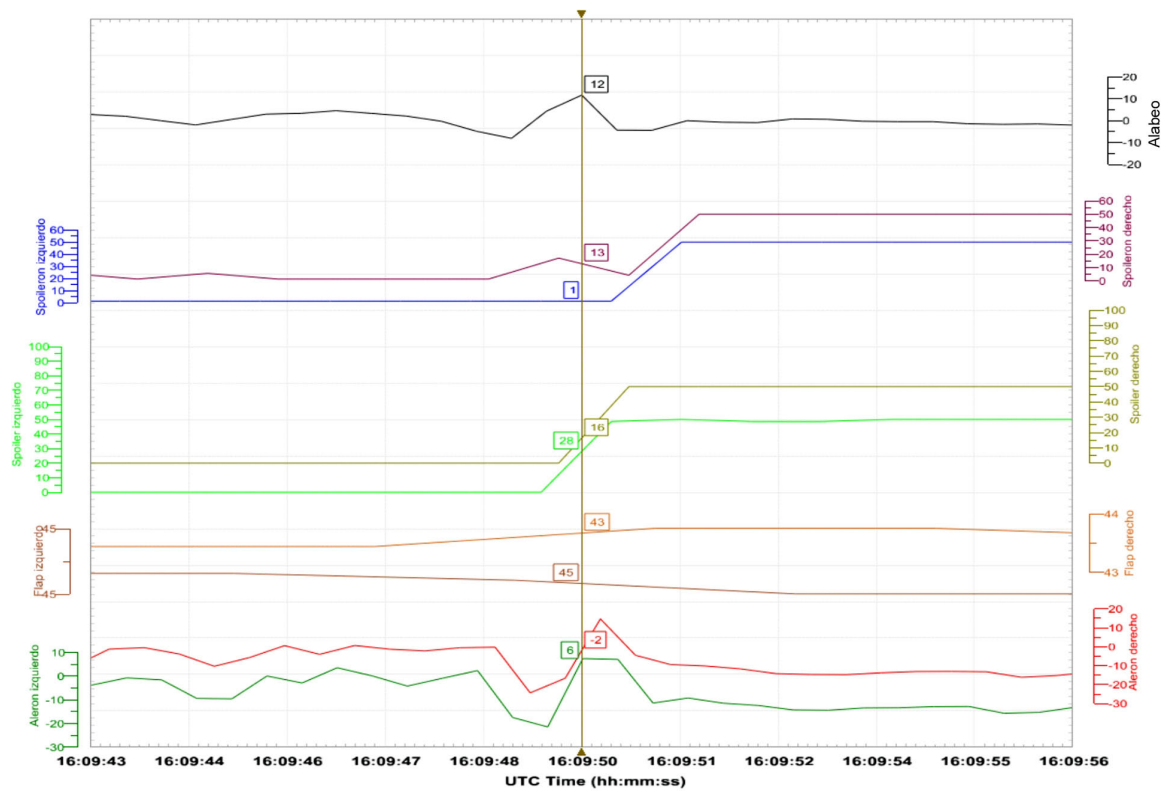
Figure 9. Flight controls during roll to right

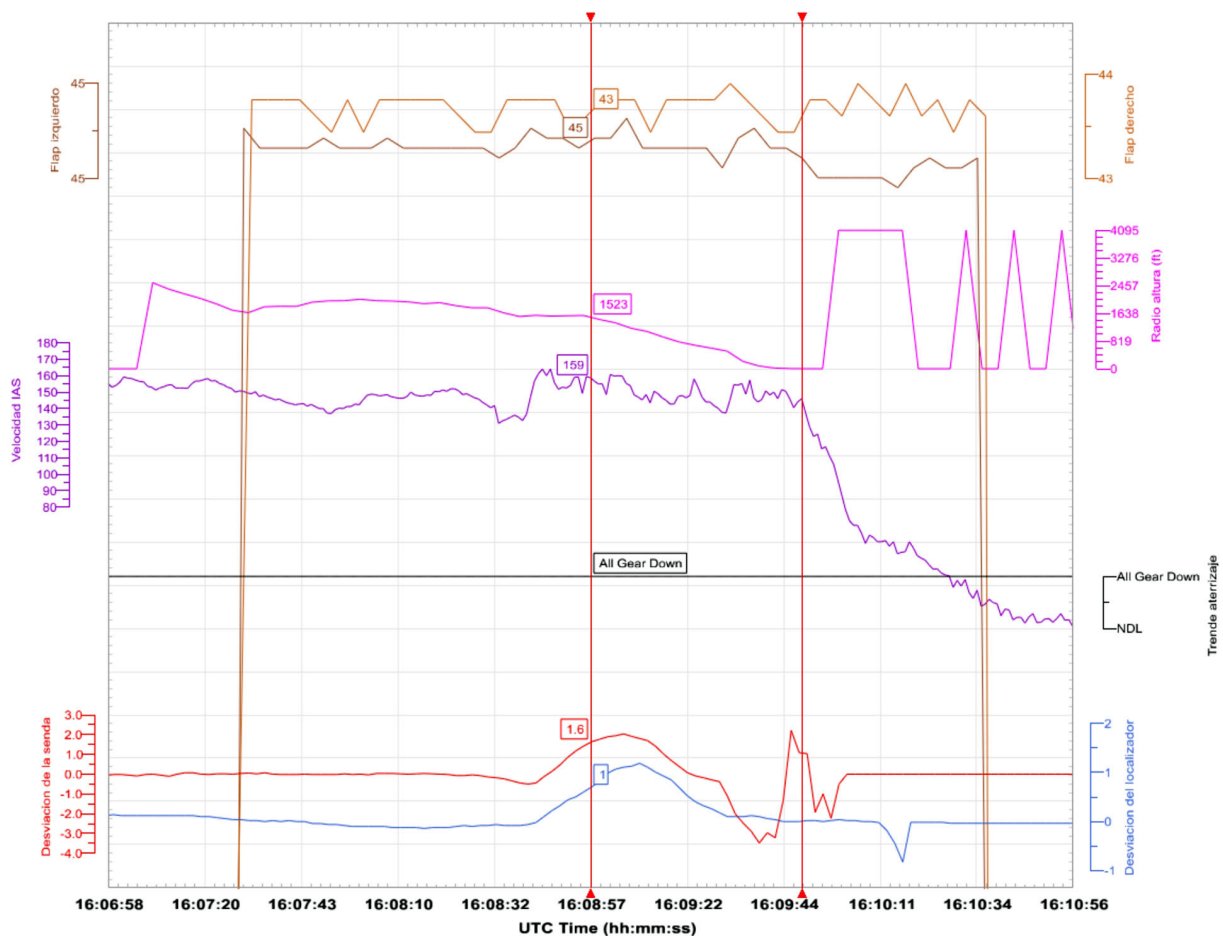
This means that in 47 s, it descended 1,457 ft, which translates into a descent rate of 1,862.56 ft/min. If a smaller interval is considered, for example, from 17:09:01 until 17:09:24, when the altitude was 695 ft, then the descent rate for those 23 s was 1,993.045 ft/min.

In transitioning through 500 ft, it went from being at 524 ft at 17:09:31 to being at 219 ft at 17:09:35, which yields a descent rate of 4,575 ft/min.

Figure 10. Stabilized approach parameters

- The investigation did not detect any type of anomaly with the airplane or any maintenance deficiencies.
- The data obtained from the DFDR revealed that a non-stabilized approach was conducted in that it was outside desired margins both in terms of descent rate and ILS localizer position.
