CIAIAC

Report A-022/2010

Accident involving
an Alexander Schleicher
ASW 27-18E, registration
D-KANR, in Castejón de Sos
(Huesca), on 7 July 2010

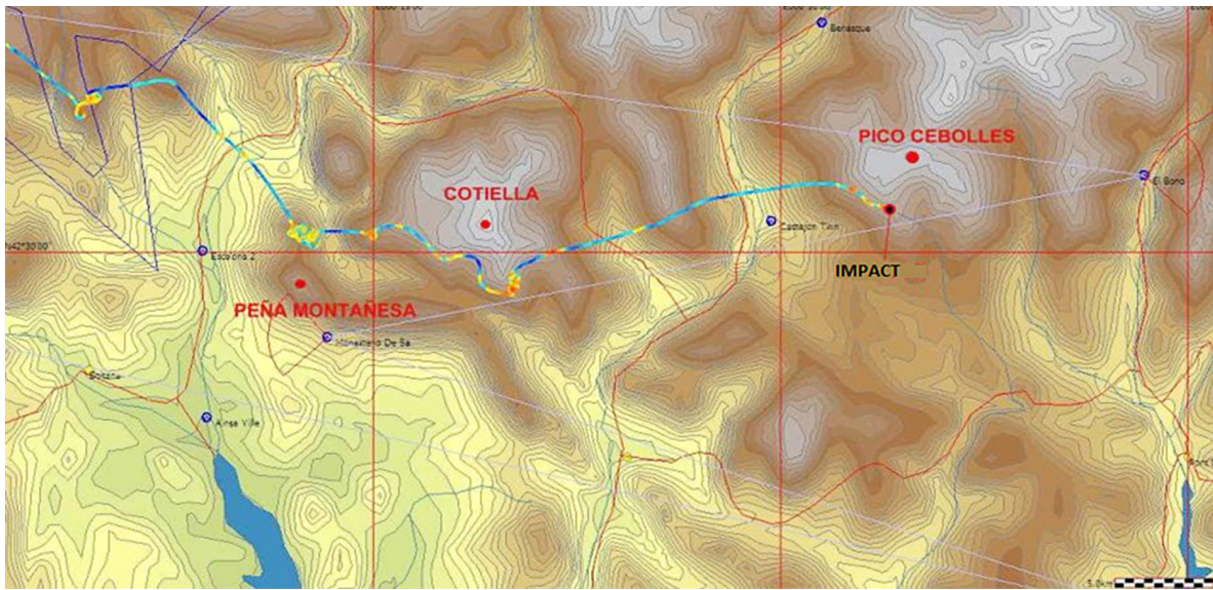
Figure 5. Final 35 minutes of the flight path

Figure 5 shows the last phase of the flight in greater detail, with the climb over the south face of the Cotiella, the crossing of the Benasque Valley, flying over Castejón de Sos, and the arrival at the SW flank of Cebolles Peak.

Based on the information from the final data points, upon arriving at the hillside where the impact took place, the aircraft's climb rate went from -3.67 m/s to $+3$ m/s. At that point, the aircraft climbed 17 m first with respect to the reference point (point of impact) and then 20 m, while the speed dropped by some 30 km/h.

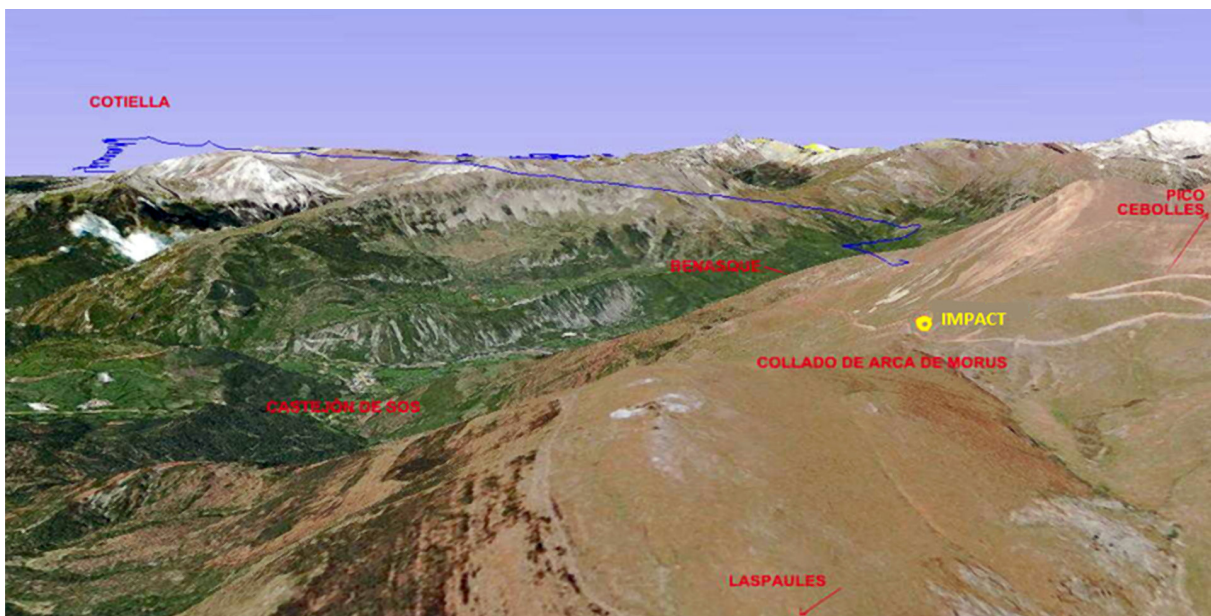
Figure 6. Diagram of the aircraft's flight path

The accident site (Figure 6) is at an elevation of 2,160 m. The hillside starts in the Benasque Valley and ends in the mountain pass of Arca de Morus. At the site of the accident, the gradient is 40° . The ground was moist and the impact site was covered in grass and low-lying vegetation.

The sailplane's nose made a crater that was 1.2 m in diameter and 40 cm deep. The right wing's leading edge struck the ground, opening a 25-cm deep and 7-cm wide gash. The left wing, however, did not leave any impact marks. The marks revealed a trajectory that was almost perpendicular to the ground on a heading of 315° .

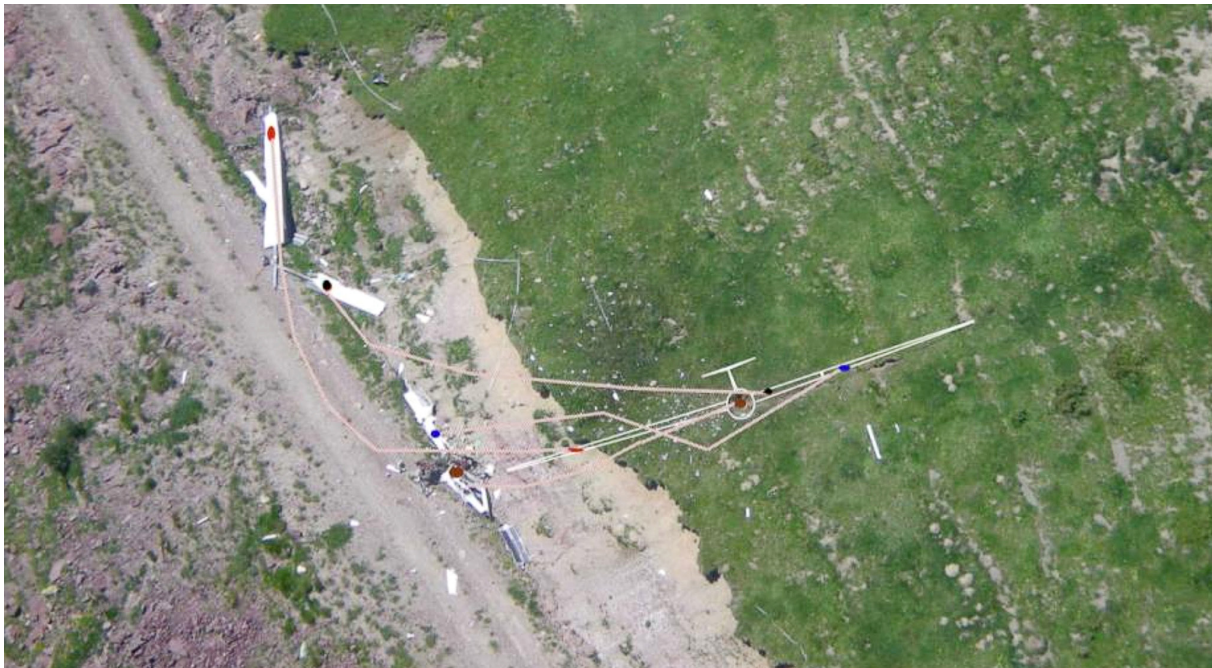
Figure 7. Debris field

The main wreckage was on a dirt road that was immediately left of the impact point. The left wing was some 20 m away from where the nose had impacted. The fuselage, with the empennage, was to the left and close to the impact site. The two main fragments of the right wing were halfway between the main wreckage and the debris from the left wing. The right wing was broken in two. The portion of the spar near the root was still joined to the left wing by its attachment pins. The skin in this section of the wing had delaminated and separated from the spar.

The debris was confined to a circle with a 25-m radius. Figure 7 shows the debris field.
