Report A-027/2010

Accident involving
a Zivko Edge 540 aircraft,
registration N-540WC, in the
vicinity of the Casarrubios
Aerodrome (Toledo),
on 17 August 2010

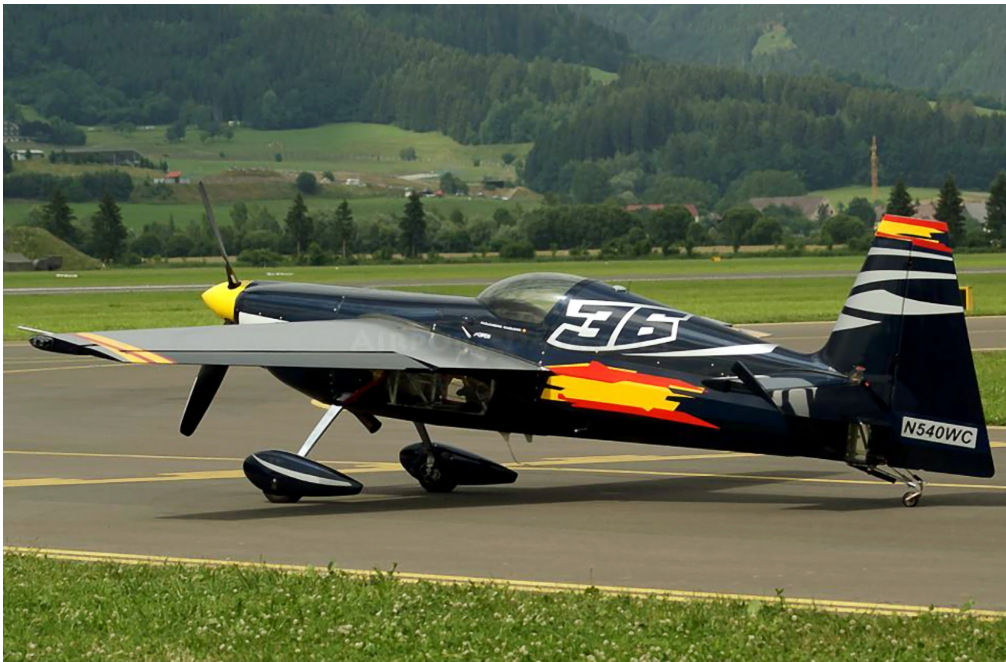
Figure 1. Picture of the accident airplane

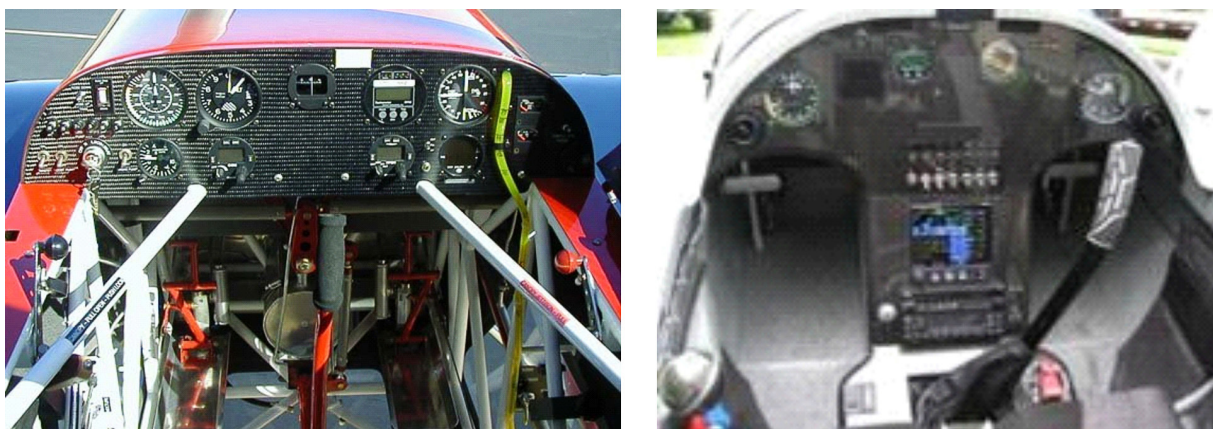
A comparison of the two aircraft models used by the accident pilot reveals a notable difference in the cockpits: the tubular structure is visible in the Edge 540, while a panel restricts direct access to the structure in the MXS-R. The design of the rudder pedals is also very different (see Figure 2).

Figure 2. Comparison of the cockpit interior in two aircraft similar to those used by the pilot (Edge 540 and MXS-R)

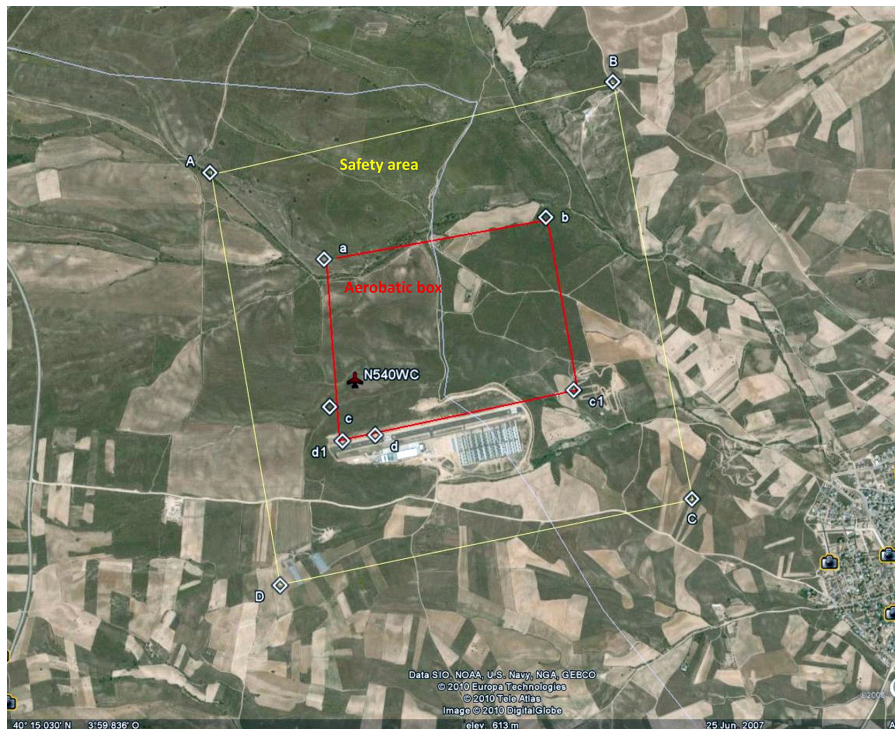
Figure 3. Aerial view of the Casarrubios Aerodrome (LEMT), showing the aerobatic box and the safety area

The aircraft wreckage was found by the south side of the runway, in a ranch adjacent to the aerodrome and within the aerobatic box (see Figure 3). There was an initial impact mark followed by debris from components and the fuselage and finally the main wreckage some 25 m away from the initial mark. The debris field indicated that the aircraft was on a heading of about 60° with respect to magnetic north, and that its nose was oriented at 150°.

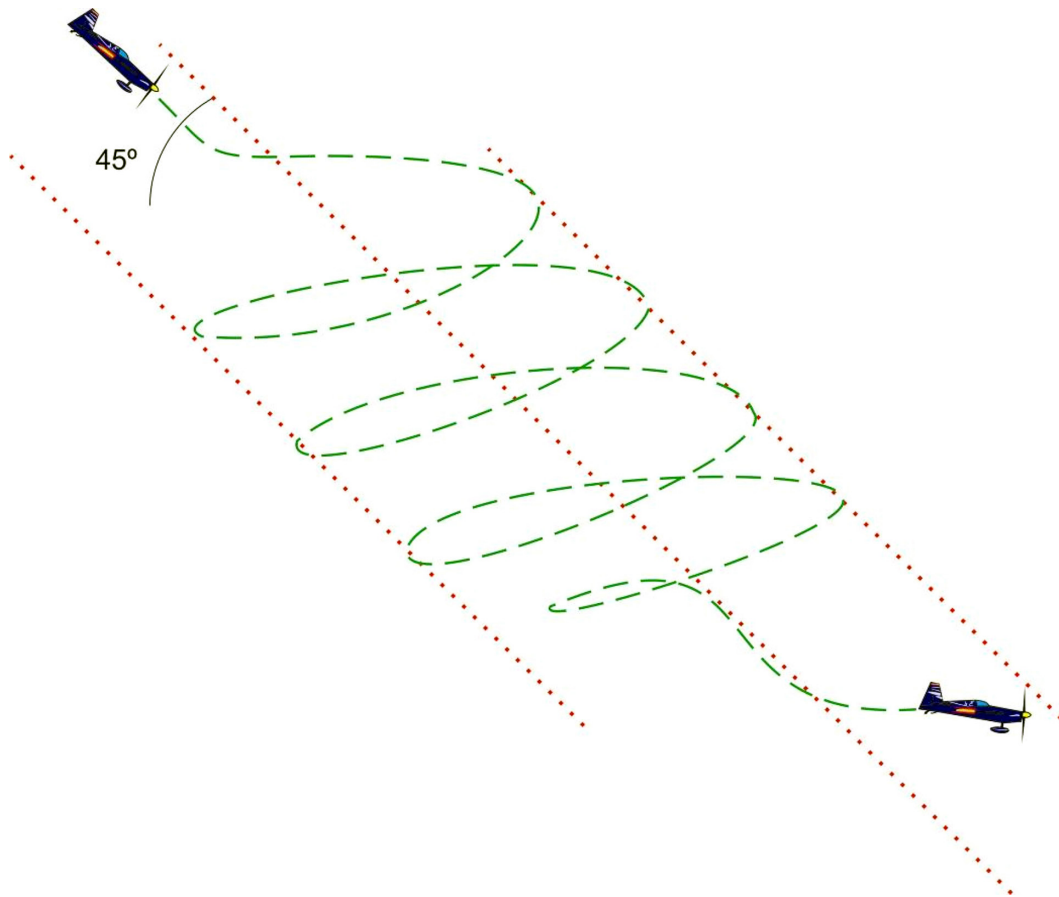
Figure 4. Snap roll maneuver with four consecutive turns at 45° descending and positive

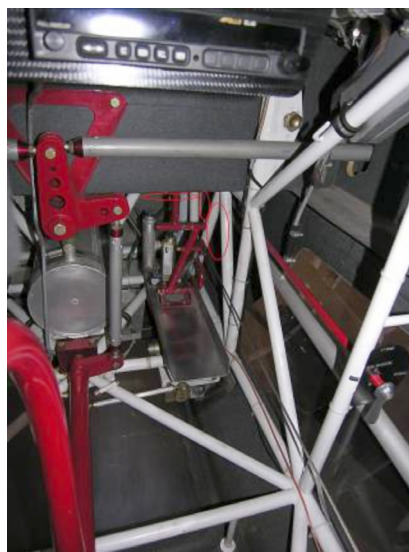
Another pilot, who did not use extensions, noted that performing negative-G aerobatic maneuvers could cause his foot to become stuck, since the negative G forces would cause his foot to move up, resulting in the toe of this shoe getting trapped under the main spar or within other obstacles in the cockpit's tubular structure (see Figure 5).

Figure 5. Areas near the pedals where the feet can become entangled

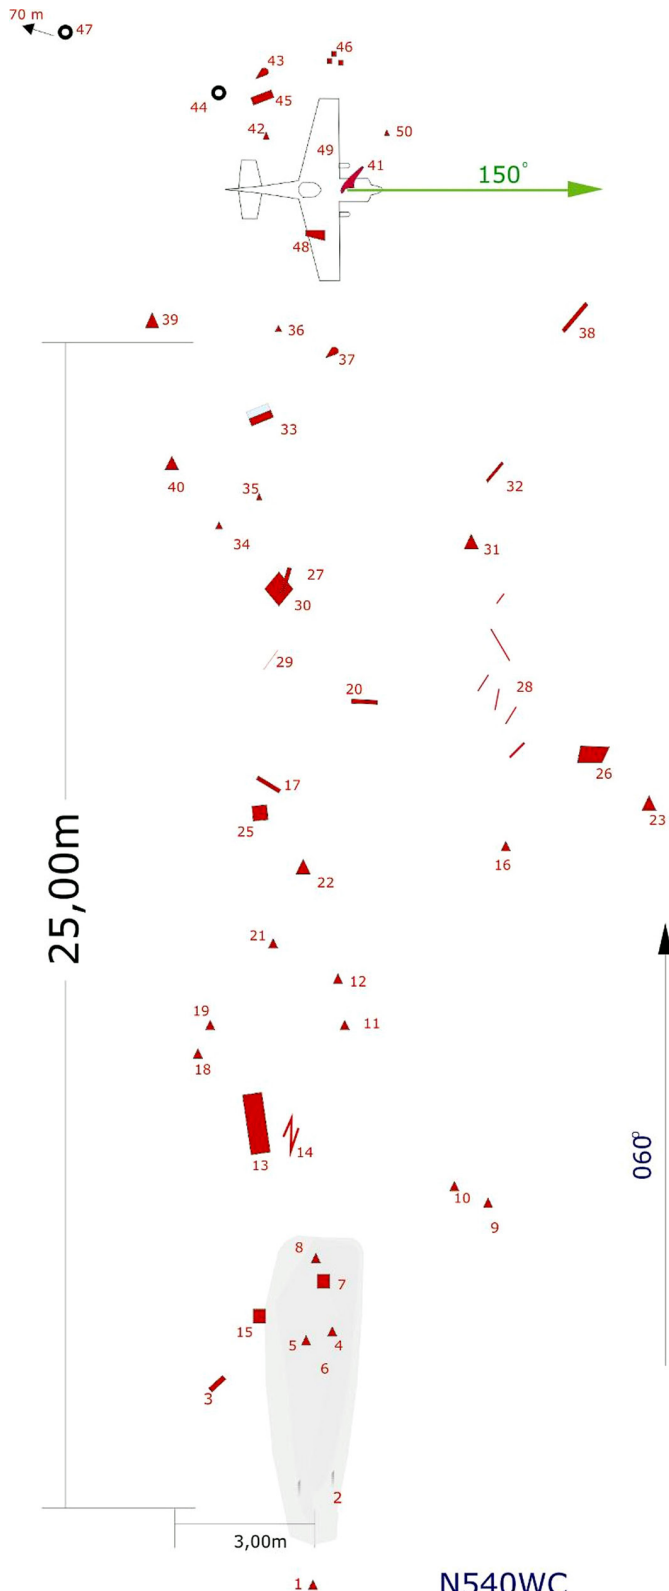
Layout of the debris field

1. Bottom part of rudder
2. Wheel marks
3. spade support bar dug into ground
4. ADF antenna
5. Horizontal stabilizer counterweights
6. 6 m impact crater
7. Lower part of cockpit (methacrylate fragments)

8. Engine crankcase fragment
9. Fragment from lower leading edge of right wing
10. Angle of attack indicator
11. Right spade
12. Fuel injector
13. Left lower side window
