Final report IN-019/2010

Incident involving an
AEROSPATIALE/ALENIA
ATR-72-500 (212A),
registration EC-HJI,
operated by Air Nostrum
L.A.M., at Madrid-Barajas
Airport (Madrid – Spain),
on 30 June 2010

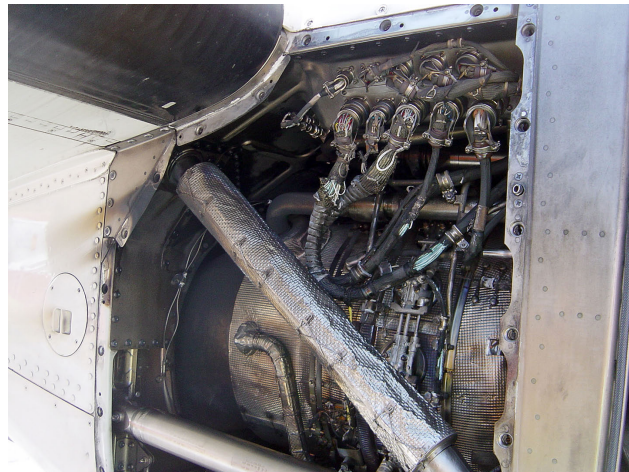
Figure 3. Area affected by the fire

There was evidence of a fire outside the hot part of the engine, behind the firewall; specifically, on the right side and in the lower center part of the engine. The fire had affected various cables and lines.

In addition to the burned areas, several engine components were damaged, namely: the lubricating oil vent line for the nos. 6 and 7 bearings was broken; the fastening screws on the tubing from the nos. 6 and 7 bearings to the oil scavenge pump were loose; and various cable and piping brackets were damaged.

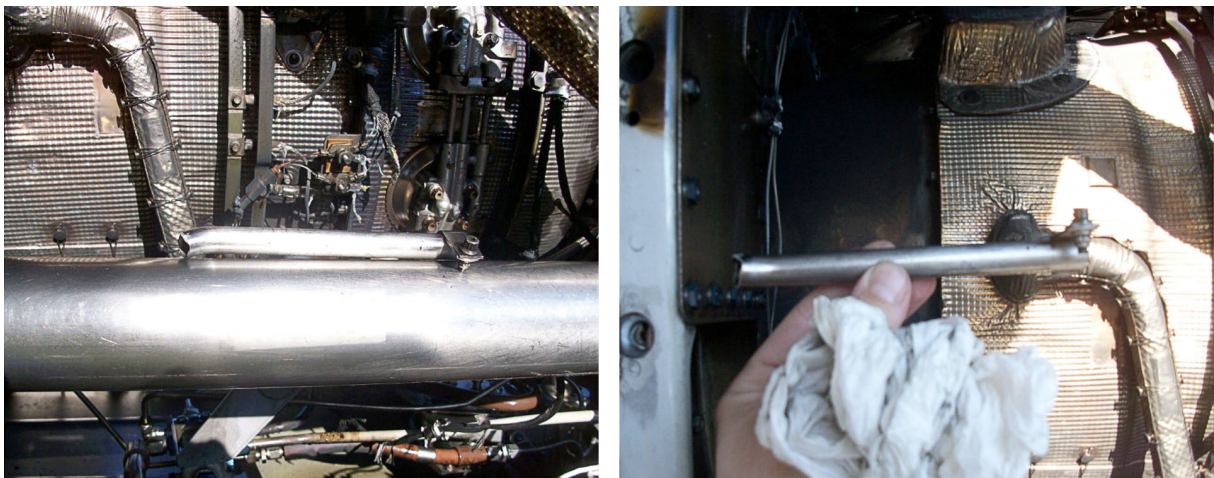
Figure 4. Lubricating oil vent line for the nos. 6 and 7 bearings

- Nos. 6 and 7 bearing vent lines: broken near the rear fastening brackets for the line and the T6 cable bracket.
- T6 cables: insulation burned.
- Low-pressure turbine (LP) abrasion ring: friction marks between the 1 and 3 o'clock positions.

All of the fractures present in the engine's external components (vent line for the nos. 6 and 7 bearings, brackets and flanges) showed signs typical of low cyclic loading fatigue.

- Piping and cable fastening components, broke due to mechanical vibrations and altered gas flow inside the engine.
- The vent line for the nos. 6 and 7 bearings broke producing oil leaks, which ignited when it contacted the outer surface of the hot part of the engine.

On the other hand, the manufacturer's engineering organization has examined the No.6 and 7 bearing oil tubes fractures as a result of the subsequent out of balance loading following a power turbine (PT) blade release. Investigations have revealed that most of the No.6 and 7 bearing oil tubes, but not all, have fractured at the fitting interface. The manufacturer is currently working on a product improvement that is changing the attachment of the end fittings from a brazed to a welded join configuration. This will improve the durability of the interface and will be aligned with it current best practice for this type of tube.

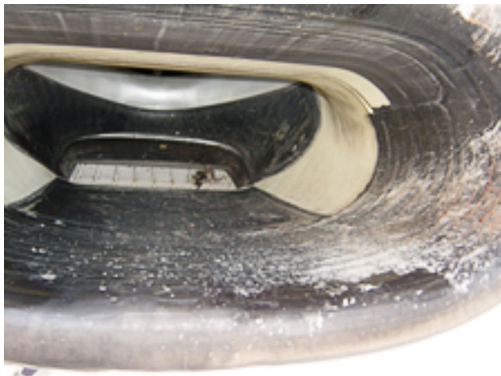
Figure 5. Intake diffuser

The engine intake diffuser exhibited impact damage on the intake lip and the remains of a bird were lodged in the radiator. The low- and high-pressure compressors were clean and rotated freely with no apparent resistance.

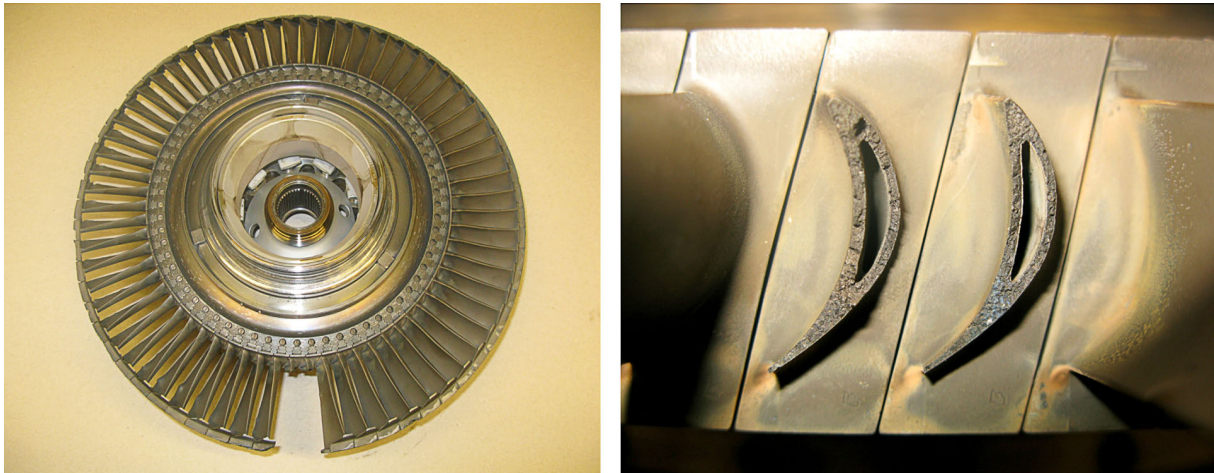
Figure 6. First-stage rotor of the power turbine and close-up

- First stage rotor in the power turbine (PT1): two sequential blades were broken, damage to every blade and to the disc from detached debris.
- Second stage rotor in the power turbine (PT2): three sequential blades broken, damage to every blade and to the disc from detached debris.

The laboratory analyses of the two broken blades from the first stage of the power turbine (PT1) showed that one had experienced a fatigue fracture, and that the other had fractured as a result of the damage caused by the piece that detached from the first blade; both fractured blades exhibited fatigue cracking originating in areas of casting micro-porosity in the airfoils.

The incident was caused by the fracture, due to fatigue failure, of a rotor blade in the first stage of the power turbine in the aircraft's no. 1 engine, which led to a damage progression in the engine that resulted in a fire in said engine.

- Issued Service Bulletins for the replacement at shop visit of blades manufactured during the period of 2005 to 2008 which exhibit a statistically higher prevalence of shrinkage porosity.

- Issued Service Bulletins for the replacement of specific blade serial numbers which were determined, through re-evaluation of manufacturing inspection records, to exhibit unacceptable levels of shrinkage porosity.

- Introduced Process Compensated Resonance Testing (PCRT) inspection methodology at final blade manufacture.
- Introduced a 10,000-hour soft-time blade replacement interval for higher-power engine models.
