Interim Statement A-004/2011

Accident involving a PZL SOKOL W-3AS
helicopter, registration SP-SYA,
operated by Heliseco, in the area
of Dos Aguas - Caldera de Taburiente
of La Palma island (Santa Cruz
de Tenerife) on 24 February 2011

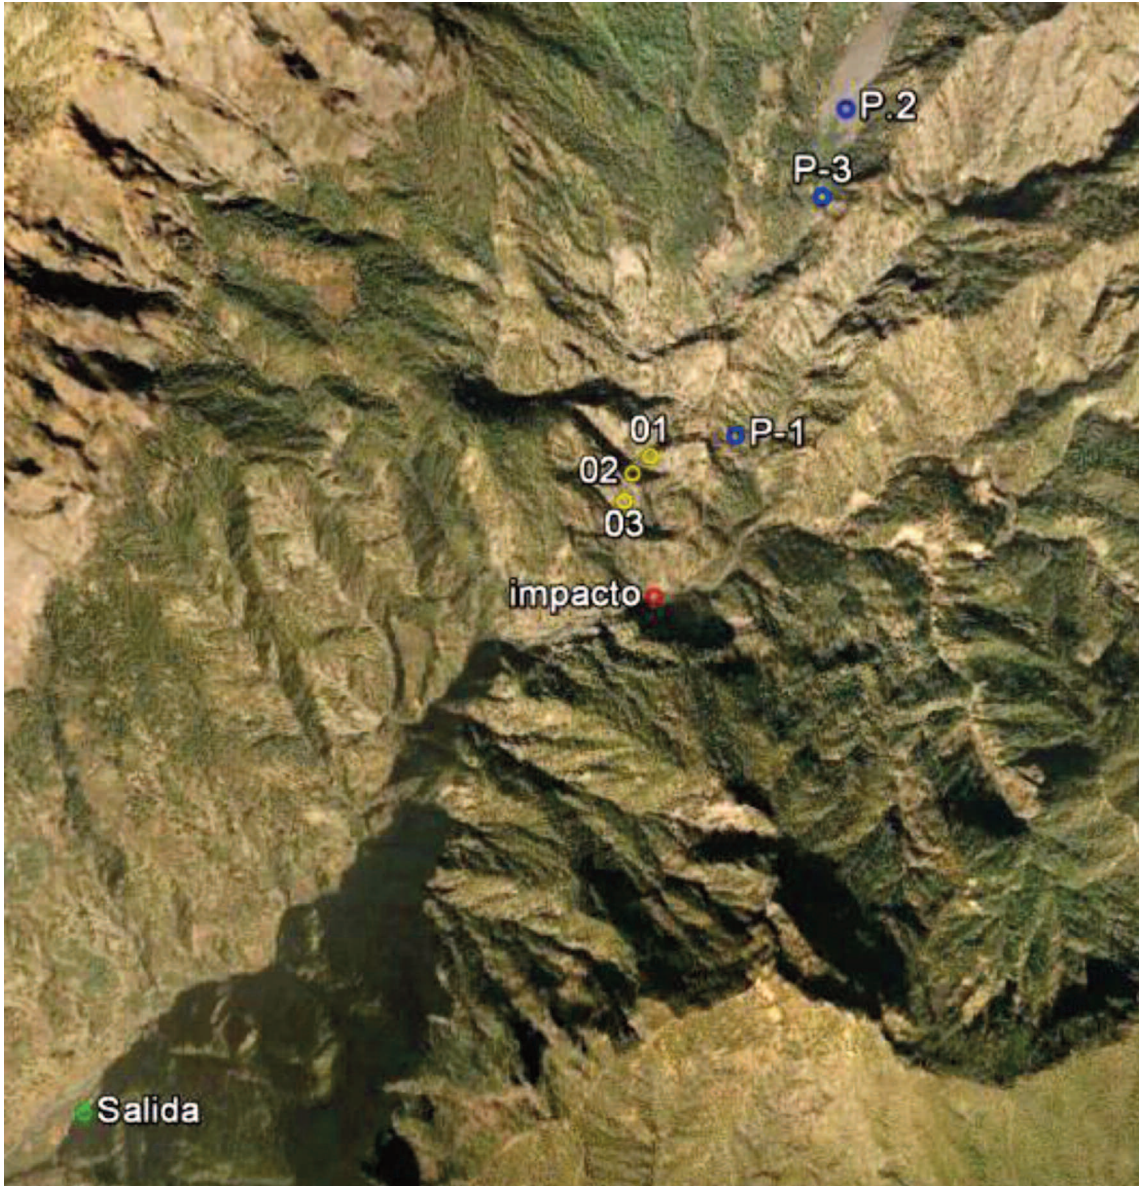
FIGURE 1. Location of the staging area (departure) and drop-off points (P-1, P-2 and P-3), as well as of the main wreckage and of associated debris.
