## DATA SUMMARY

Date and time	Thursday, 14 April 2011; 08:30 UTC <sup>1</sup>
Site	Barcelona Airport

Registration	EI-EKB	N366AA
Type and model	BOEING 737-800	BOEING 767-300
Operator	Ryanair	American Airlines

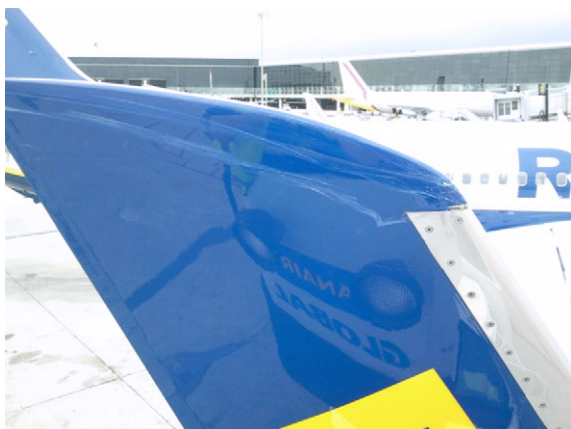
During the walk-around before the B737's next flight, the crew noticed damage to the winglet on the right wing (Fig. 1), which made them suspect that they had in fact made contact with the other aircraft.

Figure 1. Damage to the B737 winglet

Though they stated being certain that there had been no contact, the captain decided to do the pre-flight walk around personally once they were parked at the Ibiza airport. During the inspection she noticed that the paint on the right winglet was scratched. She regarded the defect as minor, one that did not justify any actions by maintenance personnel, especially as they would have had to fly from Barcelona, since the airline does not have mechanics in Ibiza. She also did not make an entry of the defect in the aircraft logbook.

- The B737 crew detected the damage during the walk-around prior to the next flight.
- Ryanair contacted American Airlines to report the incident.
- Maintenance personnel assessed the damage to the B737 and dispatched it with a deferred maintenance item. The B767 was removed from service for repairs.

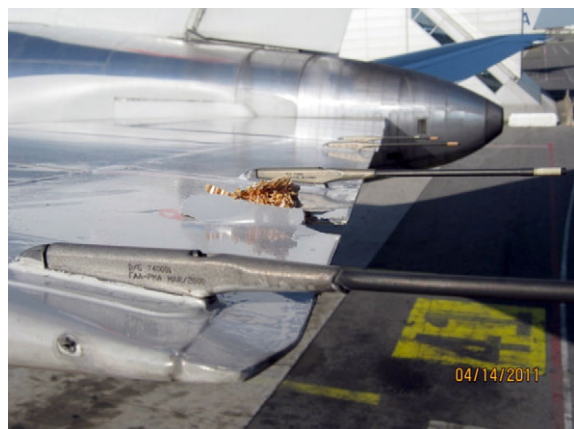
Figure 2. Damage to the B767 stabilizer

Ryanair contacted American Airlines to inform it of the incident. After the arrival of the flight, American Airlines personnel verified the existence of damage to the outboard section of the left horizontal stabilizer (Fig. 2). This damage required that the aircraft be removed from service for repairs.

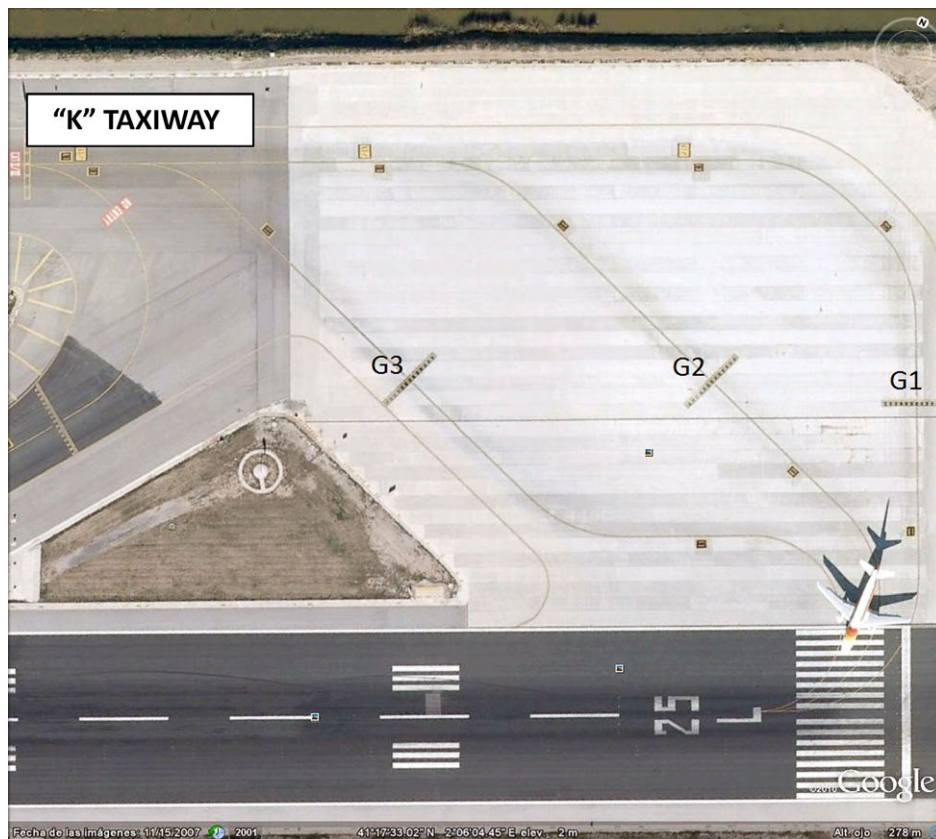
The layout of the runway 25L threshold allows three aircraft to hold simultaneously at three holding positions labeled G1, G2 and G3 (Fig. 3). These points are accessed via a single taxiway, K, whose centerline branches into three to provide access to each point. The ability to use three points at the same time gives controllers flexibility when organizing takeoff sequences and allows for smoother operations.

So as to maintain separation between aircraft, only certain aircraft categories are allowed to access the most remote points (G1 or G2) via taxiway K when G3 and/or G2 are already occupied.

Figure 3. Triple holding point at runway 25L

- REC 06/12.** It is recommended that AENA reassess the taxi limitations applicable to taxiway K and holding points G at both the runway 25L (points G2 and G3) and runway 07R (points G10 and G11) thresholds at the Barcelona Airport. Specifically, AENA is to take into account the effect that the length and position of aircraft situated at the holding points has on taxiing limitations and include these limitations, if any, in ATC procedures.
- REC 07/12.** It is recommended that Ryanair reassess those aspects of its training program involving flight and cabin crew communications and address the deficiencies noted, if any. Special emphasis should be placed on the benefits to safety that stem from the effective transmission of information from the passenger cabin to the flight deck.

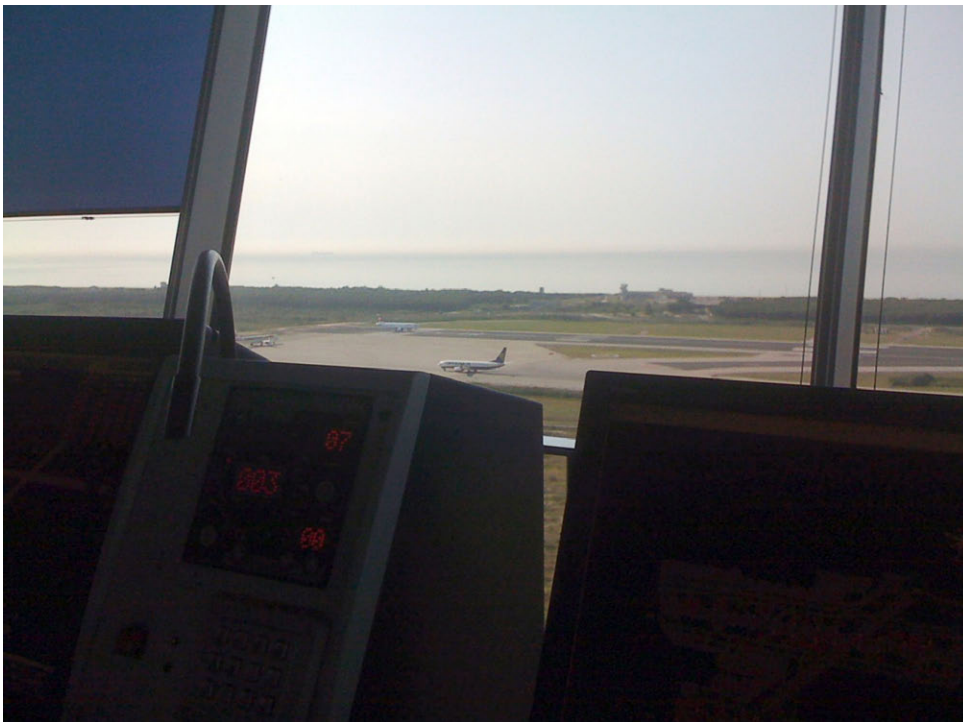
The GMC controllers are located in the control tower. The tower at the Barcelona Airport is some 600 m NW of the runway 25L holding point. The visibility of the area from the tower is ideal, though the distance and the relative geometry do not allow controllers to evaluate the separation between an aircraft at the G3 holding point and those moving into holding points G1 or G2 (Fig. 4).

**Figure 4.** View of the runway 25L holding point from the tower control room

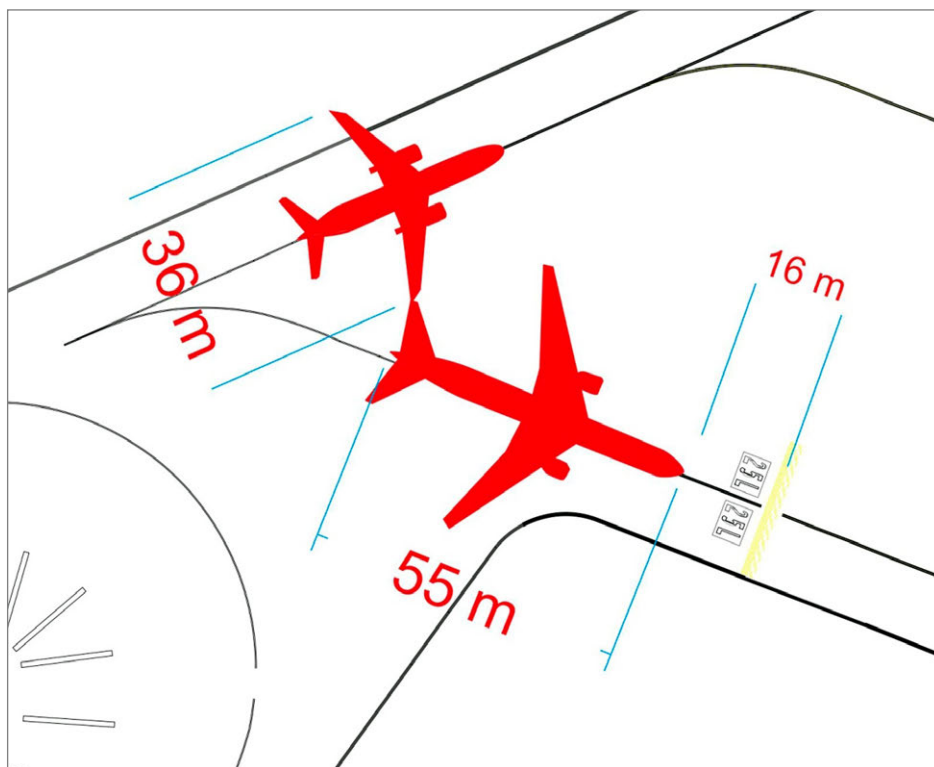
Figure 5 depicts the geometry of a hypothetical contact scenario between two aircraft of the type involved in this incident.

Assuming that both aircraft are perfectly aligned with their respective centerlines, a collision would take place if the B767 were a little over 16 m (54 ft) away from the holding point marking. This scenario would be even more restrictive if the airplane waiting at G3 were, for example, a B767-400, which is also a category D airplane but 6.4 m longer than the B767-300.

Figure 5. Collision geometry in the vicinity of G3

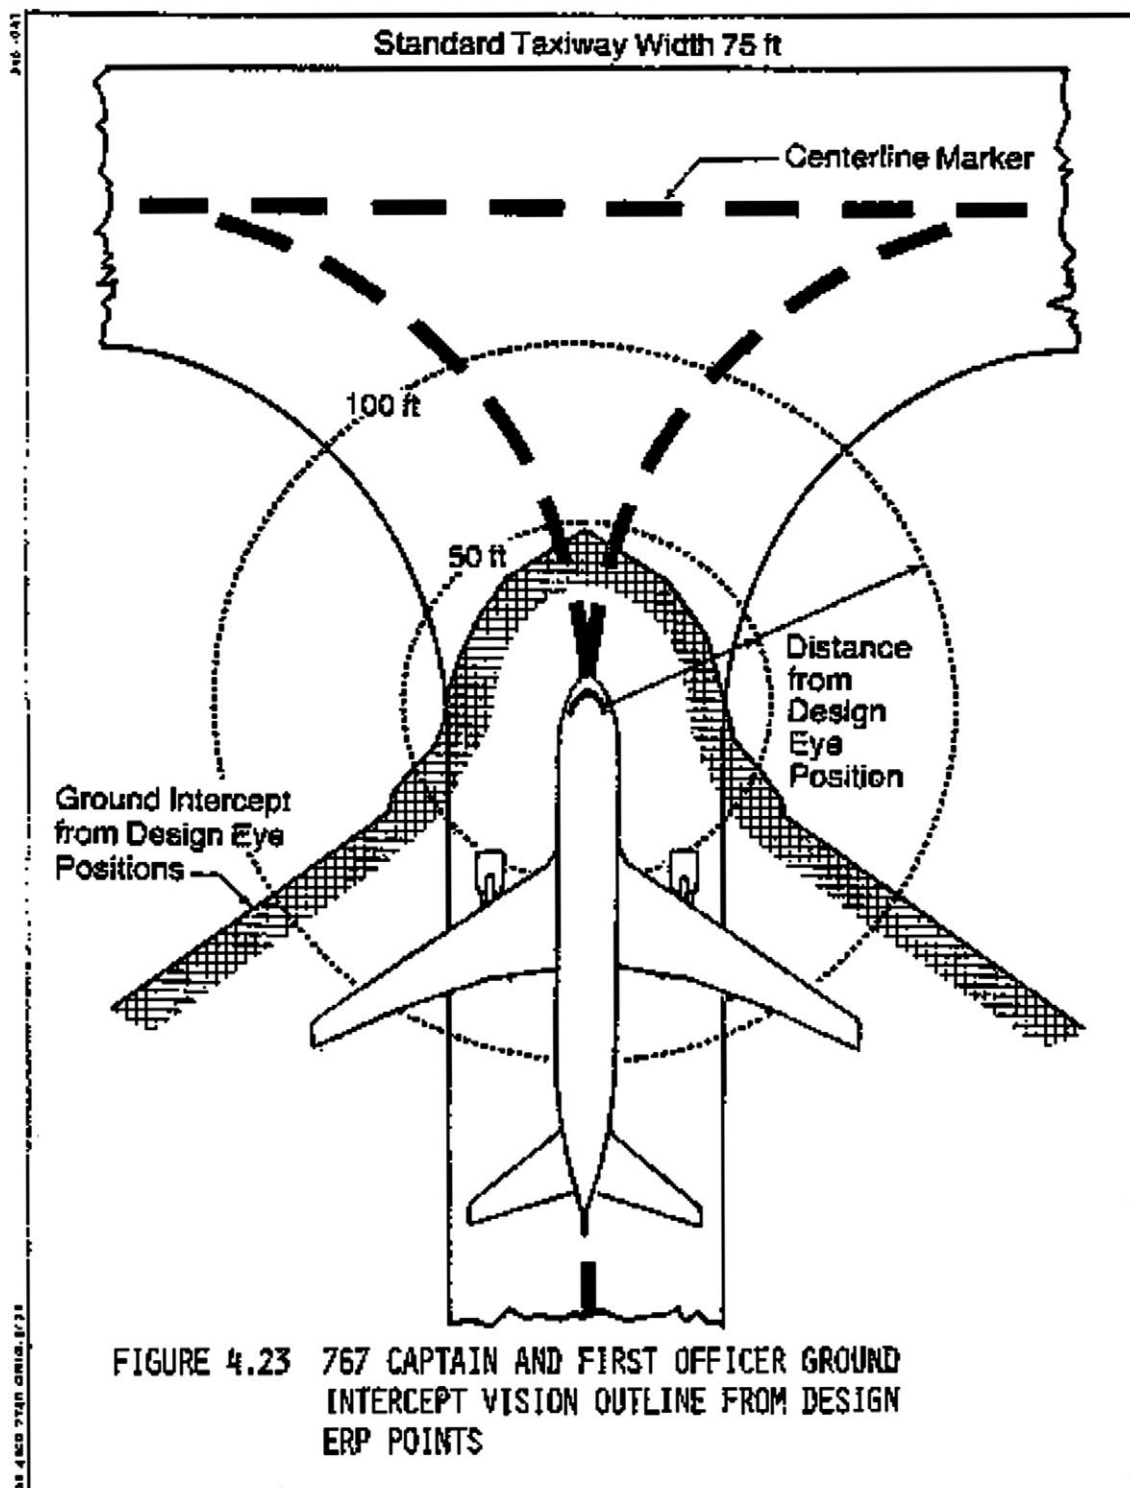
### **Visibility from the B767 flight deck**

The distance will depend on the field of view that the crew has from the cockpit. For the B767 (Appendix I), the nearest point on the ground that can be seen from the pilot's seat is 50 ft away. The typical stopping distance, then, will be along the same order of magnitude so that the marking remains within the crew's field of vision. In this case, this figure also matches that expressed by the pilots in their statement and is consistent with the result of the integration of the speed recorded by the B767's FDR as it traveled over the taxiway en route to the holding point, and with the returns from the surface radar (SMR) (Appendix III).

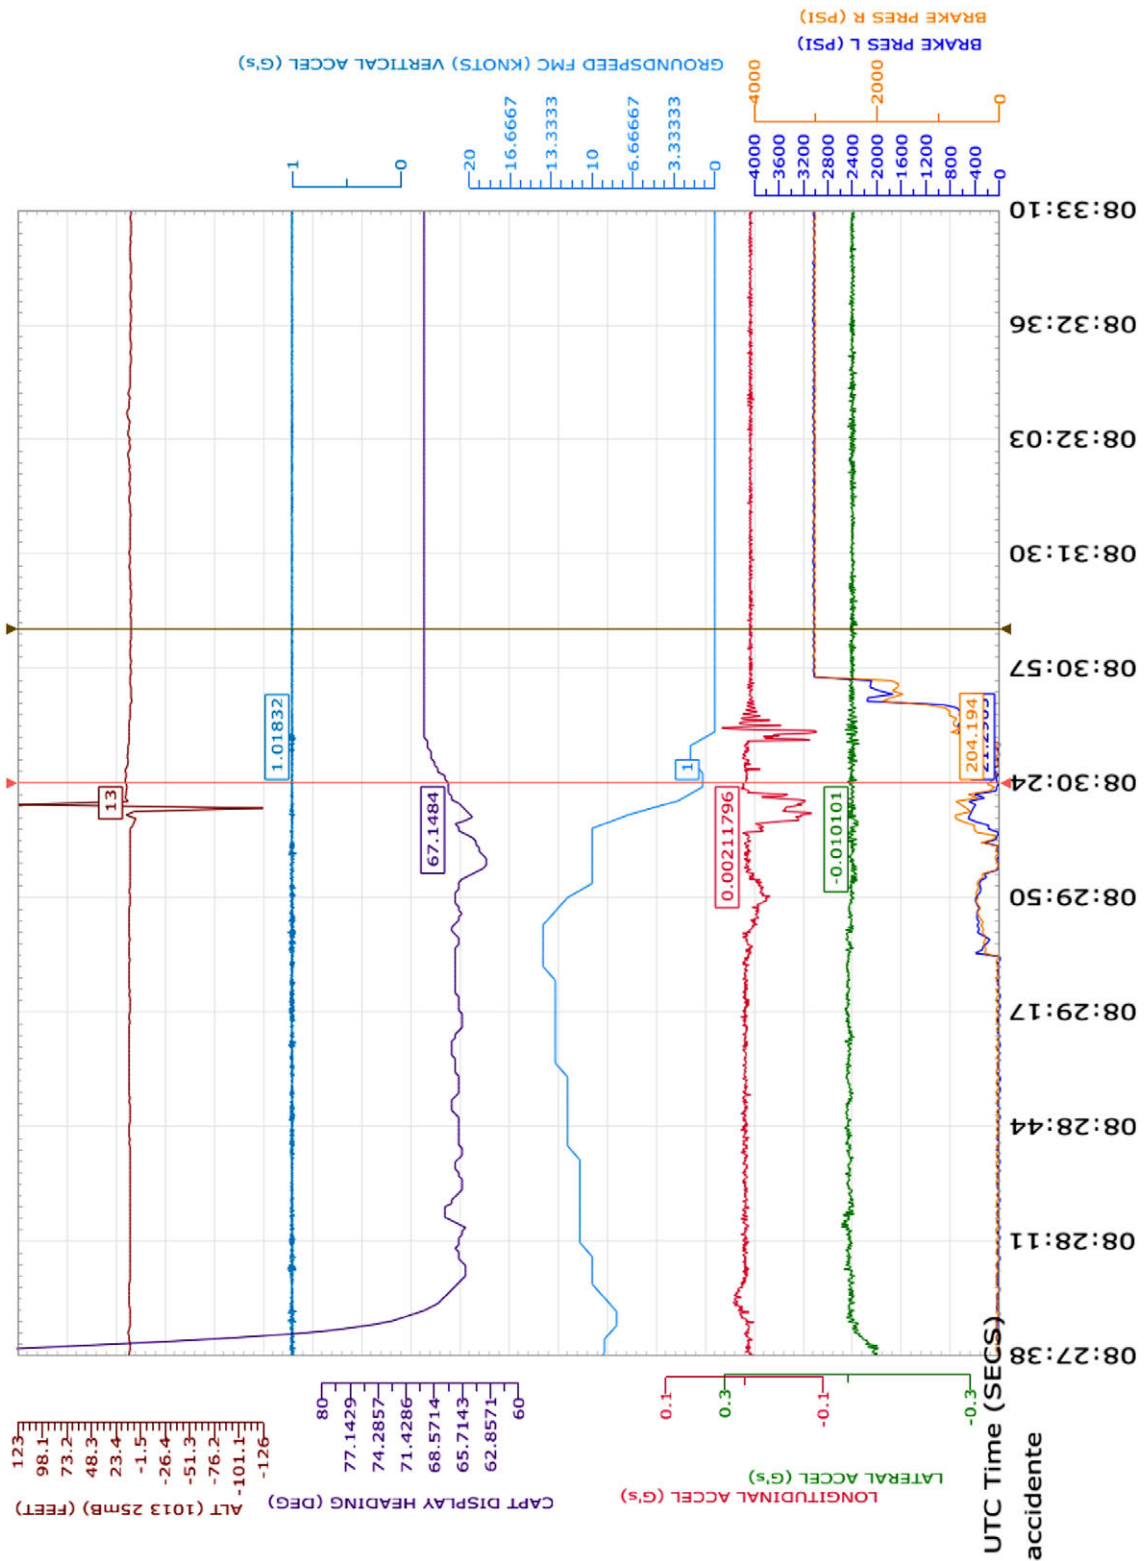
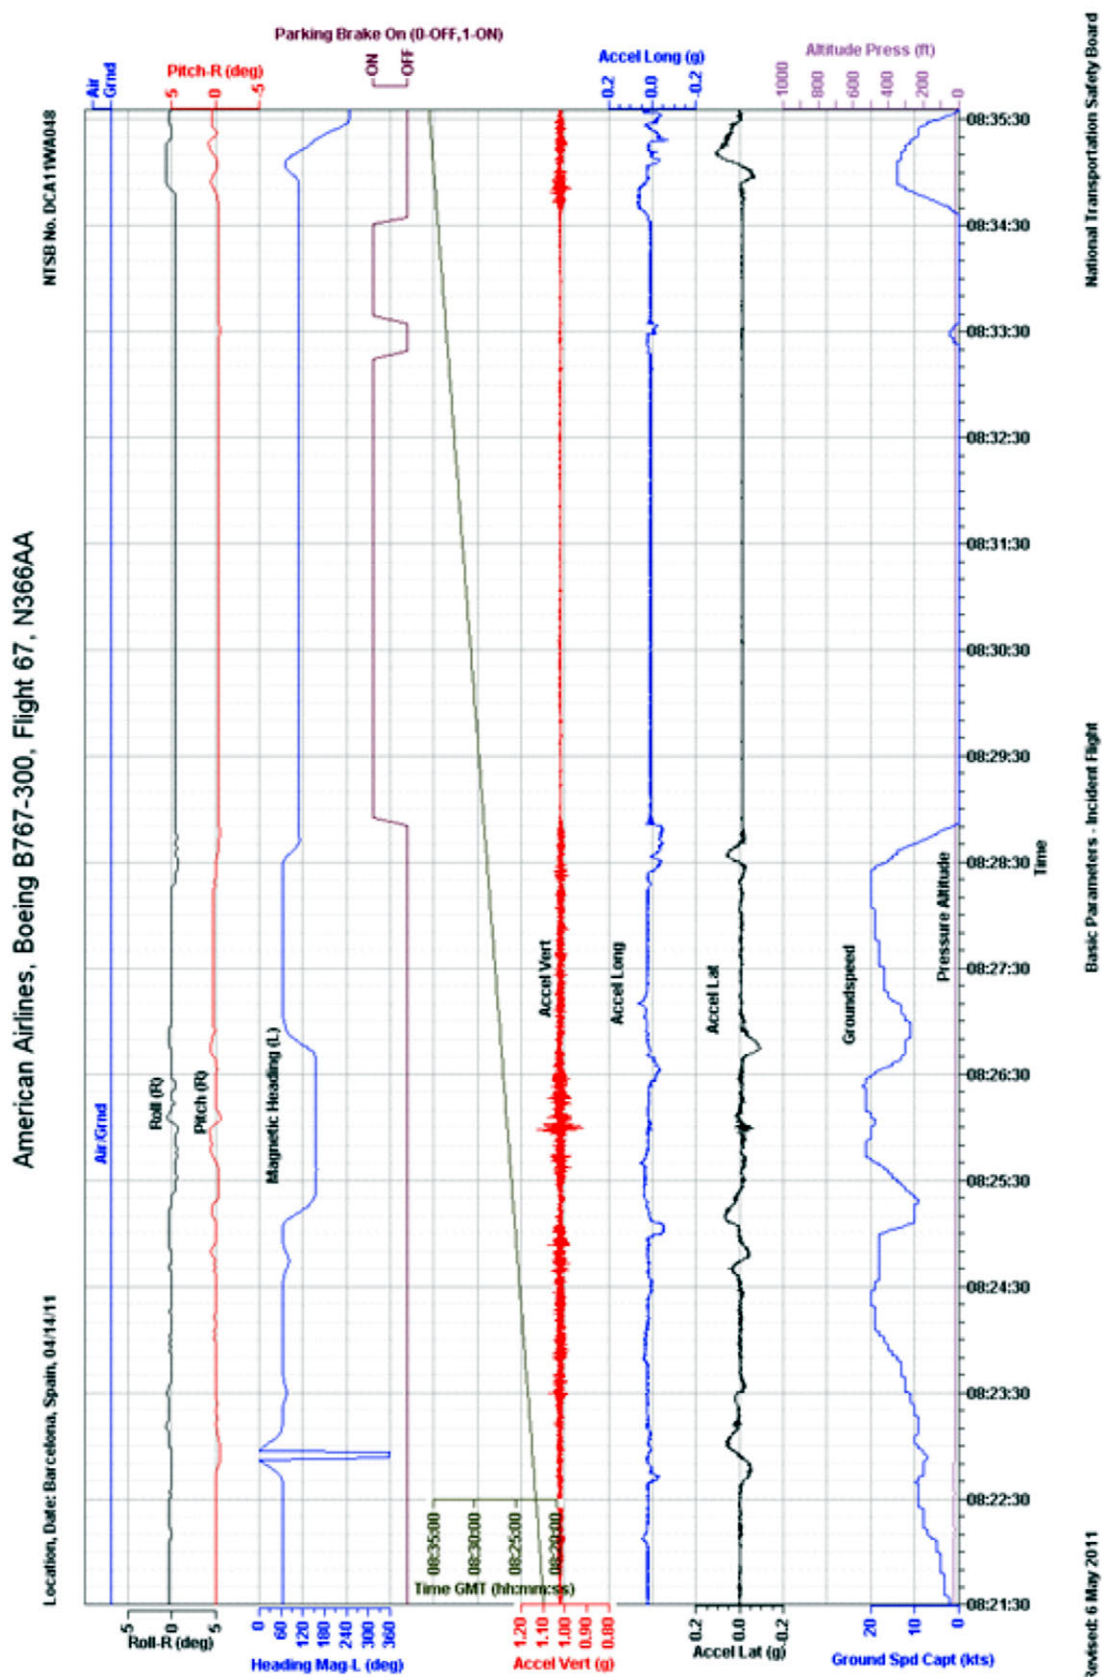
### **Graphs of flight parameters recorded by the FDR**

For the B737, the graphs show an increase in brake pressure until 08:29:30 and a subsequent reduction in ground speed from 14 kt to a full stop at 08:30:45. Also shown

is the change in heading associated with the deviation from the taxiway centerline in an effort to maintain separation between the two aircraft.

As for the B767, the ground speed graph shows that it stopped in front of the bar at point G1 at 08:28:50, where it stayed until 08:33:20, at which time it moved forward a few meters and stopped again before finally entering the runway at around 08:34:35.

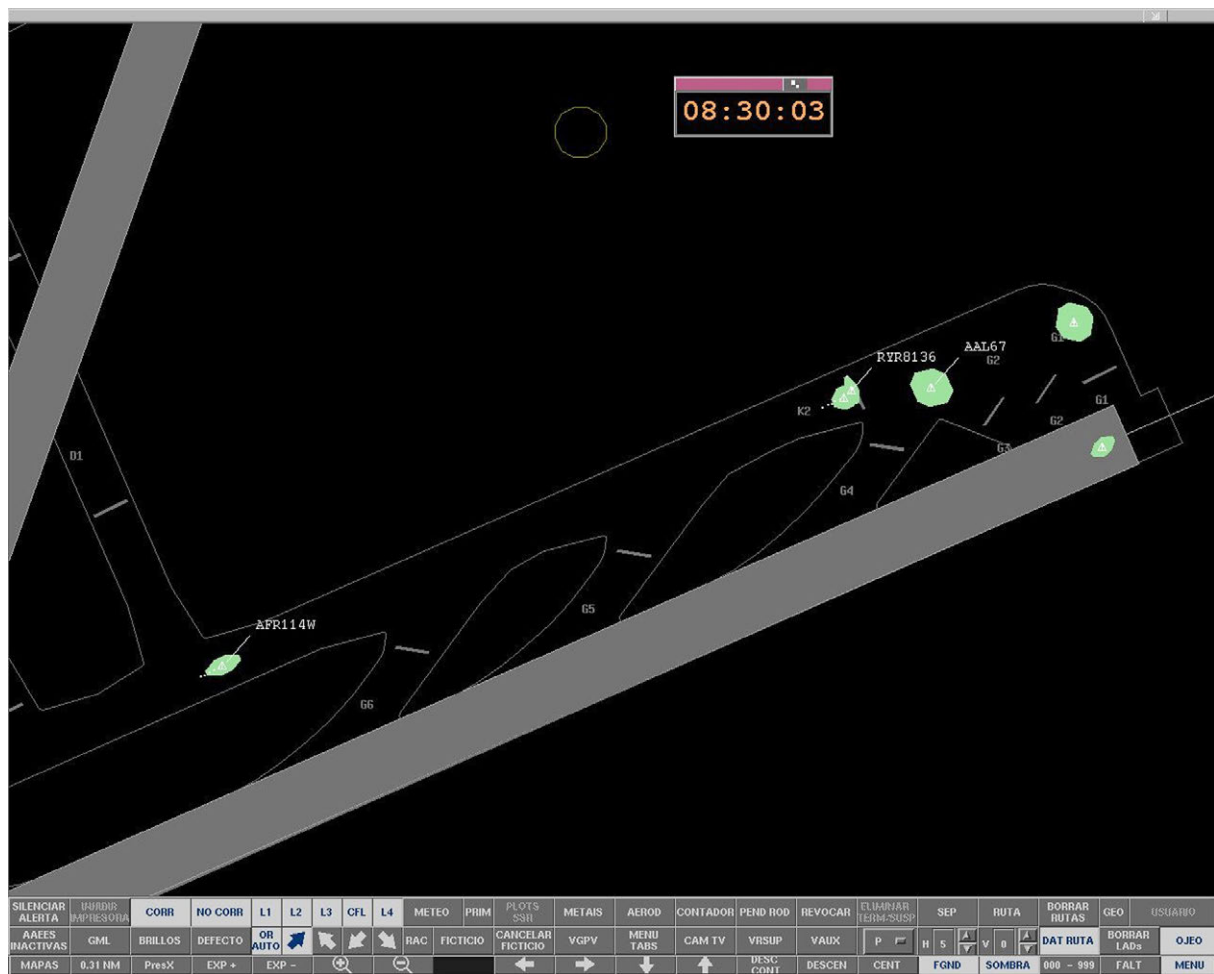
The B767's speed through the taxi line branch towards the holding point, as recorded by its FDR, was integrated to yield an estimate of the aircraft's position at its initial stopping point and of the distance covered during its subsequent displacement forward before stopping again. These calculations indicated that the B767 stopped some 50-60 ft before the marking and then moved forward about 15 ft. These figures are consistent with the crew's statements and with the information obtained from the ground radar (Appendix III).

**Echoes from the SMR (Surface  
Movement Radar) around the 25L runway  
holding point, moments before the collision**
