Second interim statement IN-013/2011

Incident involving an Airbus A-320-211
aircraft, registration EC-GRH, operated
by Vueling, on 20 April 2011 at the
Seville Airport (Seville, Spain)

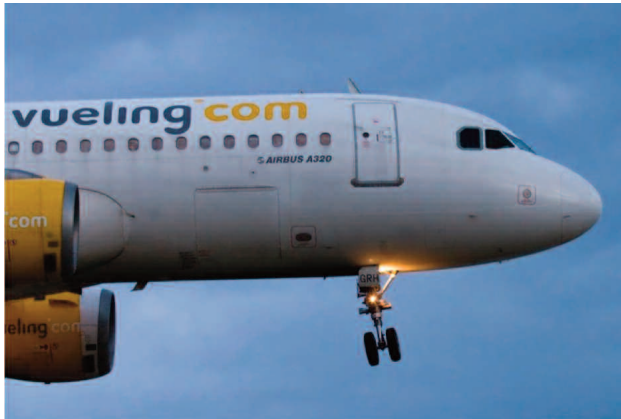
whenever the WHEEL N.W. STEER FAULT⁵ warning appears. This procedure includes a note stating that if the L/G SHOCK ABSORBER FAULT warning also appears, the nose wheels may be turned at a 90° angle from the airplane's longitudinal axis. As a result, the crew executed a low fly-over at 20:21 so that the control tower could verify the position of the landing gear. The controller confirmed that the nose wheels were turned to the right.

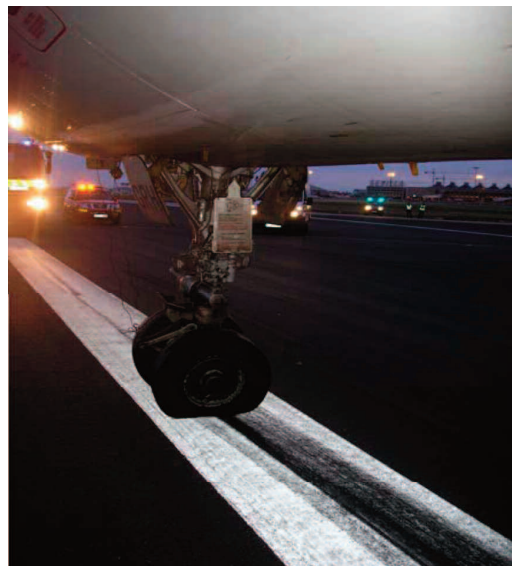
The aircraft landed at 20:51. The aircraft stayed on the center line and decelerated normally, coming to a stop by rapid exit taxiway E3. The right nose wheel had blown out. The crew stated that the landing was normal, if somewhat noisy. There were no vibrations. They turned off the engines when the airplane stopped. After confirming with the tower and firefighters that there was no fire, the passengers were disembarked normally, a process that took place from 20:55 to 21:14.
