## Interim Statement IN-013/2011

Incident involving an Airbus  
A-320-211 aircraft, registration  
EC-GRH, operated by Vueling,  
on 20 April 2011, at the Seville  
Airport (Seville – Spain)

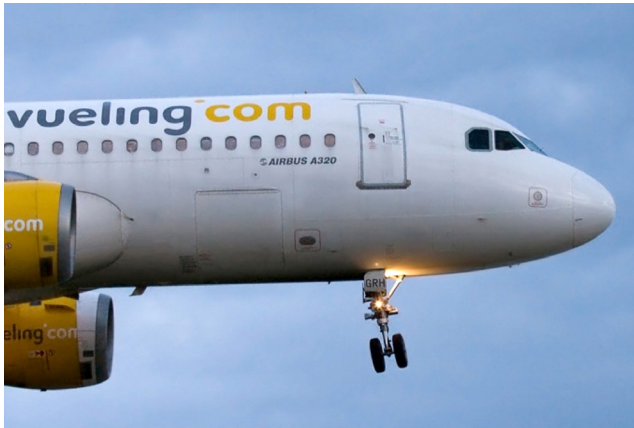
out whenever the WHEEL N.W. STEER FAULT<sup>5</sup> warning appears. This procedure includes a note stating that if the L/G SHOCK ABSORBER FAULT warning also appears, the nose wheels may be turned at a 90° angle from the airplane's longitudinal axis. As a result, the crew executed a low fly-over at 20:21 so that the control tower could verify the position of the landing gear. The controller confirmed that the nose wheels were turned to the right.

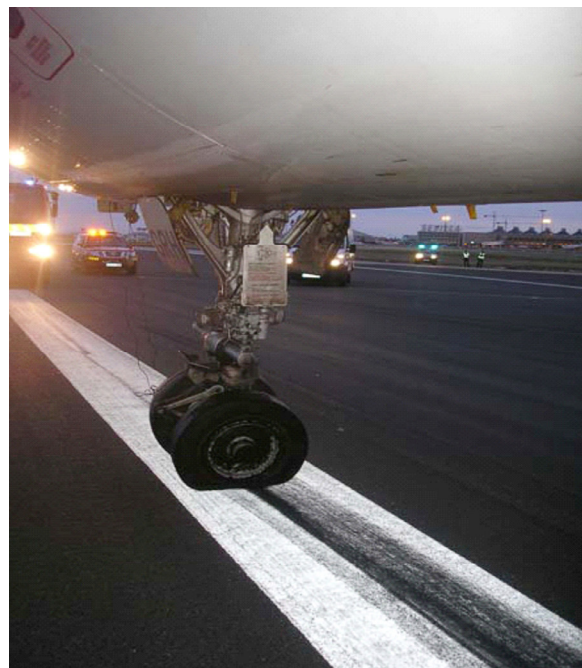
The aircraft landed at 20:51. The aircraft stayed on the center line and decelerated normally, coming to a stop by rapid exit taxiway E3. The right nose wheel had blown out. The crew stated that the landing was normal, if somewhat noisy. There were no vibrations. They turned off the engines when the airplane stopped.

Based on the instructions received from the airplane manufacturer, the alternating current supplies and steering system for the airplane's nose wheel landing gear were inspected and tested. During the inspection of the AC supply, evidence was found of arcing in one of the connectors in the bundle of cables that connects the AC no. 1 IDG (Integrated Drive Generator) and constant speed transmission fitted to the left engine to the airplane's electrical system.

As a result of this inspection, the no. 1 IDG and its associated electric harness were replaced, along with the nose wheel landing gear and its command and control elements, extension-retraction and steering components.
