Date and time	<b>Friday, 23 July 2011; 13:05 local time<sup>1</sup></b>
Site	<b>Vicinity of the Santa Cilia de Jaca Aerodrome (Huesca, Spain)</b>

Registration	<b>G-CCRC</b>
Type and model	<b>CESSNA TU-206 (S/N U206-07001)</b>
Operator	<b>Centro de Paracaidismo Pirineos</b>

Type and model	<b>TELEDYNE CONTINENTAL MOTORS TSIO 520-M7B (S/N: 532404)</b>
Number	<b>1</b>

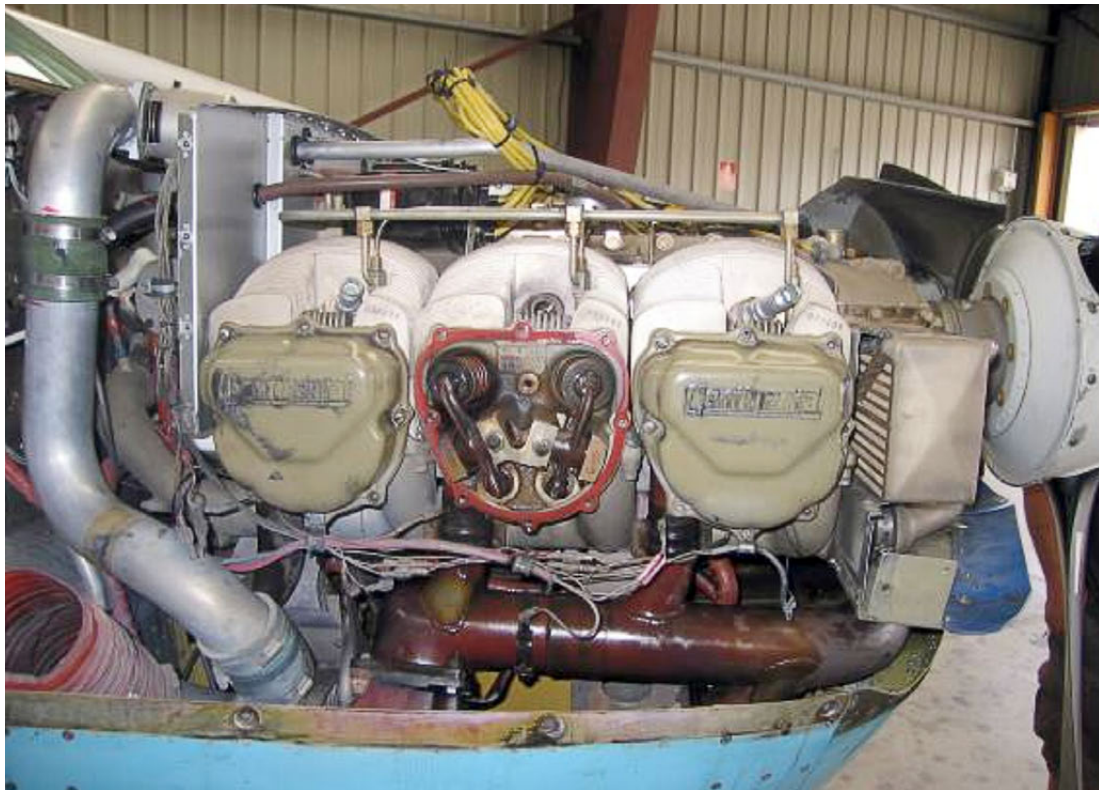
After the off-field, power-off emergency landing, the aircraft was verified to have suffered no damage beyond the engine, the damage to which was mainly confined to the no. 3 cylinder.

Figure 1. Right side of the engine; Nos. 1, 3 and 5 cylinders

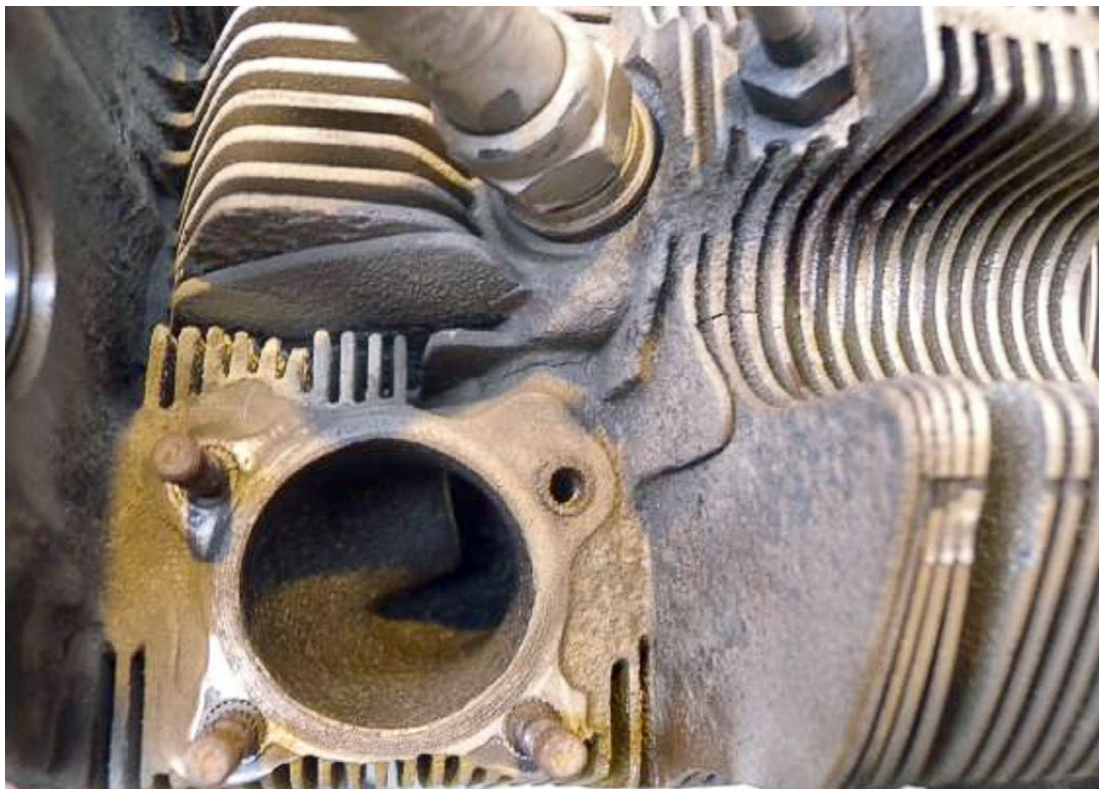
Figure 2. Cracks near the exhaust port and lower spark plug on the no. 3 cylinder

This damage resulted in cooling oil being lost to the outside of the engine through the no. 3 cylinder gasket, in bulging of the crank case in the area where the no. 3 cylinder is attached and in a recent crack at the port of the upper spark plug in the same cylinder.

Other damage found that was apparently unrelated to that caused by the failure of the exhaust valve on the no. 3 cylinder included cracks and gas exhaust deposits in the fins of the cylinder in the area of the exhaust manifold, loosening of a stud on said manifold and a broken brake collar, deformation and grouping of several cooling fins on the no. 3 cylinder, and a circumferential crack in excess of 180° at the exhaust nozzle of the no. 3 cylinder.

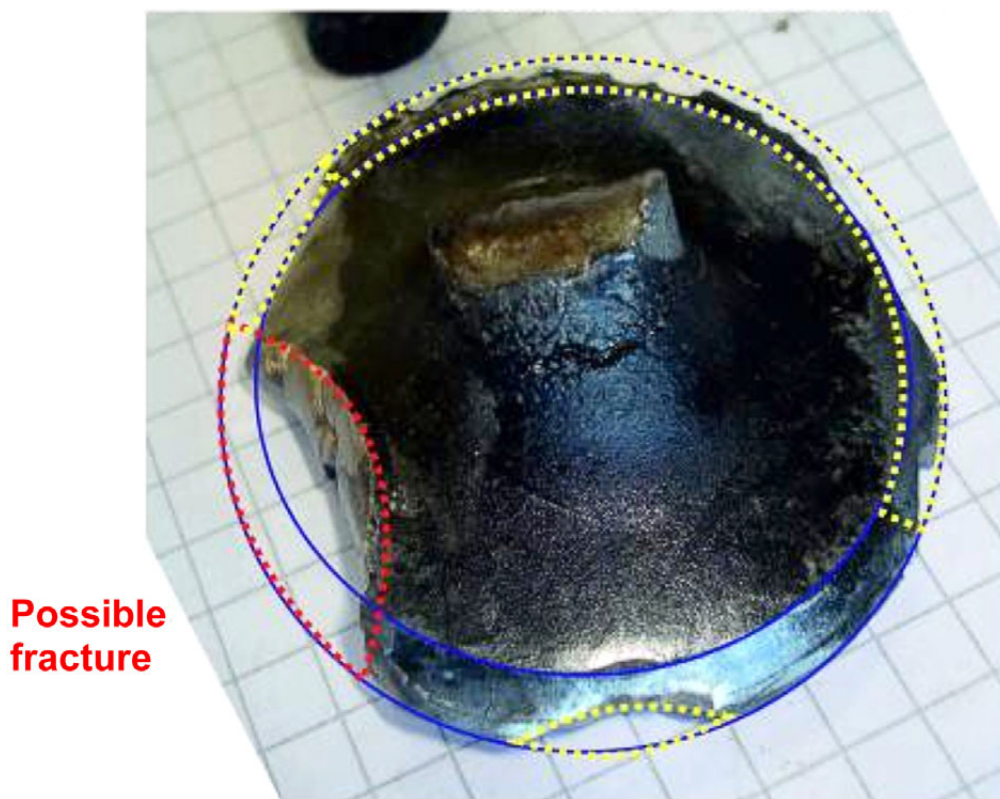
The head of the no. 3 cylinder exhaust valve struck the inside of the cylinder several times after it separated from the stem. This led to various deformations of the rest of the stem as well as of the entire circumferential perimeter. An analysis of the head showed a large groove on its skirt that seemed to have resulted from the partial fracture of the head before it broke off from the stem, as shown in Figure 3.

Figure 3. . Head of the valve on the no. 3 cylinder

Even without knowing exactly how the failure initiated, it can be surmised that since it only affected one cylinder, the cause must be related to a unique feature of that cylinder and its assembly or adjustments. In light of the evidence found, it is very likely that an improperly seated exhaust valve causing leakage through that valve (see Figure 7) resulted in the initial degradation and loss of material around the perimeter of that valve's head (see Figure 3).

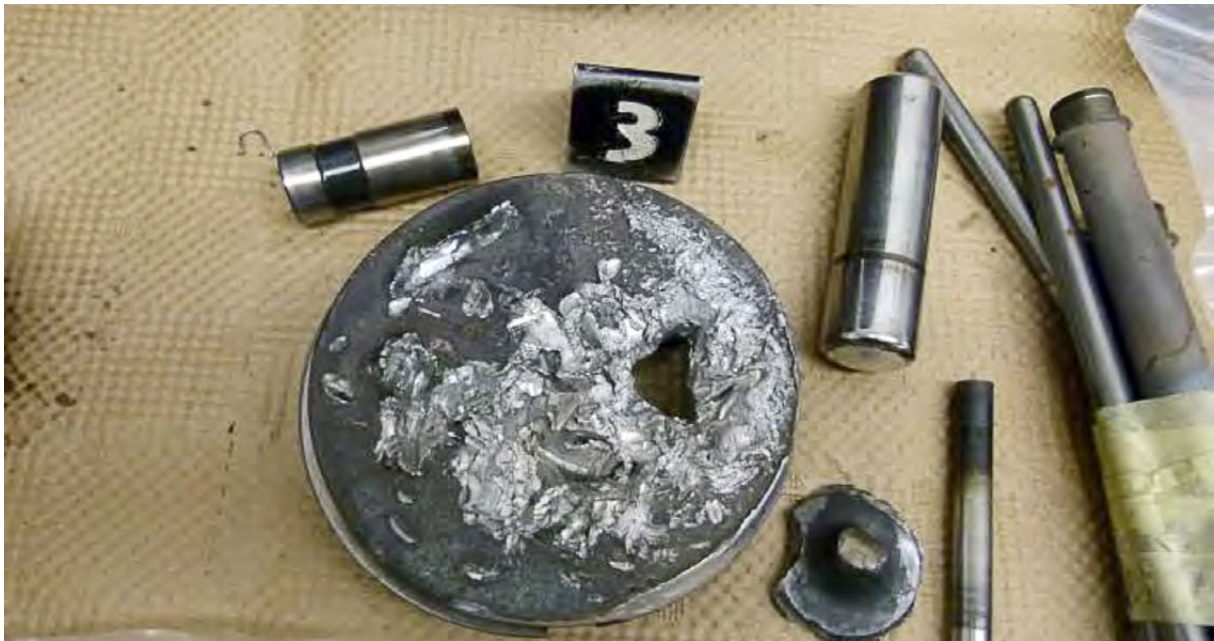
The remaining damage to the no. 3 cylinder (twisted piston rod, crushed piston, bent tappet or pushrod, etc.) was also considered secondary and caused by the engine being driven by the remaining five cylinders after the failure of the exhaust valve in the no. 3 engine.

The no. 3 cylinder and its internal components, pistons, segments, pushrod, etc., showed heavy generalized damage.

Figure 5. Piston, valve and other components of the no. 3 cylinder

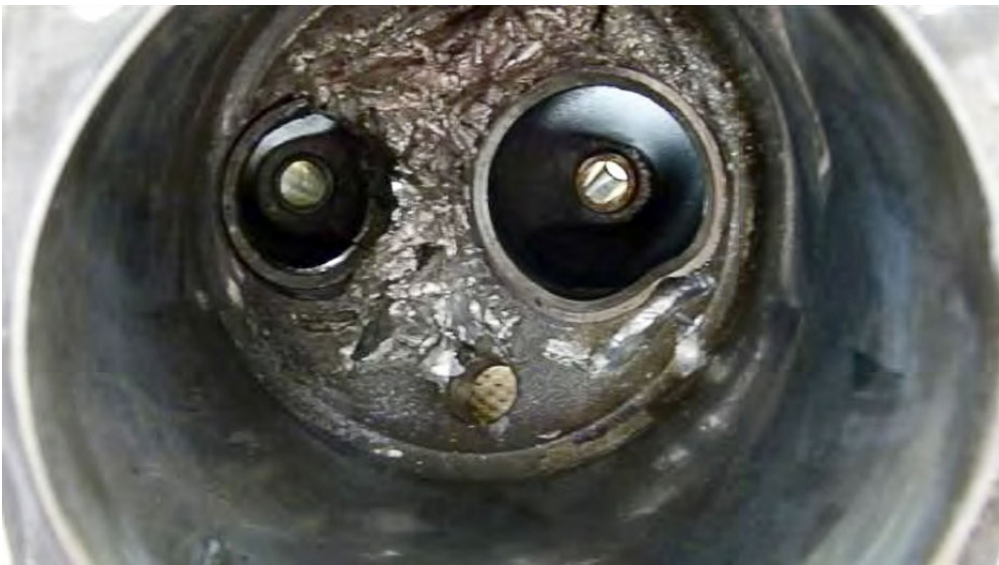
Figure 6. Interior of the no. 3 cylinder
