**DATA SUMMARY**

Date and time	<b>18 September 2011, 16:50 LT<sup>1</sup></b>
Site	<b>El Puerto de Santa María (Cádiz)</b>

Registration	<b>D-HONY</b>
Type and model	<b>BELL 206B</b>
Operator	<b>Rotorflug GmbH</b>

**REPORT**

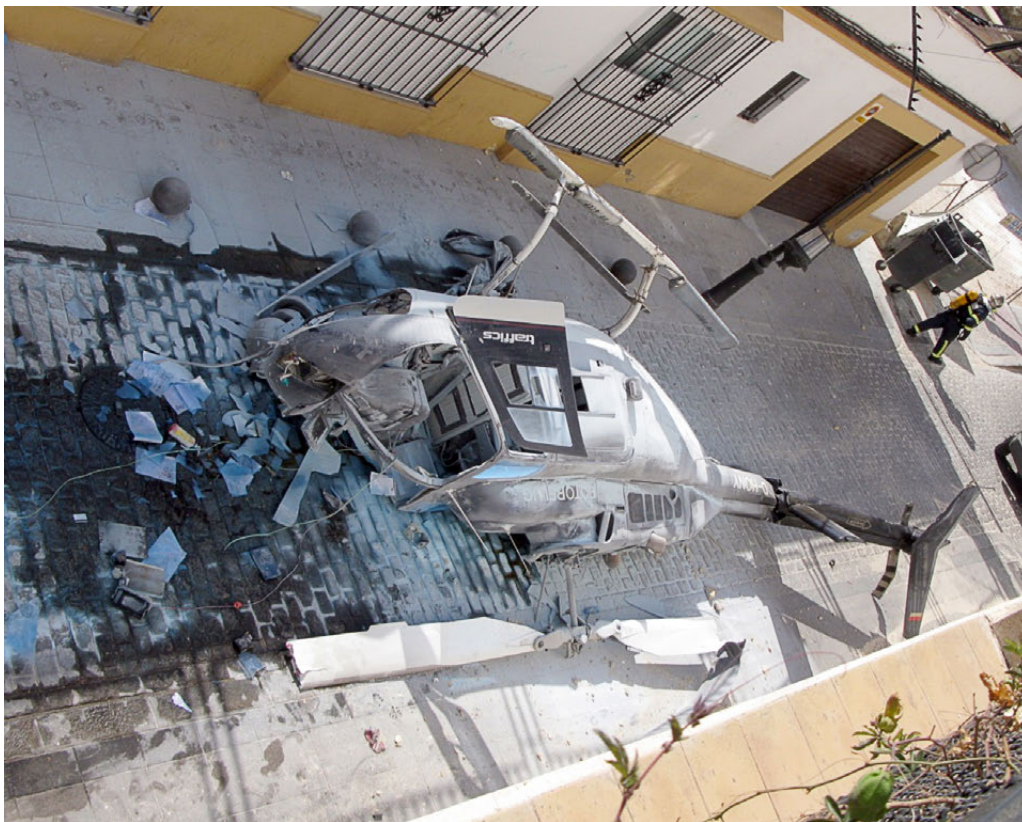
Figure 1. Helicopter wreckage

Some 20 minutes after taking off, while they were filming over the town center of El Puerto de Santa Maria, the helicopter started a sudden uncommanded rotation to the right. The pilot unsuccessfully tried to regain control of the aircraft, which eventually fell on a city street, hitting several buildings during the descent (figure 1).

There were no injuries among the passersby or the local residents. There was some damage to nearby buildings and significant damage to the helicopter.

The helicopter fell to street level, coming to rest on its left side. The cockpit retained its structural integrity for the most part. There were significant dents and fractures to the front left side and the front windshield was broken.

The tail boom was bent in front of the horizontal stabilizer, which had torn its outer skin. There were several impact marks in the area closest to the tail rotor and it was resting on the ground atop its horizontal stabilizer and one of the tail rotor blades. Both the tail rotor transmission and the control bar to change the pitch of the blades were bent and broken in the same area where the tail boom had bent. There were no signs of wear or corrosion in the fracture area.

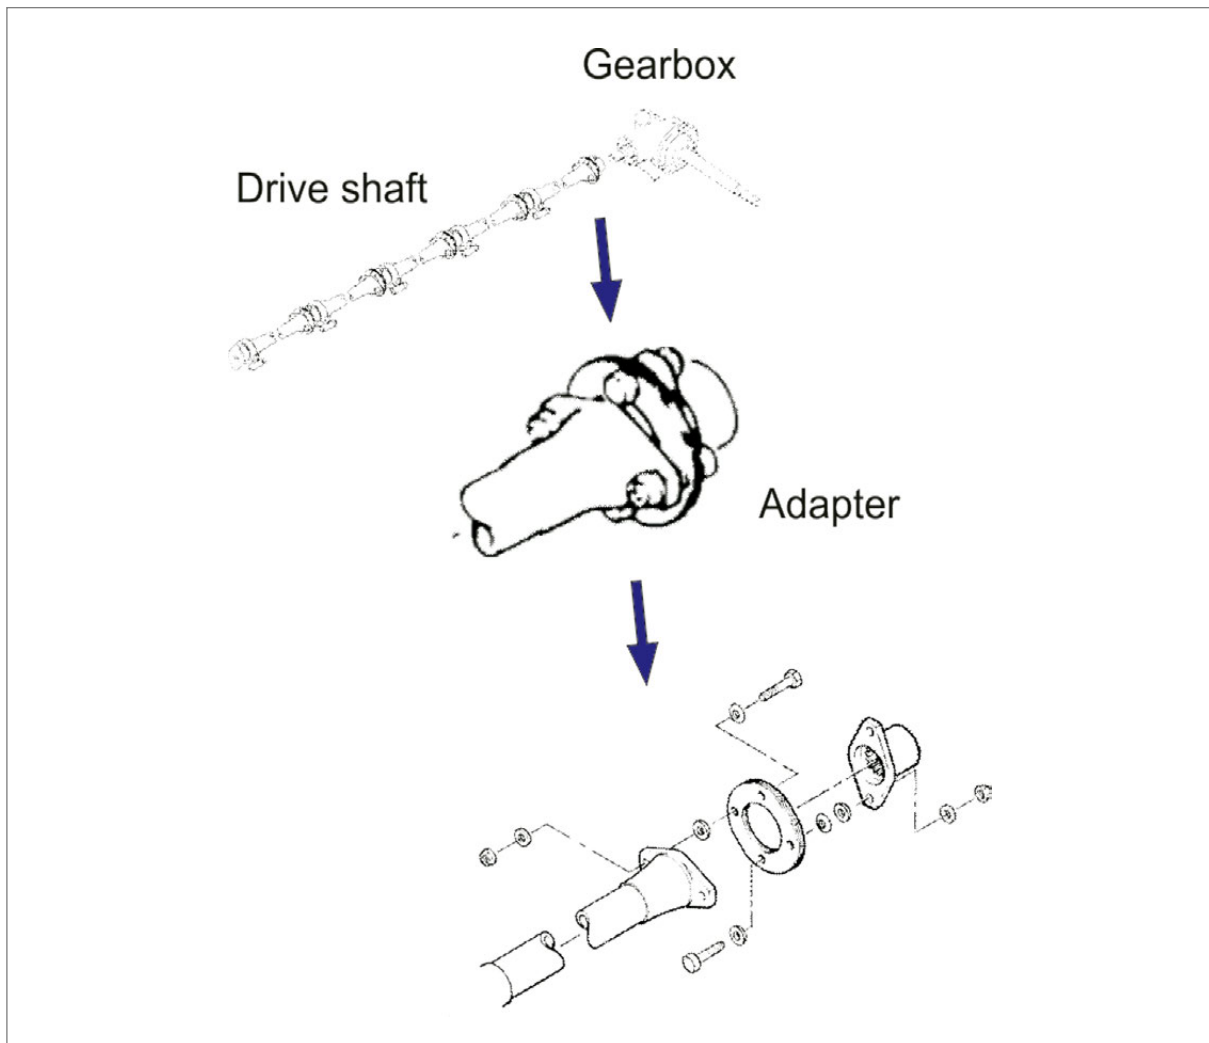
Figure 2. Diagram of the aft section of the tail rotor transmission

The drive shaft is divided into eight segments. These segments are coupled through a combination of geared adapters and a group of unlubricated laminated steel rings. The lugs at the rear of each segment are threaded onto the set of rings, which are in turn screwed onto the adapter that is geared with the next segment. Bearings hold each shaft segment to the tail boom structure (figure 2).

Three of the four bolts that attached the right-angle gearbox on the tail rotor to the tail boom structure had detached. The gearbox was still attached with one bolt, though it was slightly rotated with respect to its normal position. The broken sections of the other bolts were found inside the tail boom with their threads firmly in place.

The aft segment of the tail rotor drive shaft had decoupled from the gearbox when the lug that attaches it to the gearbox adapter broke. The adapter, and part of the broken lug still screwed onto it, was found on the ground just below the tail. Neither the adapter nor the broken segment showed any external signs of corrosion.

The decoupling occurred due to the break of the lug that housed one of the mounting screws and due to the stripping of the thread on the other screw. Both pieces were sent to a laboratory for analysis of the fracture.

AW 2014 aluminum, while the steel in the screw was identified as being alloyed with chrome, nickel and molybdenum. Both materials complied with the aircraft manufacturer's specifications. The shaft fractured due to excess stress under flexural tension. The screw was stripped of its thread by shear tear out.

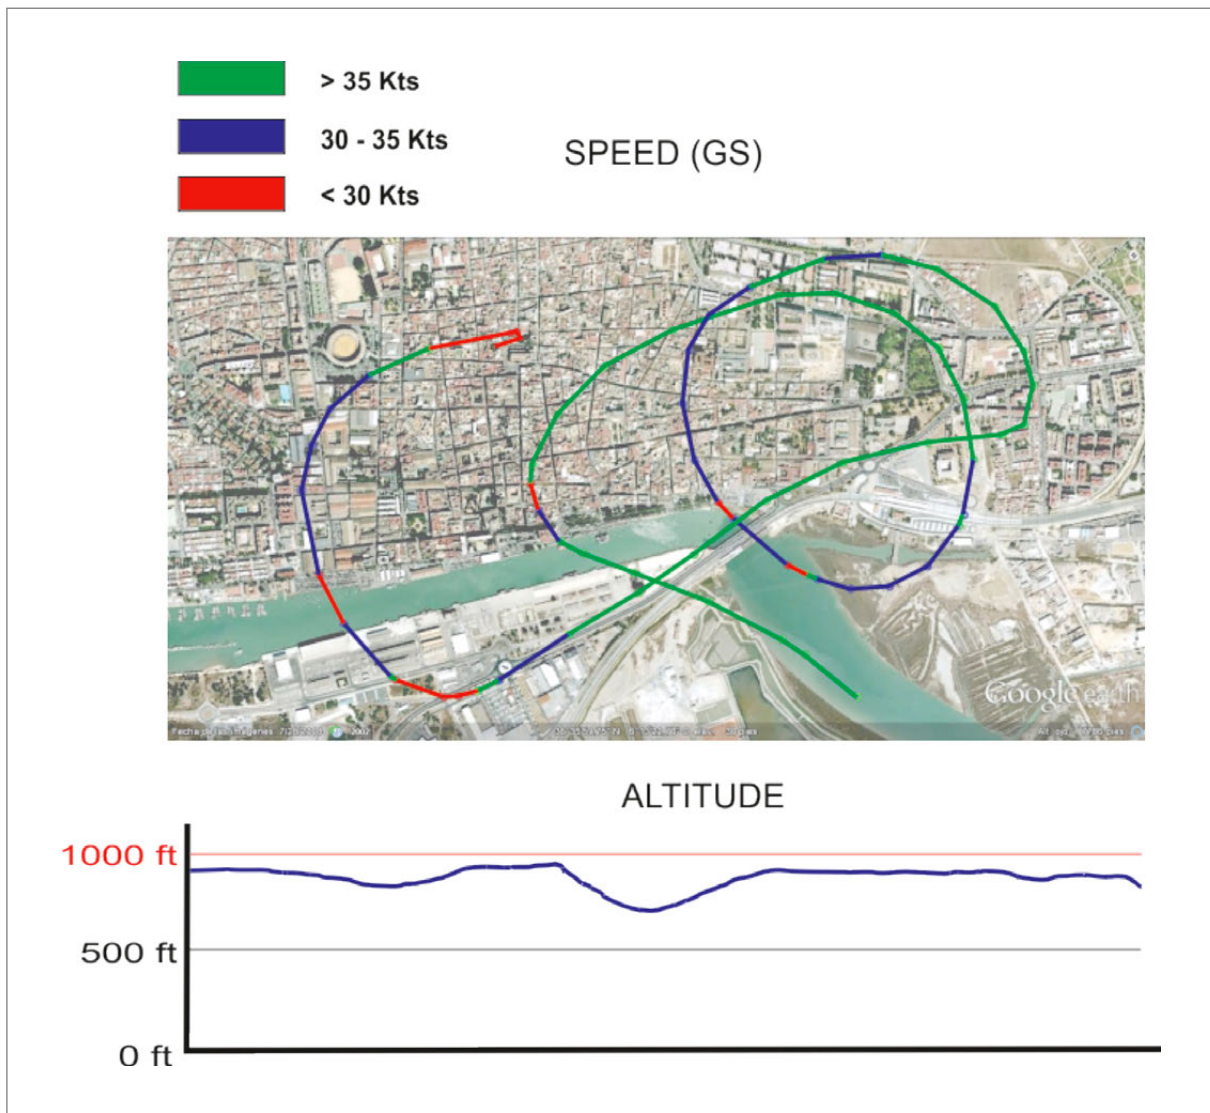
Figure 5. Flight path of the helicopter over the city

The information obtained from the footage of the onboard camera, from the surveillance radar (SSR) and from the GPS receiver recovered from the wreckage allowed investigators to reconstruct the aircraft's flight path leading up to the accident (figure 5).

The aircraft entered El Puerto de Santa Maria from the E, flying along the river and making two right-hand 360° turns over a location NE of the impact site. It then returned to the river and flew SW before proceeding to the town center on a path perpendicular to the river.

After starting a turn to the right, and while on a NE course (parallel to the river), the helicopter started yawing to the right suddenly. It is estimated that in about 3 seconds, the helicopter had turned 180° and reached a turn rate of about 90°/s. The aircraft completed approximately four full turns while losing altitude until finally, near the ground, the turn rate slowed. Immediately afterward, the descent rate slowed coincident with an increase in the turn rate just before impact. The complete sequence from the initial loss of control to impact lasted about 35 seconds.

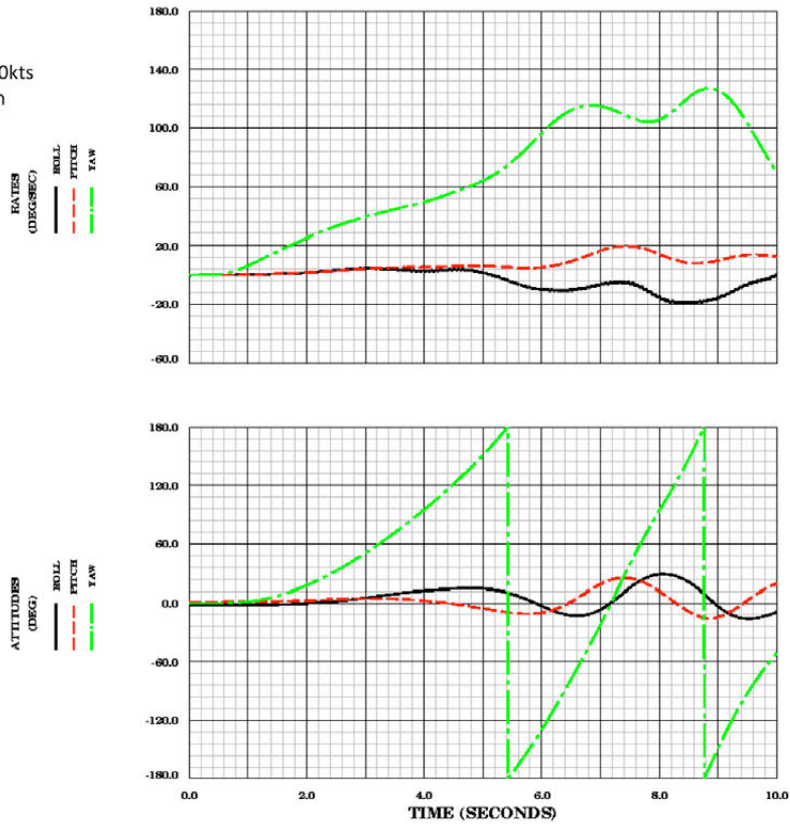
Case #6  
 T/R Torque Loss  
 Forward Flight-20kts  
 No Pilot Reaction

In order to analyze the motion observed in the helicopter after the loss of control, investigators asked the manufacturer to simulate the flight dynamics of a Bell 206 after a loss of the tail rotor. The cases considered were a full loss of rotor thrust and a full loss of the torque supplied by the tail rotor under loading and aerodynamic speed conditions similar to those present on the accident flight. The simulations considered no pilot inputs and then an input to the cyclic intended to regain speed. The results are shown graphically in Appendix I.

It was also noted that in those cases where the tail rotor was lost, the rotor continued rotating at high rpm's for a long period of time due to aerodynamic effects.

In addition, the characteristics of the yaw movement observed during the accident show similarities with the results of the theoretical simulations of an absence of lift in the anti-torque rotor, a condition that, to a certain extent, may be regarded as representative of the LTE phenomenon.

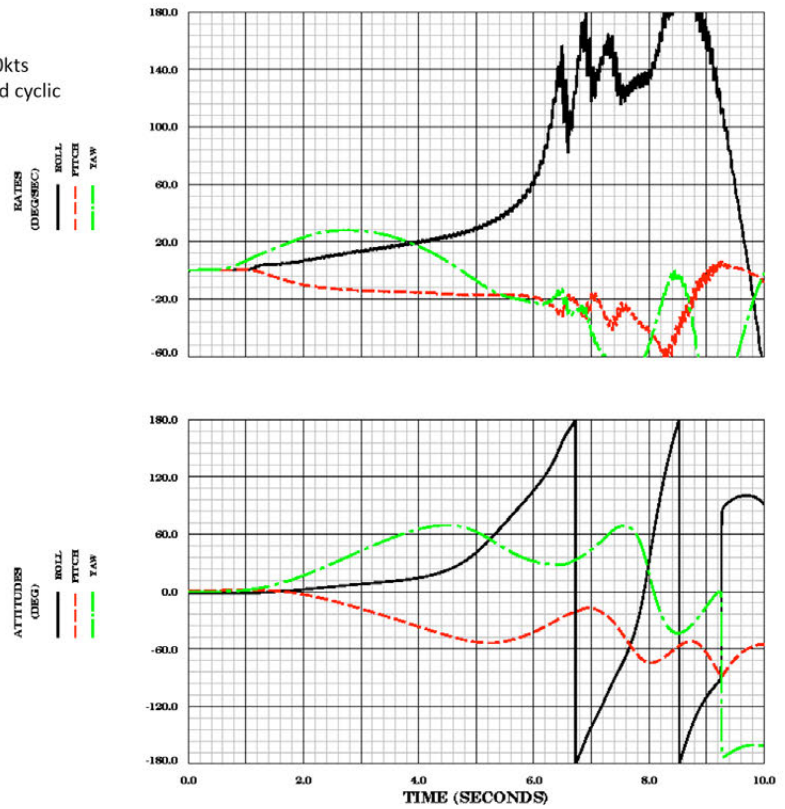
Case #8  
 T/R Torque Loss  
 Forward Flight-20kts  
 Pilot adds forward cyclic

The simulations also indicated that had the transmission failed under these flight circumstances, the pilot would have regained control immediately by pushing the cyclic forward, in contrast to what happened on the day of the accident, when the helicopter's response to this action by the pilot was mostly ineffective. While the results of a theoretical model must be taken with some reservations, it can be stated that in this regard and at least qualitatively, the actual behavior did not correspond to that expected from a failure of this type.
