Report A-042/2011

Accident involving
a Diamond KATANA DA20-C1,
registration EC-KDS,
in Amurrio (Álava),
on 14 October 2011

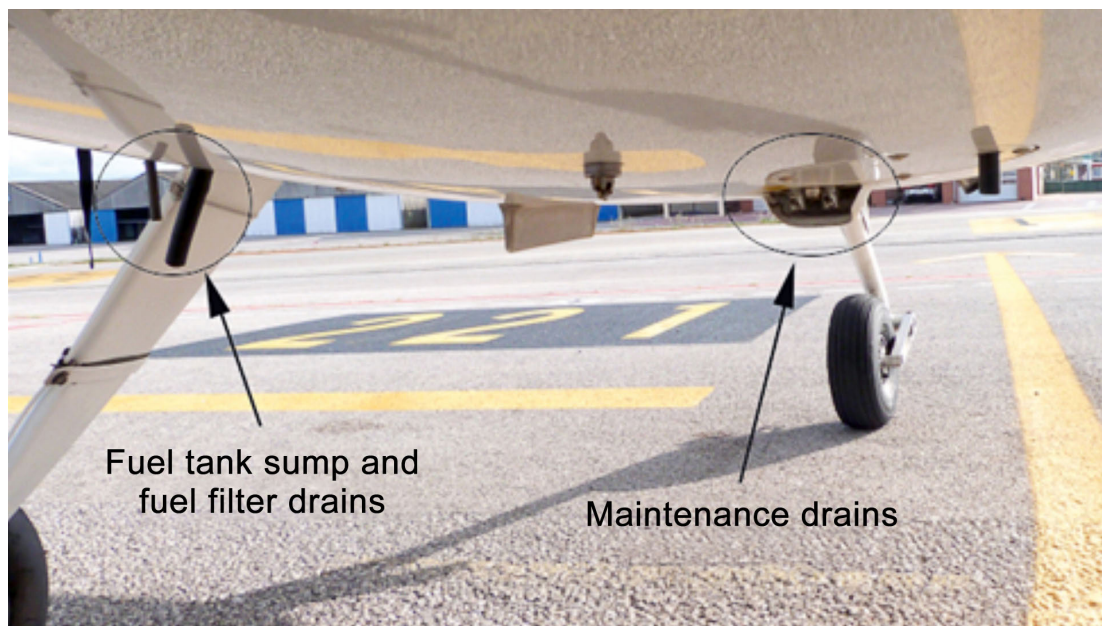
Figure 3. Fuel drains

There are two additional drains located between the wings at the bottom center of the fuselage. One drains from the return line from the mechanical pump to the tank and the other drains from the supply line. These drains are used during maintenance, as noted on the yellow sticker posted next to them. This sticker is not easy to see unless the pilot looks up from underneath the airplane. The drains consists of two taps that are opened by overcoming spring pressure and turning a quarter turn, at which point a notch allows them to remain open.

There is a modification to the Flight Manual dated December 1999 stating that as part of the pre-flight check, these maintenance drains must be inspected to make sure they are not leaking.

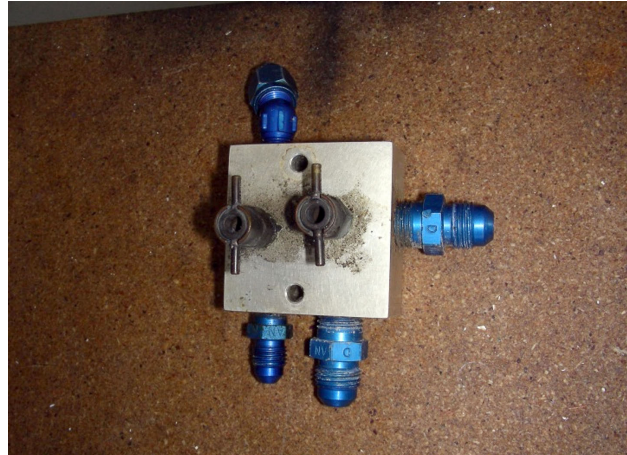
Figure 5. Fuel drain from the accident aircraft

Another test conducted involved checking the operation of the fuel drains, specifically of the maintenance drains, which were confirmed to be working normally. These drains were found closed at the accident site, though the possibility that they may have been closed by emergency personnel working on the aircraft or as a result of the strong impact could not be ruled out.

Based on the investigation conducted on the ground after the accident, it was noted that with the aircraft on the ground, between 1.0 and 1.2 l of fuel could be lost per minute through the maintenance drain on the return line. The amount lost in flight could not be checked, but the Venturi effect would have made this rate higher.

Even though the drain was found in the closed position after the impact, it may have closed as a consequence of the impact given its violent nature, or been closed by emergency personnel during the rescue operations.

Although the cause for the loss of fuel during the flight could not be reliably determined, the investigation found that inadvertently leaving the drain on the fuel return line open is compatible with the accident scenario in terms of the initial amount of fuel and the time elapsed between the refueling, takeoff and engine stoppage.

The type of drainage used for the fuel return line, and labeled as maintenance drainage, is considered a potentially aircraft unsafe condition both for its location and its design, as it is very similar to the standard fuel drainage system for the pilots. As a result:

REC 25/13. It is recommended that the manufacturer, DIAMOND AIRCRAFT INDUSTRIES INC., revise and modify the design and location of the maintenance drainage systems, replacing them by new ones that cannot be manipulated with the standard drainer normally used by the crews.

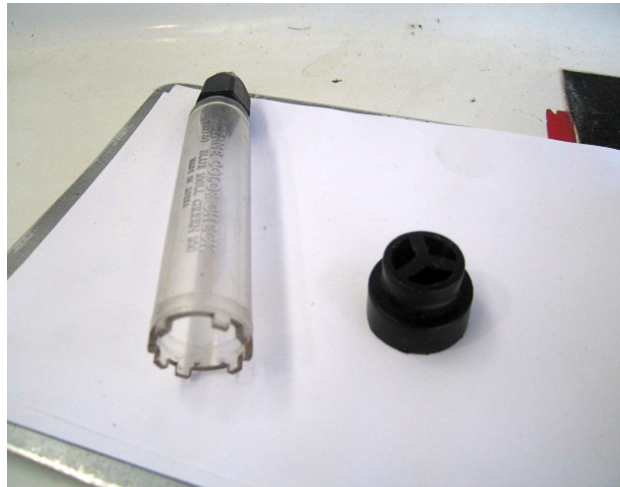
Figure 6. Drainer for the aircraft

Statements were also taken from all of the students the instructor had at the time of the accident. Almost all of them were in their initial hours of flight training. When asked if they were aware of the maintenance drain, only one knew what it was. He said that the pre-flight check was done jointly by the instructor and the student and that during the check they drained all of the drainage points with a drainer.

The drainer used, which was onboard the aircraft, is shown in figure 6.
