DATA SUMMARY

Date and time	Saturday, 12 November 2011, at 11:12 local time ¹
Site	Andratx, wooded area in La Trapa (Balearic Islands)

Registration	G-WOOW
Type and model	HUGHES 369E
Operator	Private

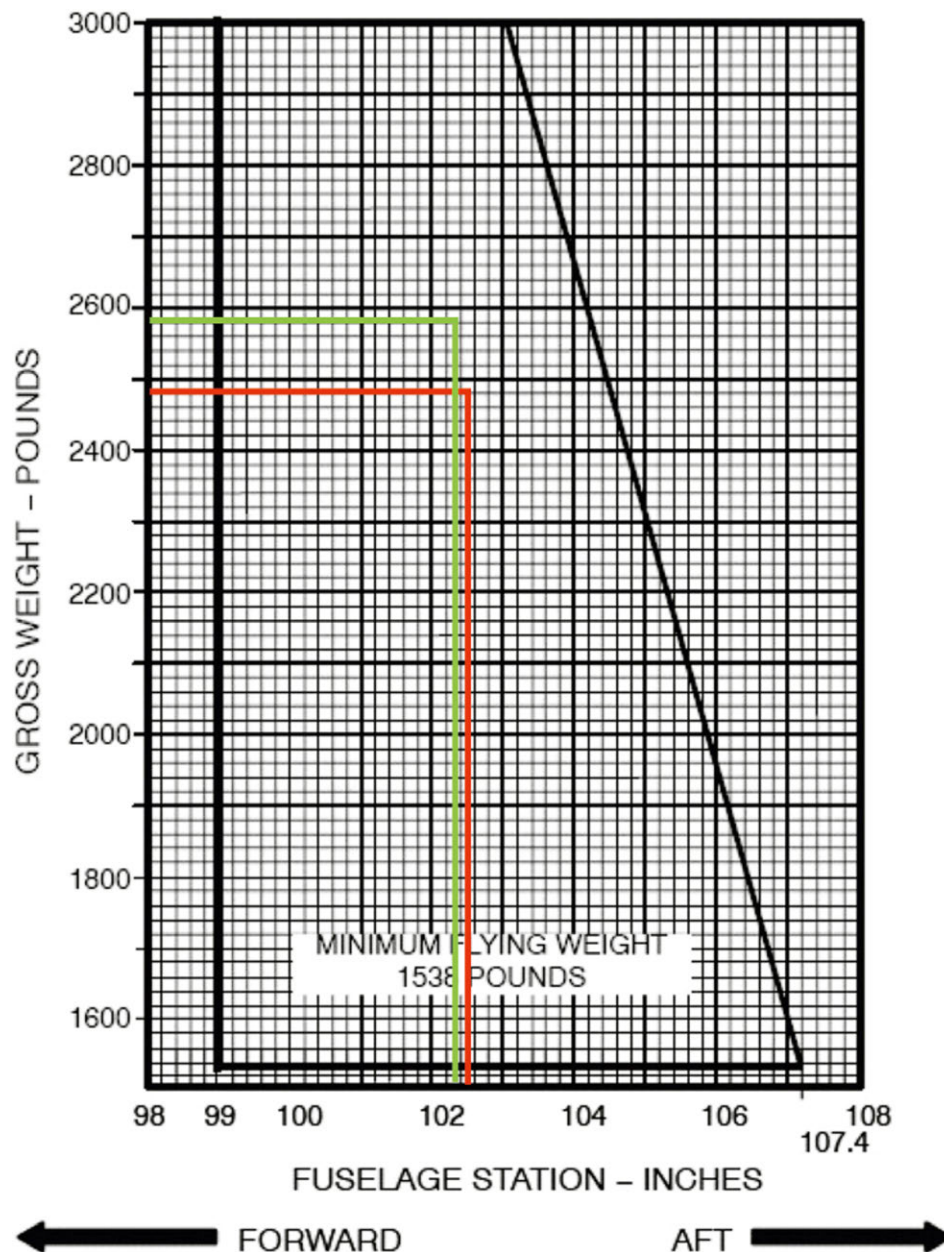
Figure 3. Center of gravity

The full fuel load at takeoff situation is shown in green, and the situation reached after a 30-minute flight is shown in red. In both cases the flight was being carried out within the limits established by the manufacturer.

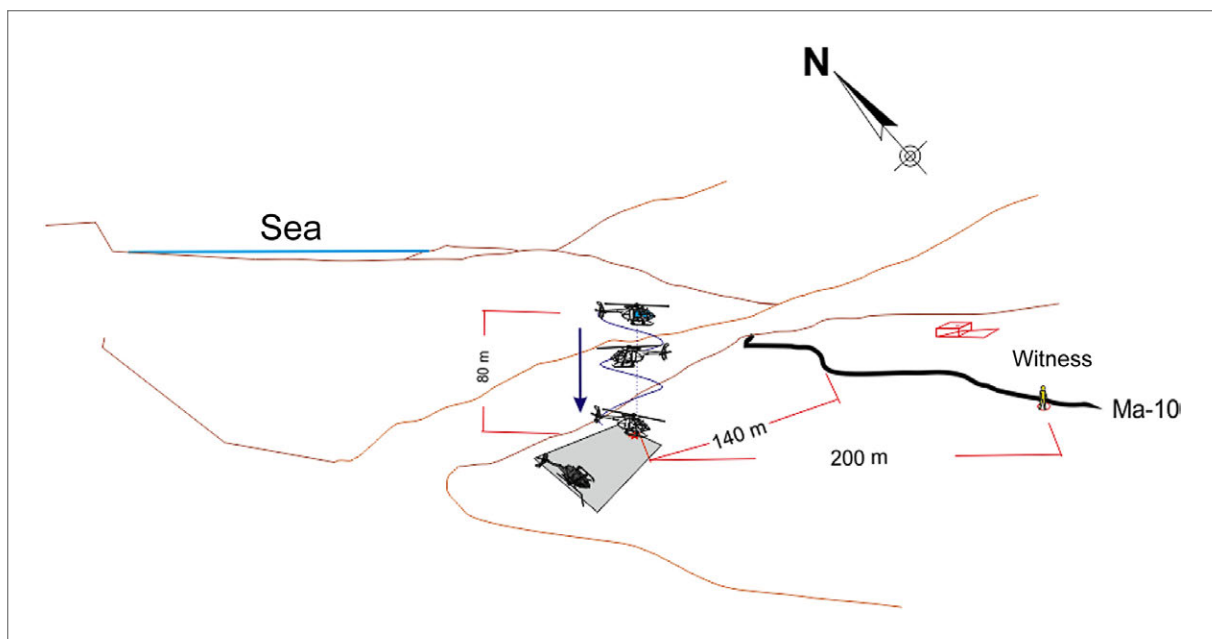
Figure 4. Diagram of the accident sequence

off more or less as it had been. It then immediately started turning about its own axis to the right as it descended vertically, losing altitude. It completed one turn and started another as it continued to fall. It was at the completion of the second full turn that it struck the side of the mountain in a slight nose down and right bank attitude.

The diagram above (not to scale) shows the locations of the various sites mentioned.

When it struck the ground, it exploded into flames. The wreckage slid a few meters downhill before stopping.

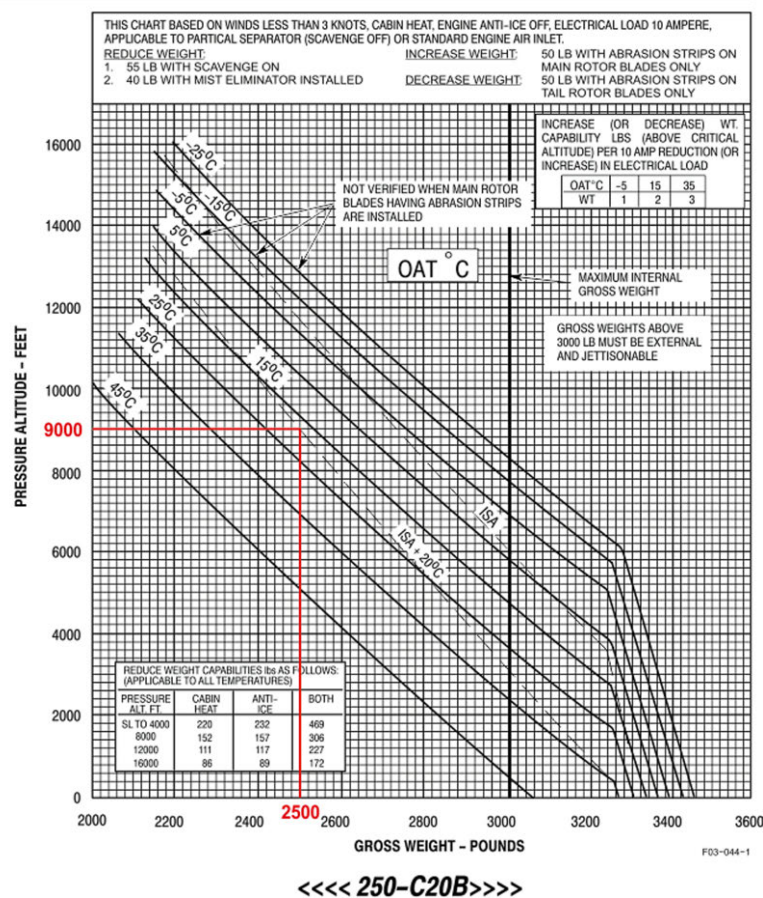
Figure 8 1. Hover Ceiling Versus Gross Weight, Out of Ground Effect, Takeoff Power, Two or Four Bladed Tail Rotor, Rolls Royce 250 C20B

Under the conditions at the time of the accident (weight of around 2,500 lb, outside air temperature of 18 °C¹⁴), the maximum hovering altitude is 9,000 ft.

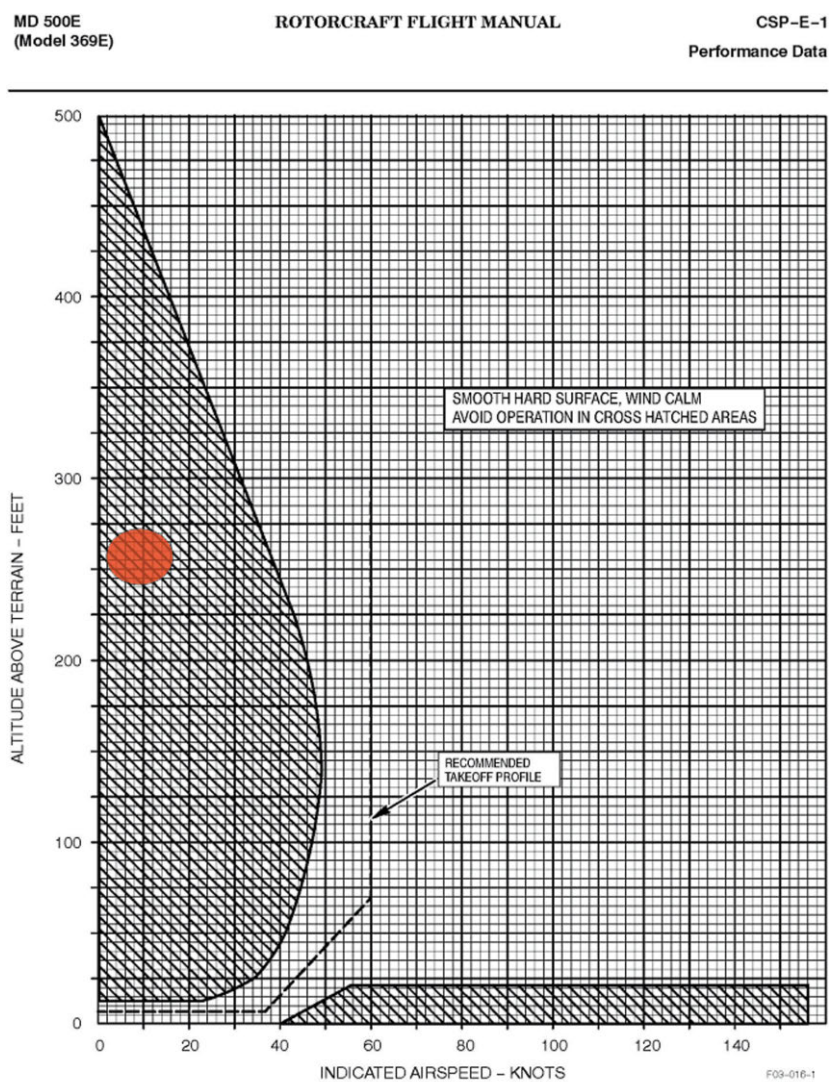
Figure 5-15. Height Velocity Diagram

The area shaded in red shows the conditions under which the pilot was hovering before the loss of control of the helicopter and the subsequent accident.
