## Interim statement IN-002/2012

Incident involving an ATR-72-212A  
aircraft, registration EC-HCG, operated  
by Air Nostrum, at the San Sebastian  
Airport (Spain) on 21 January 2012

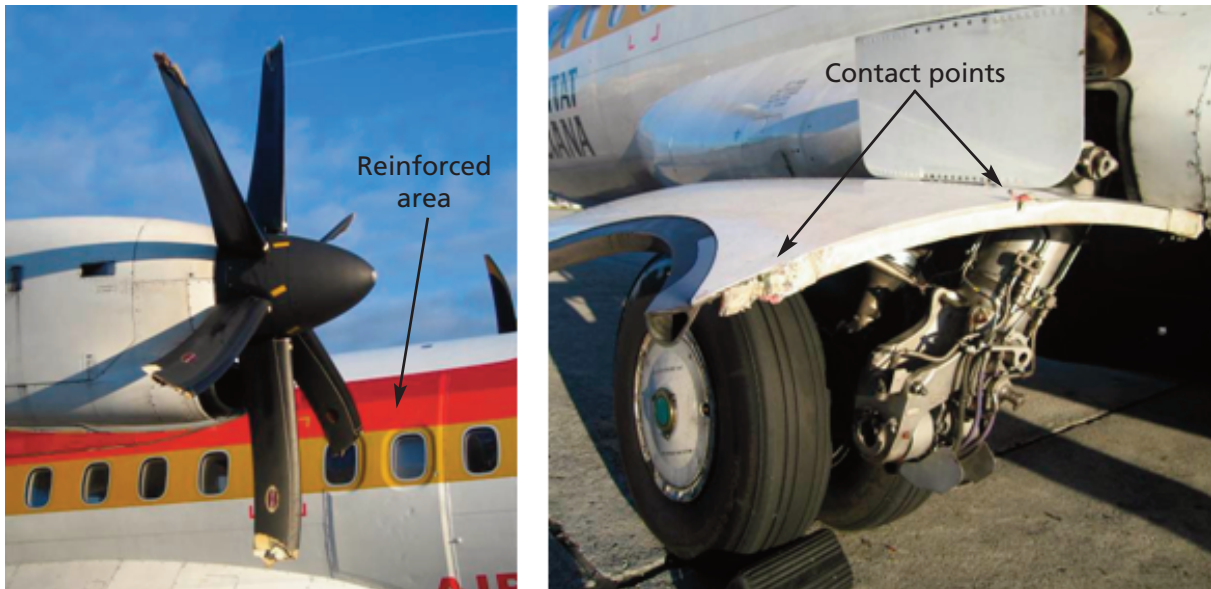
Shortly thereafter the propeller struck the GPU. The impact broke six of its blades, the fragments of which were ejected, some of them striking the part of the fuselage that is reinforced so as to absorb the impact of objects that may be thrown off by the propellers, such as chunks of ice.

The crew felt the impact and stopped the engines. Upon checking the position of the controls in the cockpit, they noticed that the parking brake lever was in the disengaged position.

*Figure 1. Photographs of the damage to the propeller and to the right main landing gear door.*
