Report A-022/2012

Accident involving a Bell 412
aircraft, registration EC-KSJ,
operated by Inaer, at La Forata
reservoir (Valencia, Spain),
on 2 July 2012

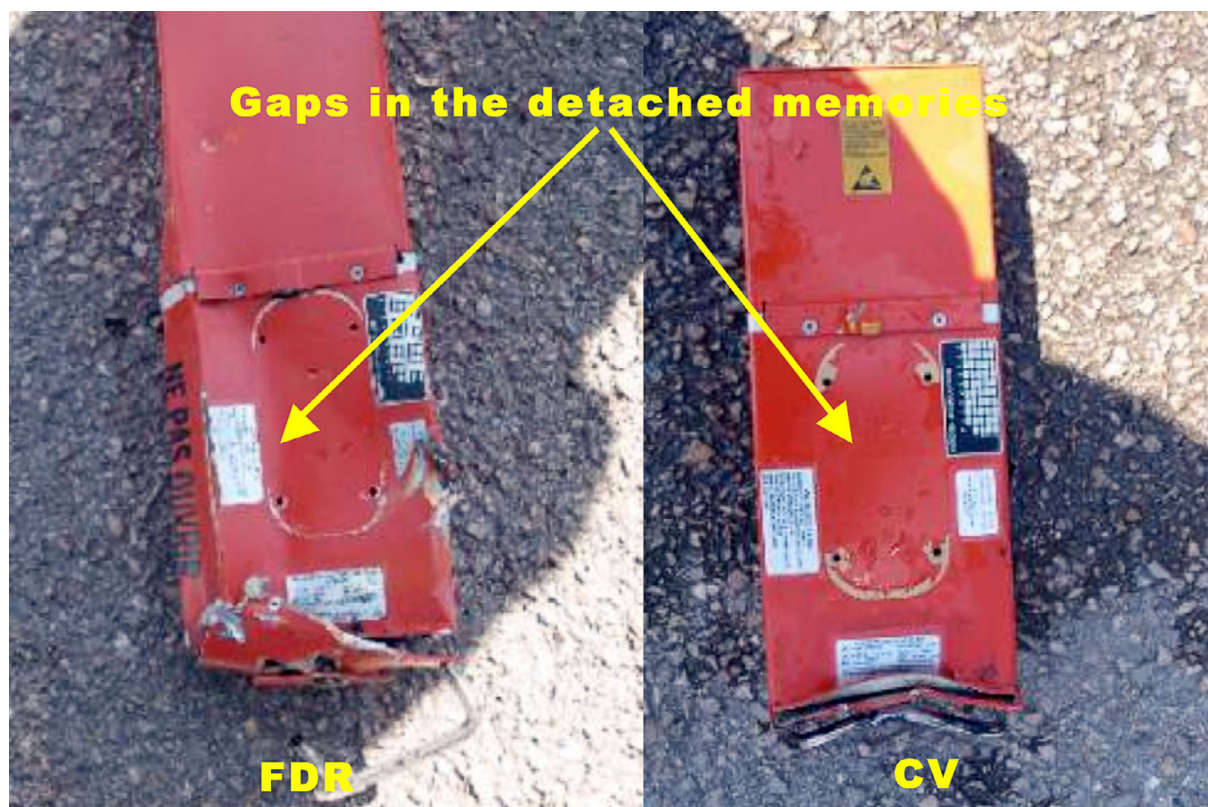
Figure 2. Recorders in as-found condition

Once the helicopter was taken out of the water, it was noted that the CVR was in its housing at the forward part of the helicopter. The DFDR was next to it but slightly out of its housing. When they were removed, both were noted to be incomplete, as the memory housing was missing. Attached to this housing is the underwater locator beacon (ULB). This beacon is activated when it is submerged in water, emitting on a 37.5 KHz frequency for a minimum of 30 days.

The subsequent inspection revealed that the recorder memories had detached because the screws that attached them to the body of the recorder had been sheared, probably when they were struck by one of the blades at the moment the helicopter impacted the water. Figure 7 shows the condition of the blades as the helicopter was being taken out of the reservoir, and Figure 8 shows the fractures exhibited by each.

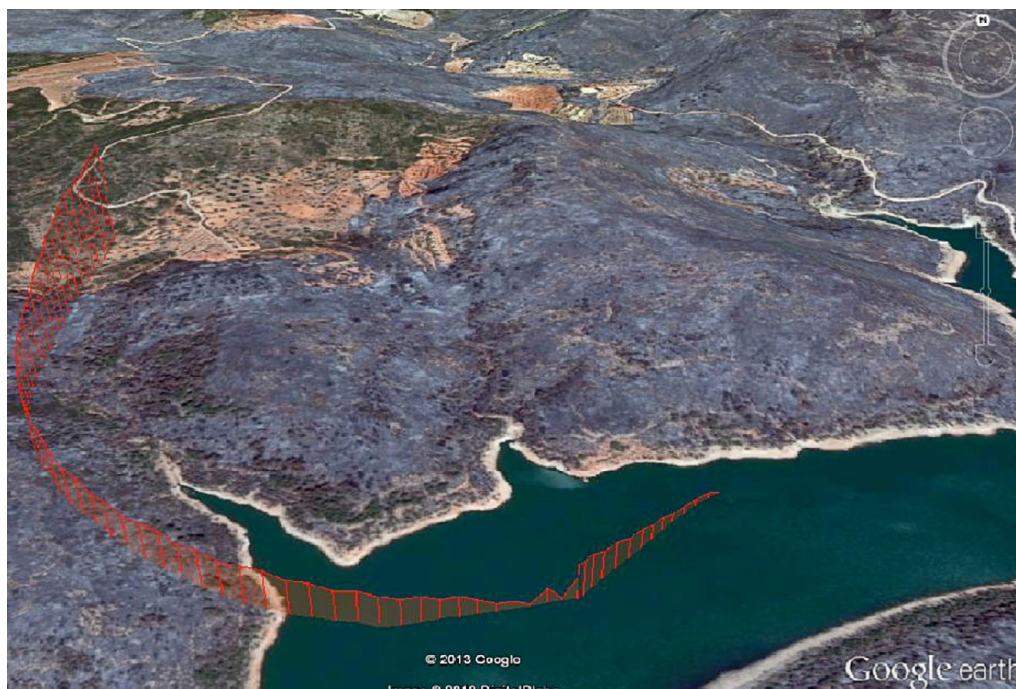
Figure 5. Flight path in the final moments of the flight

Figure 5 shows the final moments of the ninth water pick-up, which is when the accident took place. Appendix 2 shows the entire trip, with the flight paths for the various water pick-ups marked in different colors.

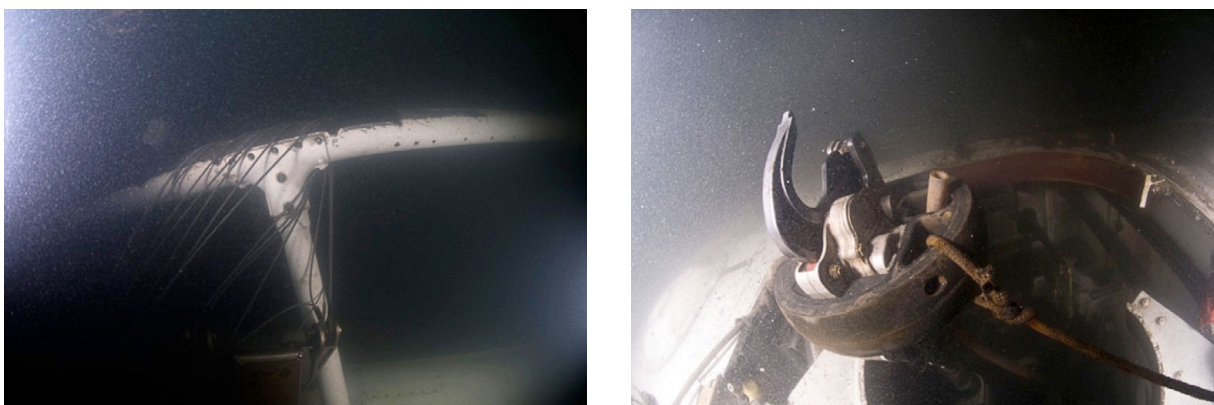
Figure 6. Condition of the cables and bucket load hook

the helicopter's load hook and when the cables were placed over the marks on the skid, it was noted that the rearmost mark had been made by three cables, and the most forward mark by four.

It was also determined that the both the load hook and the head of the bucket had struck the bottom of the helicopter, specifically, the area that houses the load hook, bending the fairing. There were marks from the tank cables that extended toward the rear and along the entire underside of the helicopter. This impact had affected the command bars for the throttles of both engines, which were fractured at various points on their travel.

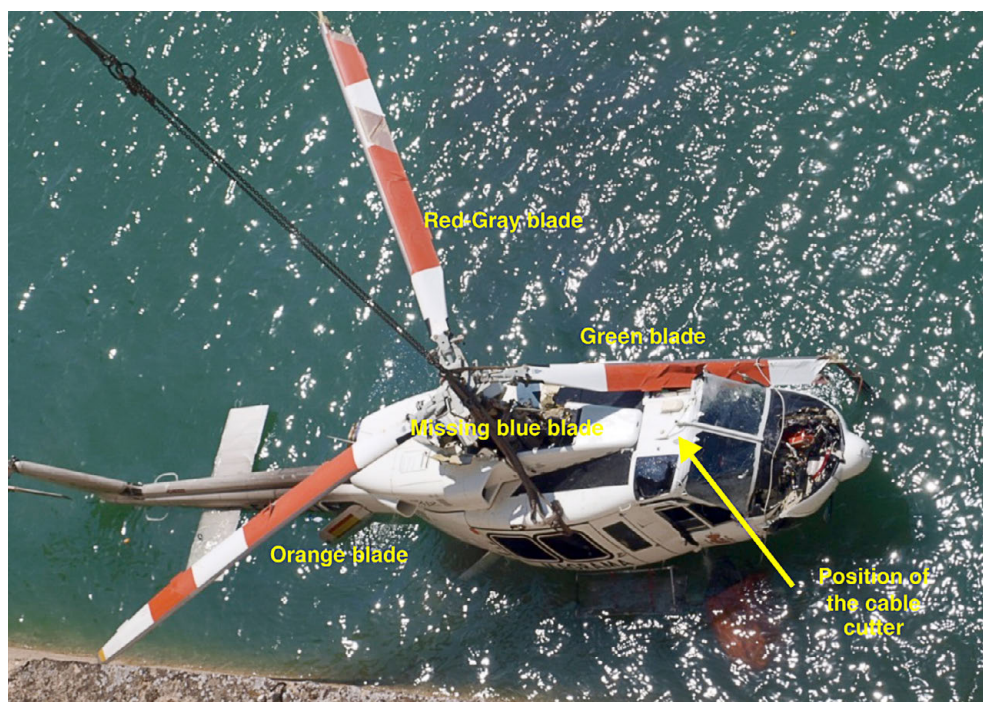
Figure 7. Condition of the blades

When the helicopter was taken out of the water, it was noted that the three other blades were still anchored to the rotor and damaged to varying degrees. The orange blade was practically whole. It had some small scratches on the underside near the root and on the top surface 1 m away from the tip.

The other two blades were significantly damaged. The gray-red blade was missing about a third of its length and had also lost material from its lower surface. The green blade had also lost material from two sections of the lower surface. A part of this

blade was also found in the cockpit when the helicopter was pulled up. All of the fractures and losses of material exhibited by the blades were in the same direction, at a 45° angle to their longitudinal axis, no doubt a result of the way in which they had been manufactured.

The stringers on the blue and green blades exhibited bending fractures, consistent with impact stresses.

Once the pilot lost control and the helicopter fell in the water, the main rotor blades struck the water and the cockpit, as evidenced by the fact that the fractures they sustained were consistent with a bending force against the direction of rotation. This force undoubtedly occurred at the moment of impact with the water.

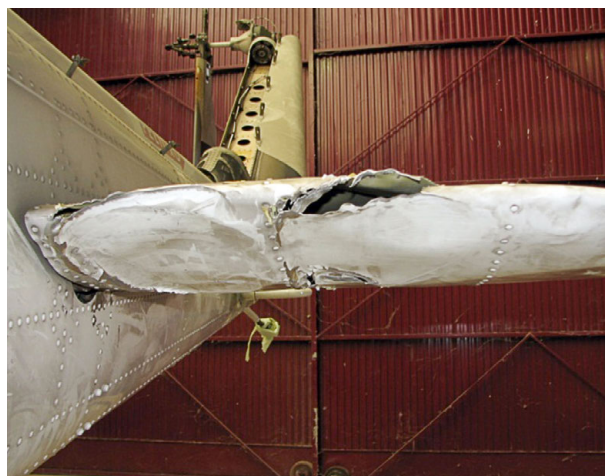
Figure 9. Left horizontal stabilizer

This inspection revealed friction marks that indicated that the bambi bucket had struck the left horizontal stabilizer, damaging its underside and the leading edge.

The bucket assembly, in contrast, had not sustained appreciable damage. When the attachment cables were stretched as far as they would go, they were verified to reach exactly as far as the part on the left horizontal stabilizer that had been damaged.

The evidence found during the inspection of the wreckage indicates that the bambi bucket had struck the engine control shafts and the left horizontal stabilizer. This is fully consistent

with the maneuver described earlier in which the bucket is lowered into the water while the helicopter still has translational speed, causing the bucket to act like an anchor and resist any movement. The impacts caused damage to the underside of the fuselage and to the area where the load hook is secured. The bucket then swung forward, striking the engine control linkages, and then backward, hitting the horizontal stabilizer.

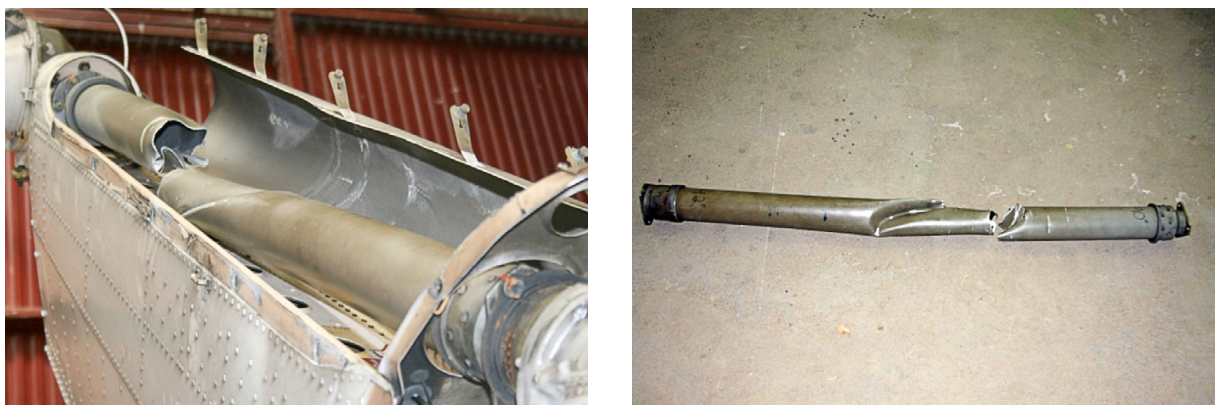
Figure 11. Final segment of the transmission shaft to the rear rotor

segment) were also intact. The third segment, however, the one that extended into the gearbox at the rear of the rotor, had a torsional fracture halfway along its length.
