## Interim Statement A-022/2012

Accident involving a Bell 412 aircraft,  
registration EC-KSJ, operated by Inaer,  
at the La Forata Reservoir (Valencia)  
on 2 July 2012

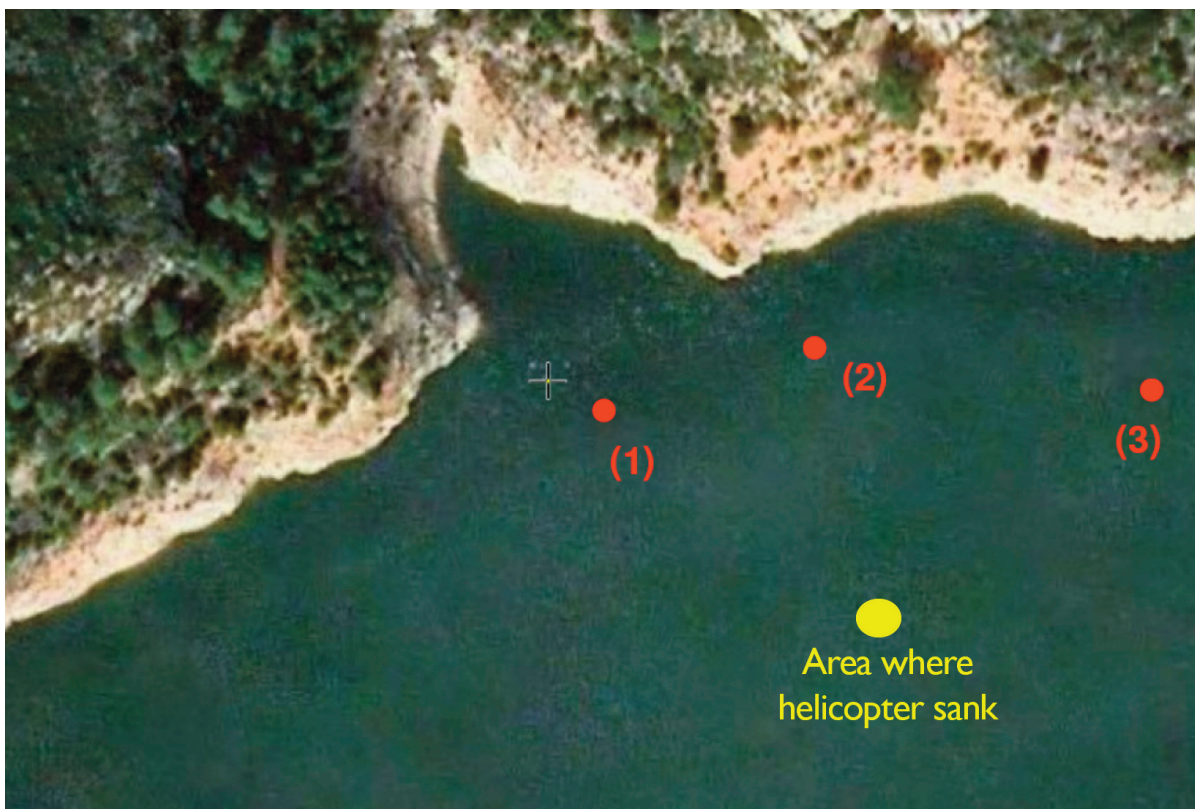
On 5 September 2012, this same company started a new search using an underwater proton magnetometer<sup>3</sup>, which narrowed down the search area even more, as shown in Figure 1.

As a result of this search, GEAS divers were able to recover the DFDR memory in the vicinity of point (1).

Figure 1. Points referenced in the proton gradiometer.

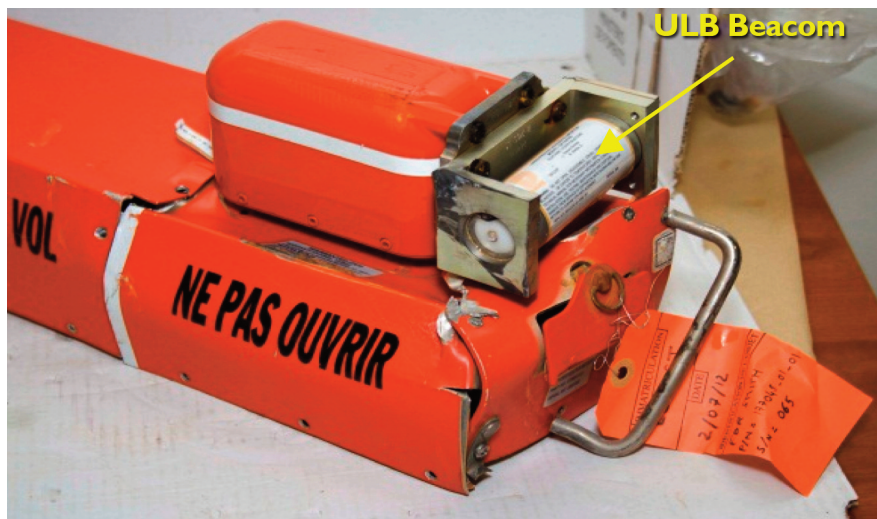
The two flight recorders were recovered as soon as the helicopter was removed from the water. Missing on both units was the part that housed the memories, which had detached on impact.

Clear evidence was found during the investigation that the memories on the recorders had detached, because they had been struck by one of the blades, shearing the screws that attached them to the body of the recorder, probably when the helicopter impacted the water.

Figure 2. DFDR memory in its normal position.
