Report A-023/2012

Accident involving a Sokol
PZL SWIDNIK W-3A aircraft,
registration EC-JUN,
operated by INAER,
at Yátova (Valencia),
on 2 July 2012

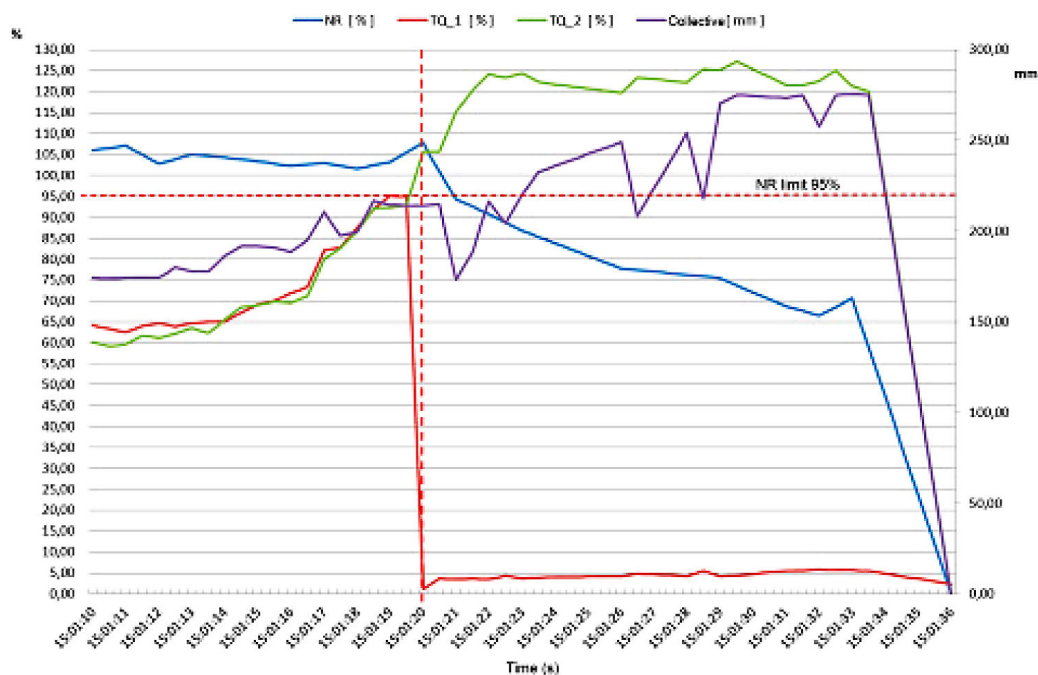
Figure 4. Input to the collective control lever, torque readings for both engines and main rotor rpm's

The pilot continued to apply more collective during the ten seconds leading up to the loss of power, at 15:01:20, when the values of engine torque were 95% and 92% (for engines 1 and 2, respectively). Under these conditions, the pitch of the main rotor blades is very high (and increasing as the collective lever is raised), and thus their drag is also very high. This could be why N_r only managed to climb from 105% at 15:01:10 to 107% at 15:01:20.

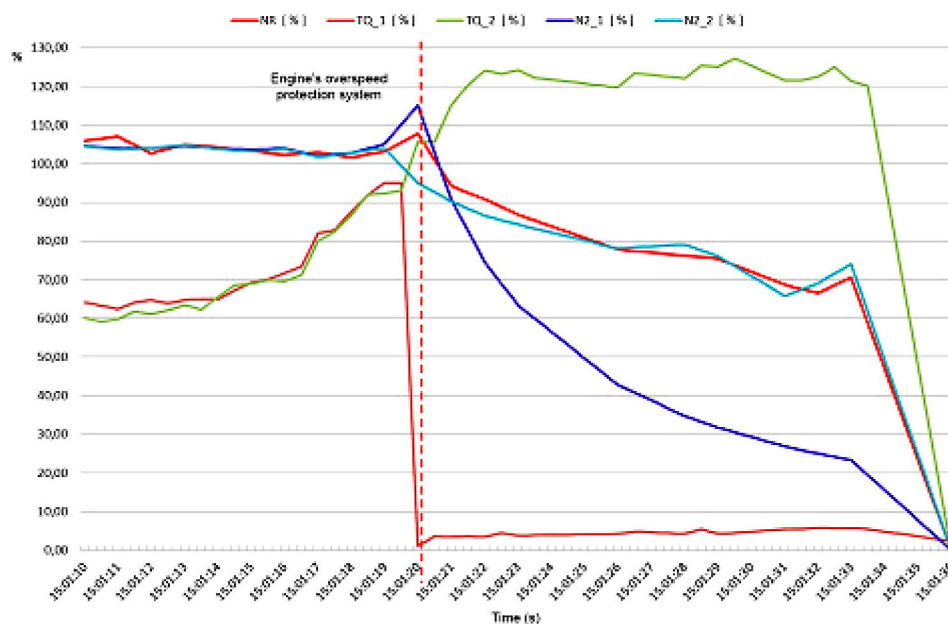
Figure 6. Torque (TQ) and N_2 values for both engines, and main rotor rpm's

At 15:01:20 the torque on engine fell suddenly and sharply to 2.34%, while its N₂ increased to 115% (this is expected since removing the mechanical load on the engine causes the turbine to freewheel and accelerate). Although the N₂ reading for engine 1 on the FDR do not reflect this value reaching 120%, this must have been the case since the engine overspeed system stopped the number 1 engine.

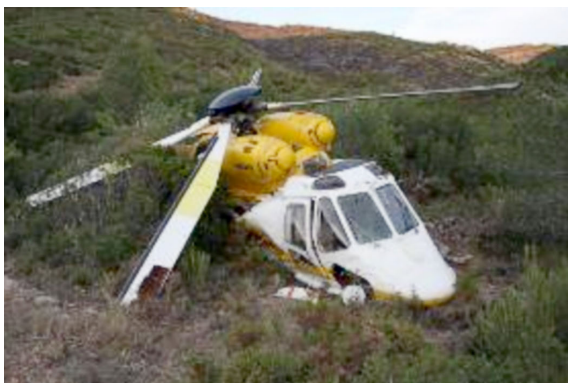
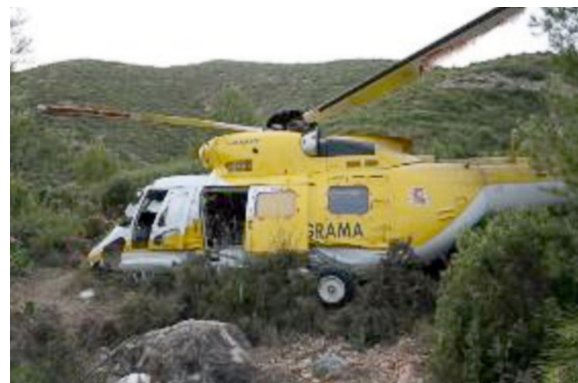
Figures 8 and 9. Aircraft after the impact

The forward gear leg bent backward and broke, becoming lodged in the opening where the leg folds into and is attached to the helicopter fuselage.

The two legs on the aft gear and their respective wheels retracted backward until they touched the lower part of the fuselage.

The right side of the airframe was more damaged due to the way in which the impact with the ground took place. The roof of the airframe (weighed down by the mass of the engines and transmission) also gave way as a result of the impact, noticeably reducing the clearance in the passenger cabin, especially on the right side.

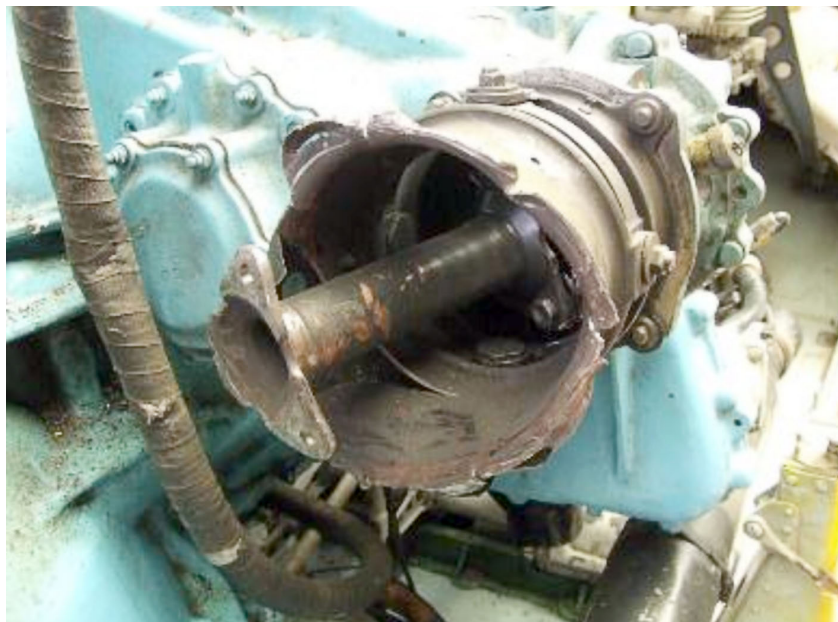
The flexible coupling that joins the shaft exiting the turbine with the intermediate shaft was fractured in a way that it decoupled the transmission (the fragments that were found were recovered). Such a decoupling would leave the output of the turbine unloaded, causing an immediate overspeed in N_2 as the turbine goes from having a load (and a high one at that moment) to having zero load. In addition, the flexible coupling that joins the intermediate shaft with the shaft that enters the combined gearbox exhibited partial fractures.

Figure 10. Intermediate shaft decoupled from the engine 1 turbine output shaft. Around it is the mounting cone, which was fractured by the ejected fragments of the flexible coupling. At the rear, in blue, is the combined gearbox

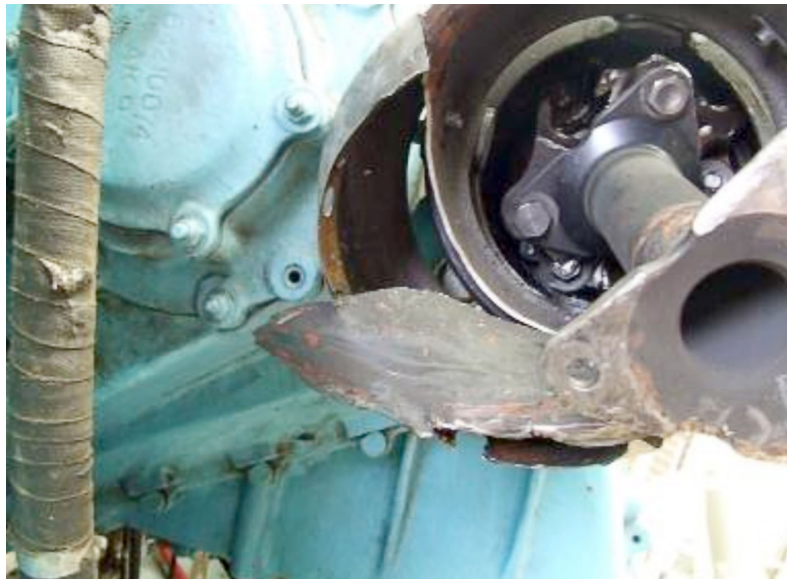
Figure 11. Same assembly seen from another angle, showing the partially broken flexible coupling between the intermediate shaft and the shaft entering the combined gearbox

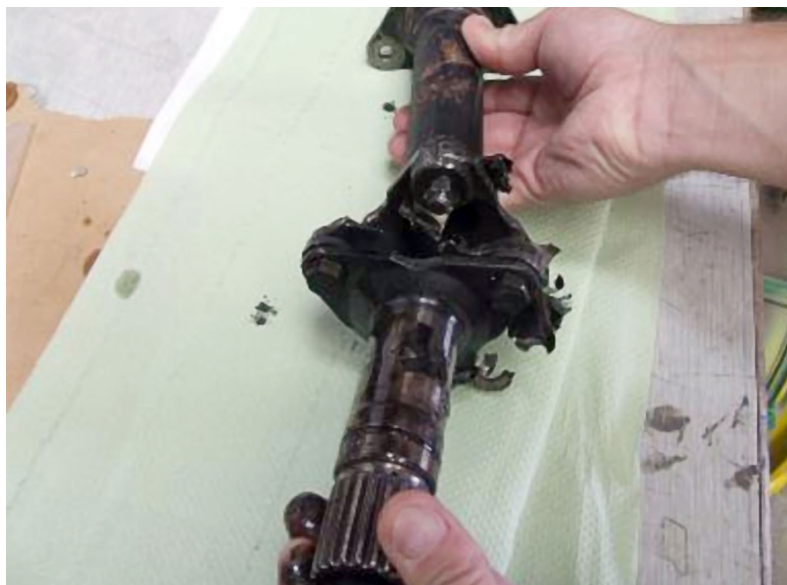
Figure 12. Partially broken flexible coupling between the intermediate shaft and the shaft entering the combined gearbox

The damage exhibited by the flexible coupling that joins the intermediate shaft to the shaft entering the combined gearbox occurred after the fracture of the flexible coupling between the turbine output shaft and the intermediate shaft, and resulted from the excess stress that was transmitted to it.

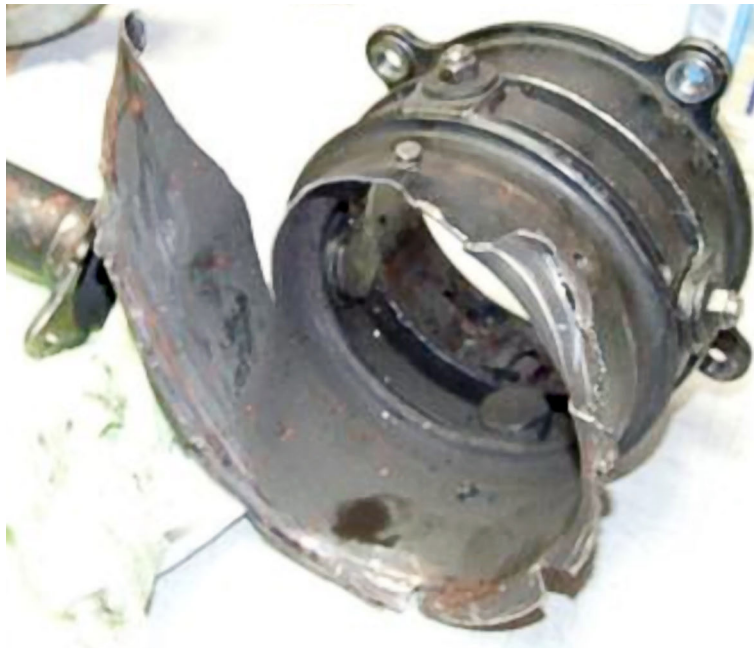
The clearances between the Cardan coupling on the mounting cone and the combined gearbox were also found to be excessive in both directions where this clearance exists to avoid mechanical overloads. In the opinion of the Polish experts, these clearances were not caused by the same impact that caused the dent (in fact, they were not found in the other engine). Moreover, the fracture of the flexible coupling between the turbine output and intermediate shafts had ejected its components at a sufficiently high radial speed to break the metallic plating in the area where the shaft rotates (mounting cone).

Figure 13. Broken mounting cone. Note the fracture caused by the fragments of the flexible coupling projected radially

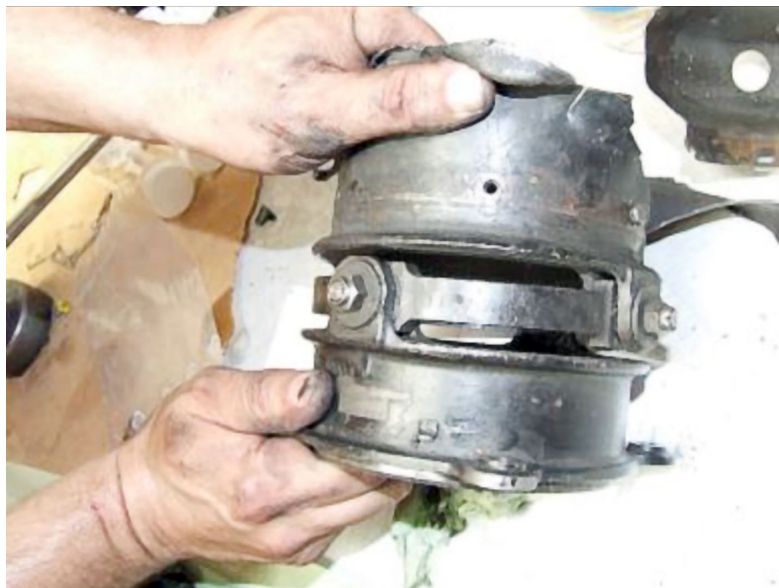
Figure 14. Broken mounting cone showing a close-up of the Cardan coupling

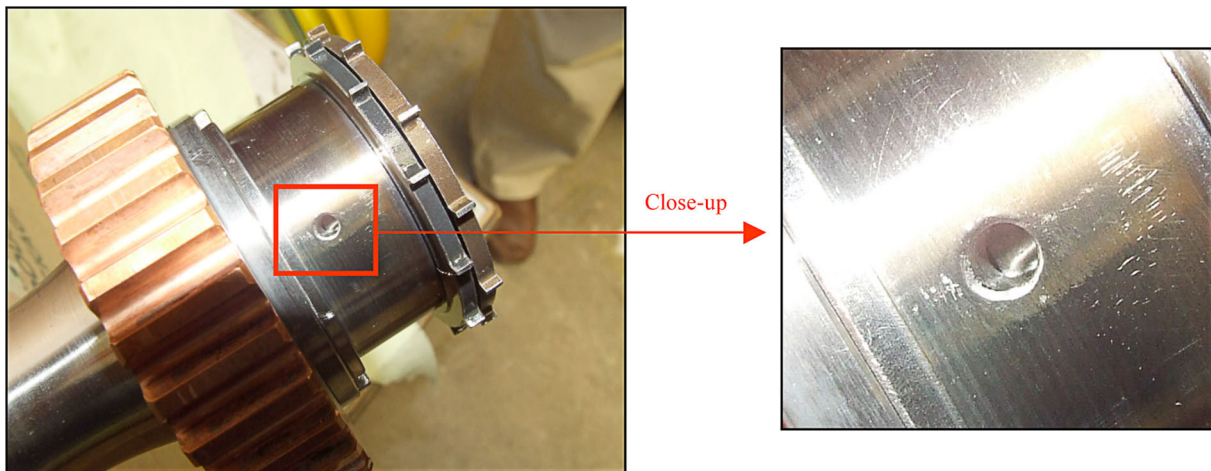
An inspection revealed that the two orifices drilled in the system to check for such a defect were misaligned, indicating that engine 2 was subjected to an excessive torsional load, which was transmitted to the combined gearbox.

Figure 15. Orifices to check for excessive torsion and close-up

¹⁵ The input shaft to the combined gearbox on engine 2 was also subjected to excessive torsional loading, though investigators were unable to determine if this was a result of the high load before the failure of engine 1 or afterwards, when it had to bear all of the propulsion demand.

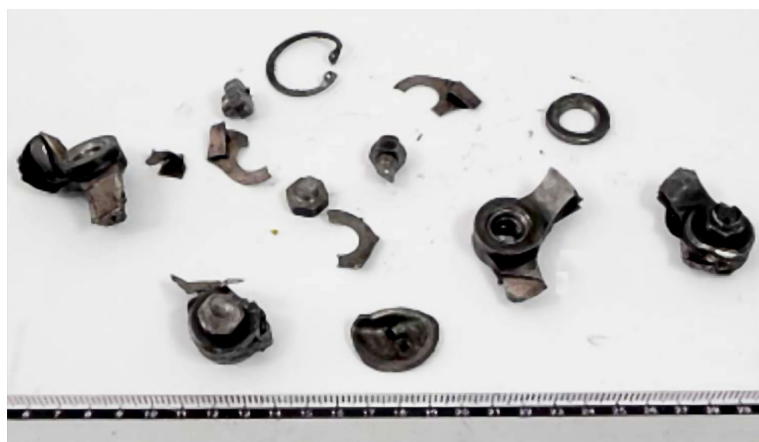
Figure 16. Pieces of the destroyed flexible coupling that attached the turbine output shaft to the intermediate shaft

A fractographic study of the breaks in the flexible coupling joining the turbine output shaft and the intermediate shaft revealed that these breaks were produced by fatigue mechanisms that started in the central part of the sheets and advanced outward. The small size of the area of the final tear indicates that the fracture took place with little stress forces. The areas where the fault in the material started did not show signs of cracking produced by any mechanism other than fatigue in the material.

The loss of power of engine 1 was caused by the fatigue failure of the flexible coupling between the turbine output shaft and the intermediate shaft, which resulted in a sudden interruption of the power transfer between the turbine and the combined gearbox.

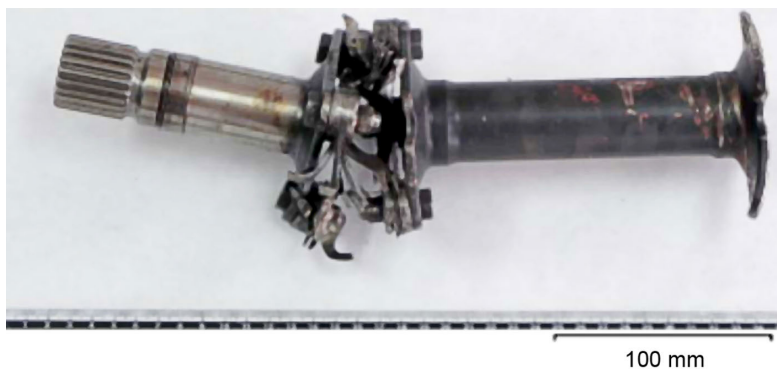
Figure 17. Intermediate shaft coupled to the shaft that enters the combined gearbox via its partially broken flexible coupling

The broken sheets of the flexible coupling between the intermediate shaft and the one that enters the combined gearbox, however, failed due to ductile tearing under shear stress, exhibiting plastic deformation indicative of fracture from overloading.
