DATA SUMMARY

Date and time	Saturday, 11 August 2012; 19:47 h¹
Site	Almeria Airport (Spain)

Registration	D-EEDM
Type and model	CESSNA 177RG
Operator	Private

On Saturday, 11 August 2012, a Cessna 177RG, registration D-EEDM, made an emergency landing with the main gear not locked in the down position at the Almeria Airport. Onboard the private flight were the pilot and three passengers.

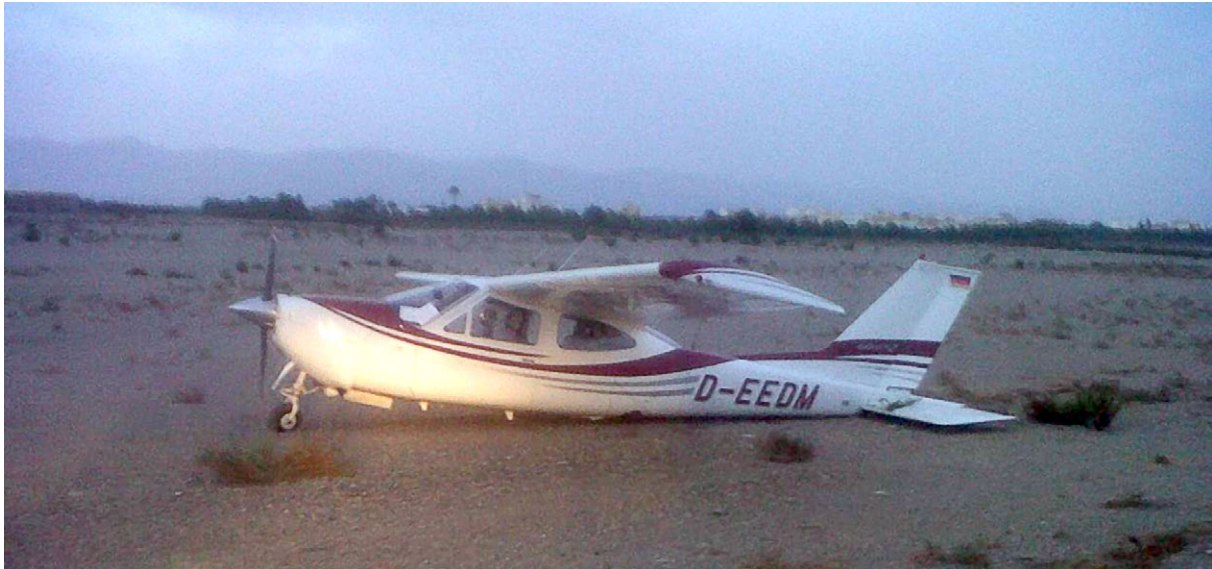
When the airplane landed, the main gear legs, which were not locked, gave way under the weight of the airplane, causing it to land on the front gear leg (which was properly locked) and the aft lower part of the fuselage. The airplane eventually departed the runway to the right and came to a stop on the dirt and gravel runway strip.

Figure 1. Aircraft on runway strip after emergency landing

- Bottom surface of the horizontal stabilizer.
- Lower aft part of the fuselage.

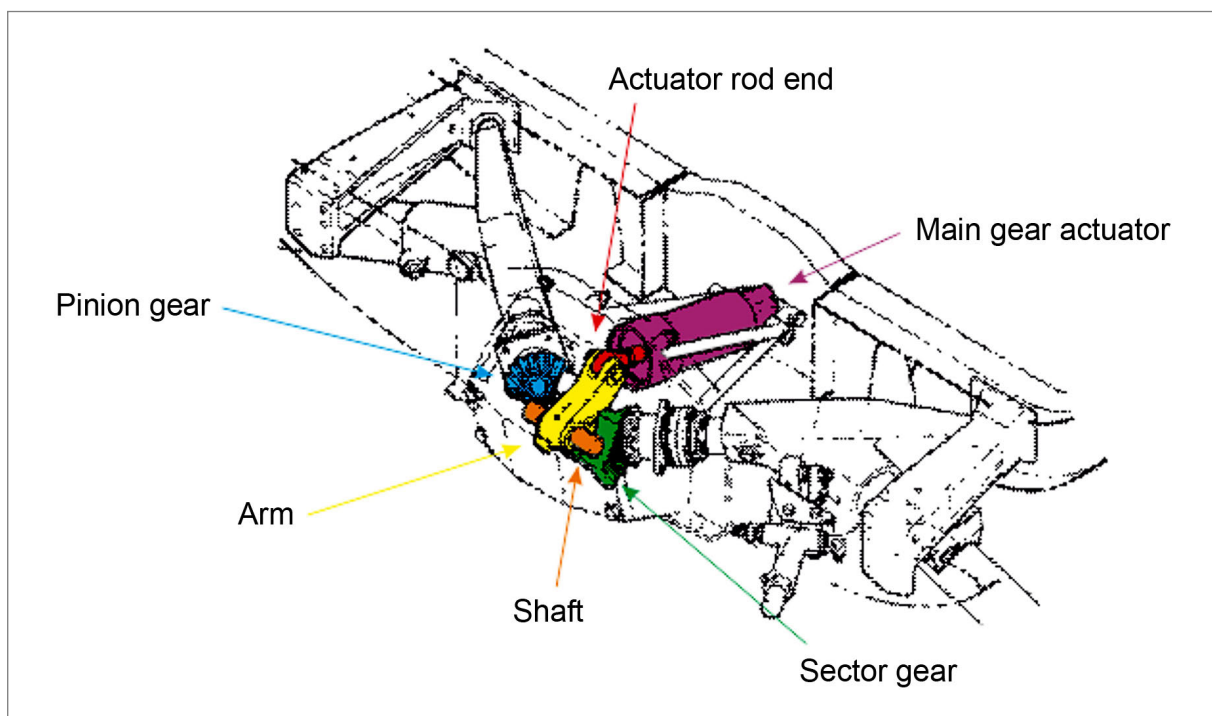
The actuator rod end, however, was broken.

The hydraulic piston was actuated, it worked properly in both directions, but since there was no mechanical continuity at the rod end, it was impossible to transfer forces to the rest of the system.

Figure 2. Main landing gear extension/retraction system

REC 07/14. It is recommended that the FAA require the replacement of the rod end with the original design by the one recommended in Cessna Service Information Letter SE79-37.

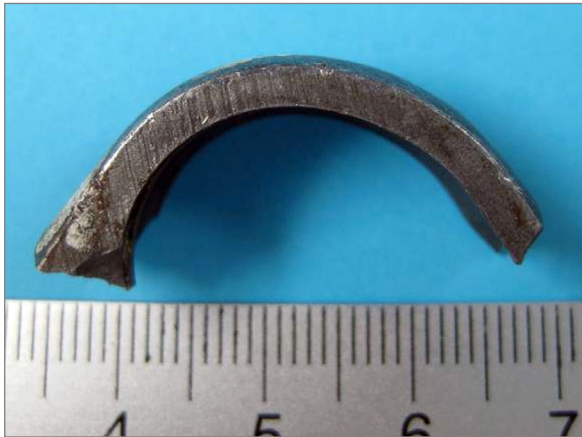
Figures 3 and 4 show the two sides of the rod end fragment analyzed. They clearly show that the rod end's original circular shape was substantially altered, especially toward the narrower end of the fragment. This means that during the failure process, the rod end underwent a considerable amount of plastic deformation before the component completely detached.

Figure 3. Side view of rod end fragment

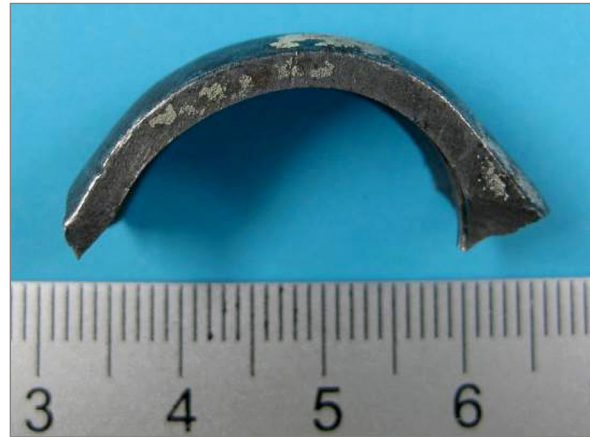
Figure 4. View from opposite side

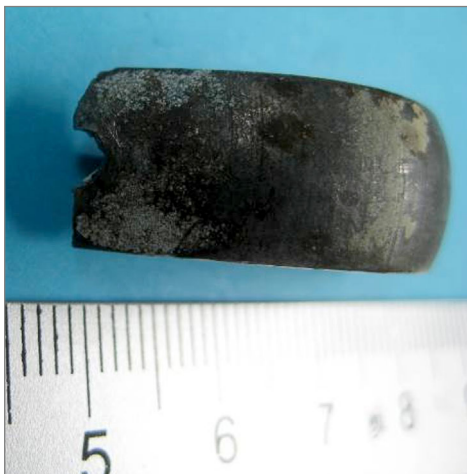
Figure 5 shows the central through-hole at the thicker end of the rod end, which is used to grease the interior of the rod end. Figure 6 shows the inner surface on the rod end

Figure 5. Front view

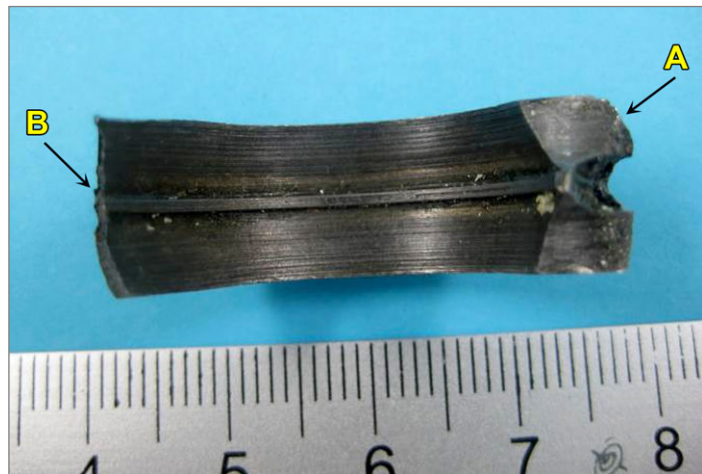
Figure 6. Inner surface

fragment and the presence of a projecting rib, at either side of which there are yellowish bands produced by residue from the rod end's internal brass bearing.

The failure process of the rod end began in area A (see Figure 6), which was the first to break. The fracture occurred in the section with the greasing hole.

Part of the fracture surface is completely covered in corrosion products. The rest of the fracture exhibits features consistent with a ductile failure.

The failure of the rod end in area A took place either as a result of a single overload that instantaneously broke the rod end at area A, or of a series of overloads that led to progressive cracking.

There were no signs indicating the presence of a conventional fatigue failure process.

Once area A broke completely, area B fractured instantly.

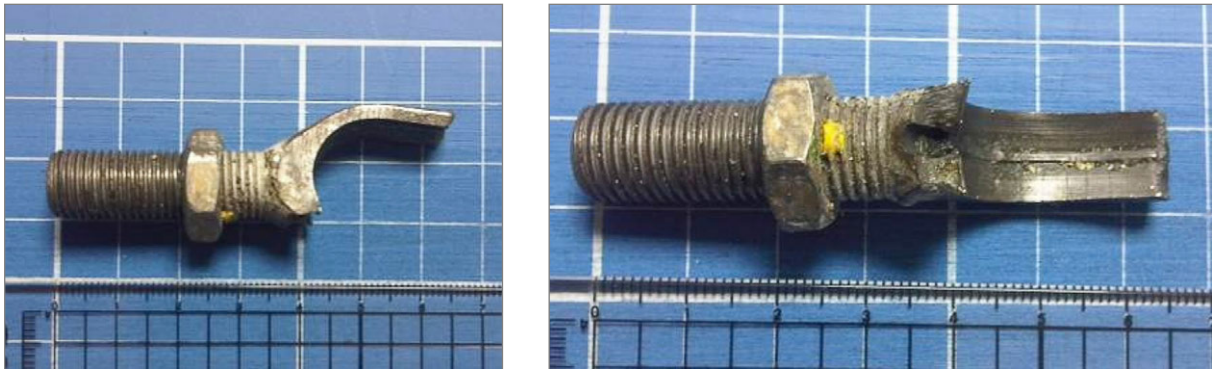
Figures 7 and 8. Fragments from the rest of the broken rod end

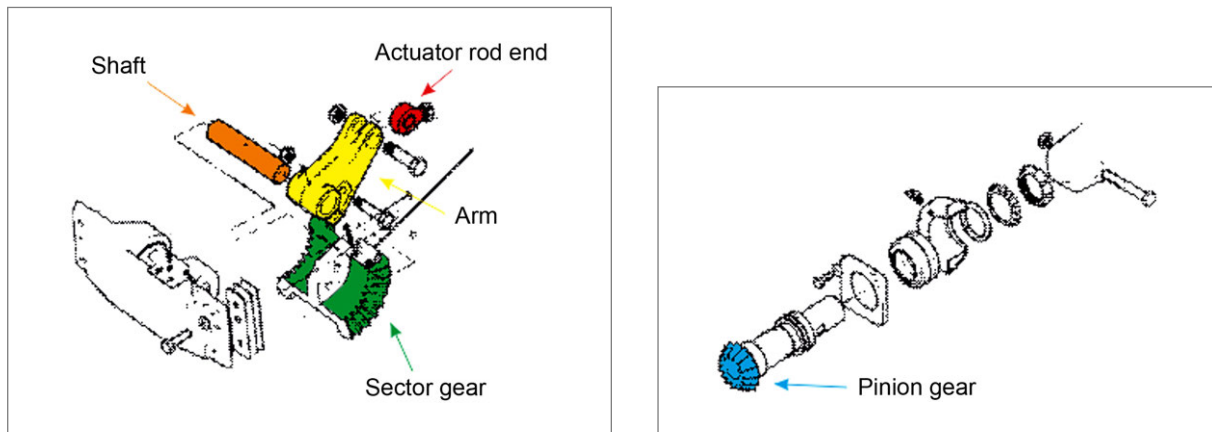
As a result of the simultaneous movement of both main landing gear legs in this type of aircraft (interlocked with the sector gears), the legs cannot be locked independently through the application of inertial forces in high-g turns.

Figures 10 and 11. Close-ups of the main landing gear extension/retraction system

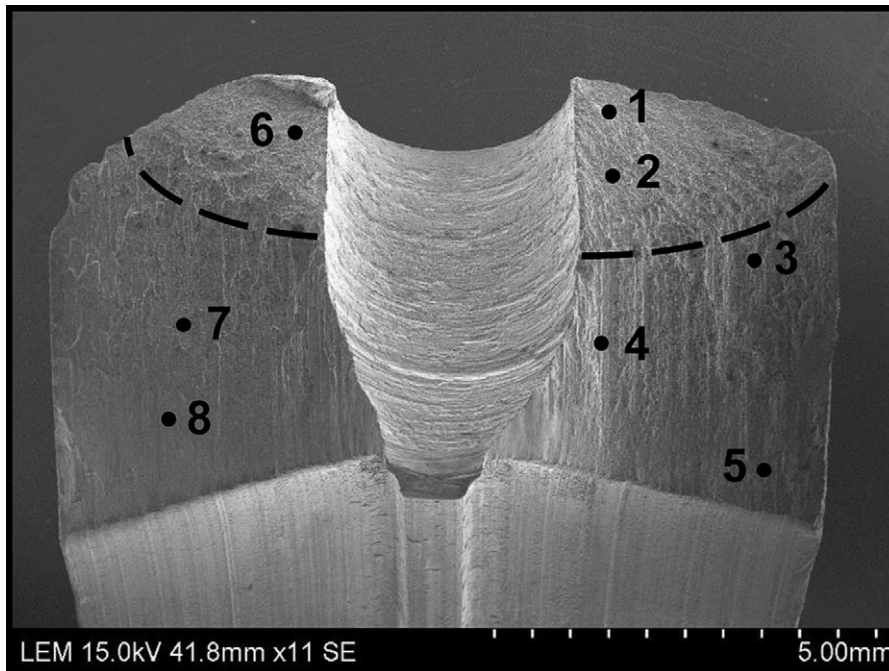
Figure 12 shows a full image of this fracture, which extends to both sides of the central through-hole. At low magnifications there are two regions with a different appearance. These regions are separated as shown by the dashed line.

There is an area near the outer surface of the rod end at either end of the hole with an apparent uniform and non-directional roughness. The rest of the fracture surface, in contrast, exhibits a high directionality along the plane of the rod end and parallel to the through-hole.

Various areas from both fracture regions and on either side of the through hole, numbered in Figure 12, were selected for determination of their microfractographic features.

At high magnifications, area 1, near the hole and very close to the rod end's outer surface, shows a microrelief that cannot be associated with any specific fracture mechanism, but rather with the presence of corrosion products on the surface that prevent a proper observation of the original fracture relief in this area.

Figure 12. General view of fracture A

In area 2, situated in the same region as 1 but deeper inside the rod end, shows a prominent microrelief that has also been deteriorated by the subsequent corrosion of the surface. Some points show marks resembling elongated ridges facing from the rod end's outer surface to its inner surface.

Area 3, located at the other end of the dashed line but close to it, shows a relief that is similar to that of 2 but with less deterioration due to corrosion, which revealed at some points signs of the plastic deformation that occurred during the failure process.

Area 4 is in the region where the microrelief is directional. At low magnifications, the relief is not that dissimilar from the one found in area 3, though at high magnifications it exhibits evidence of plastic deformation and dome formation with underdeveloped vertical walls.

Area 5 is very close to the rod end's inner surface. Its microrelief consists of clearly developed domes of different sizes. There are also elongated ridges, some parts of which exhibit the presence of a phase, probably a steel inclusion. There are no corrosion products on the surface.

Area 6 is on the other side of the through-hole, near the rod end's outer surface in a position equivalent to area 1's. Its microrelief is identical to that of area 1, with the presence of corrosion products that hamper the observation of the original relief. The X-ray spectrum from this field is completely analogous to that of area 1, with the presence of the same surface contaminants.

Area 8 is near the rod end's inner surface. Its microrelief consists of small domes that are slightly elongated in the direction of the prevailing microrelief present in that region. There are no corrosion products on the fracture surface. The spectrum for this area does

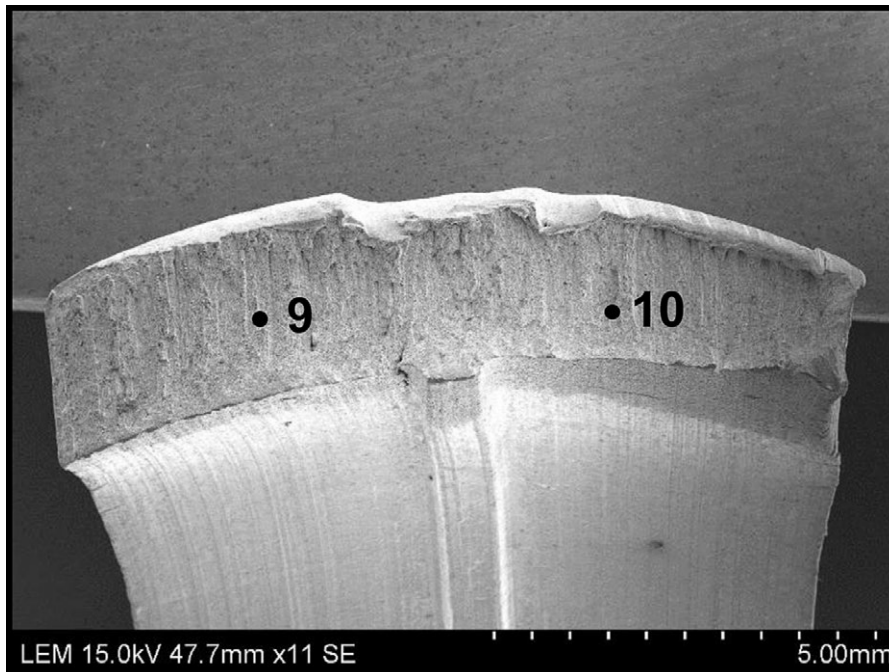
Figure 13 shows a general view of fracture B, which is at the other end of the rod end fragment that was analyzed.

Area 9 typifies this fracture. At high magnifications we can see a microrelief consisting of domes and elongated ridges that are similar to and in the same direction as those noted for fracture A. There are also sections of the fracture surface that are covered in corrosion products, while other sections appear unaffected.

Finally, area 10 is near the rod end's inner surface. Its microrelief consists of clearly developed domes. There are also some elongated ridges with inclusions in their interiors. There are no regions with corrosion products.

Figure 13. General view of fracture B

The X-ray spectrum of this area did, however, reveal the presence of small quantities of surface contaminants (Cu, Na, Al, Si, S, Cl and Cd).

The fracture of area B clearly corresponds to a single instantaneous fracture process of a ductile nature that occurred after the fracture of area A. This fracture surface was the last to form, and it also exhibits regions that underwent a corrosive attack very similar to that seen in fracture A.
