Report IN-036/2012

Incident involving a Boeing
737-800, registration EI-EKV,
operated by Ryanair, climbing
from Madrid airport (Spain),
on 7 September 2012

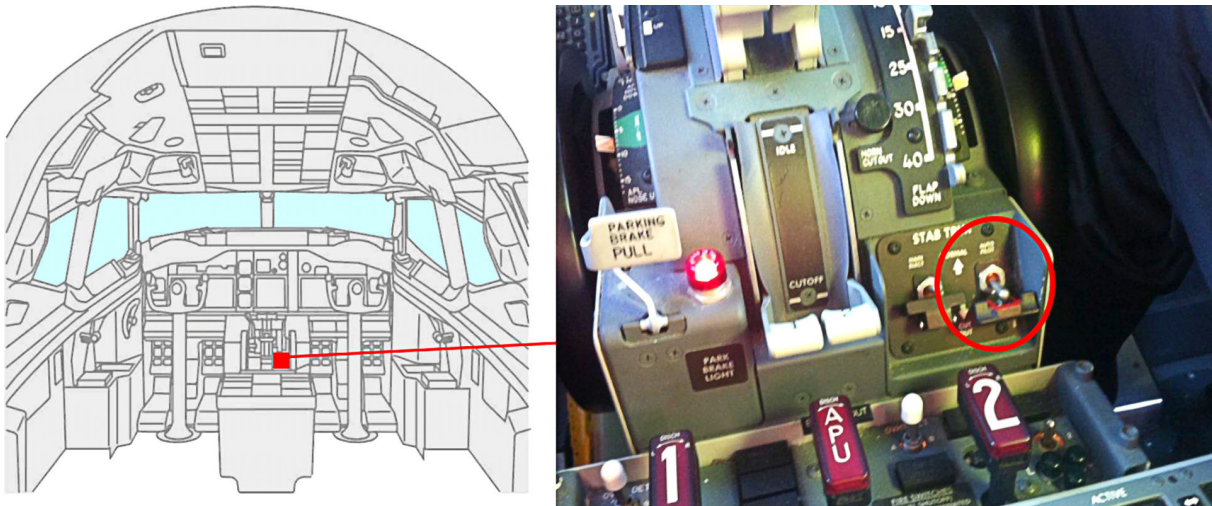
After the event the aircraft was found with the following configuration (figures 1 and 2):

Figure 1. AUTOPILOT STAB TRIM switch in CUT-OUT

- After the takeoff, the incorrect position of the STAB TRIM switch caused the MASTER CAUTION to activate three times and the autopilot could not be engaged.

- The STAB TRIM AUTOPILOT SWITCH was placed in its correct position and the autopilot system was tested. No anomalies were found.
- The two flight control computers were interrogated and the information saved.

- (F) Return the aircraft to its usual condition:
 - (2) Remove the tag and close the LANDING GEAR AURAL WARN CB.
 - (3) Place the AUTOPILOT STAB TRIM SWITCH in the NORMAL position.

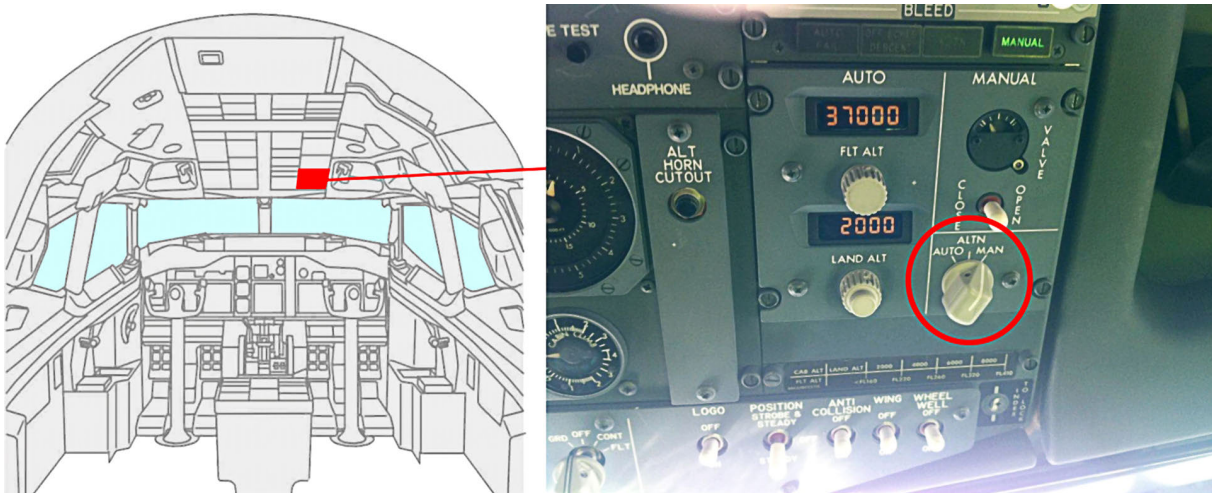
Figure 2. Pressurization mode switch in MAN

They reviewed the go-around procedure and the fuel they had used, and did the checklists and the DESCENT CHECKS, as part of which the crew was heard changing the value for the altitude of Barajas on the pressurization panel, "Pressurization... landing altitude 2,000", which is how it was found after the incident (figure 2).

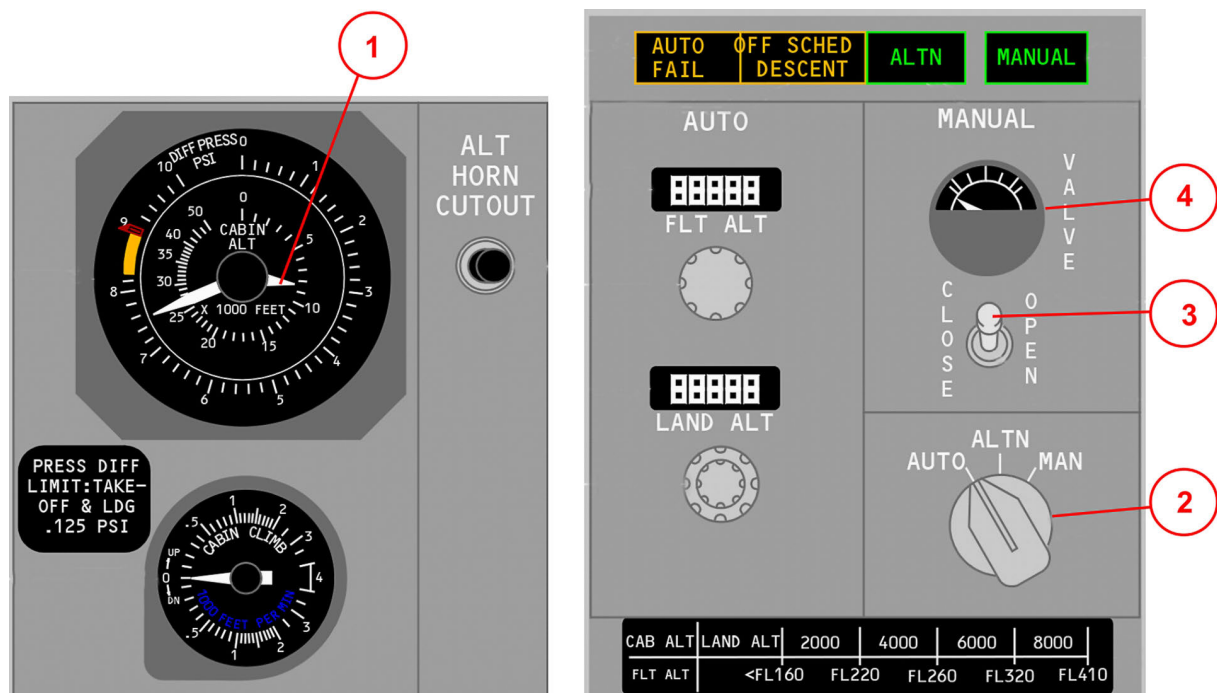
Figure 3. Pressurization system panel

through two identical controllers (CPC – cabin pressure controllers- 1 and 2), or manually (MAN) by the pilot. In the cockpit there is a pressurization panel (figure 2) where certain system parameters, such as cabin altitude (1 in figure 3), can be monitored, and the system’s mode of operation (manual or automatic) can be selected (2 in figure 3). The system has two relief valves that limit the maximum differential pressure²⁸ between the inside and the outside of the airplane to prevent structural damage.

When the pressurization system is operated manually, the pressure in the cockpit is regulated by the crew’s direct inputs to the outflow valve using its associated switch (3 in figure 3). This switch is located on the cabin pressurization panel, located in the overhead panel (figure 2). The switch only works when MAN mode is selected (2 in figure 3). To open the

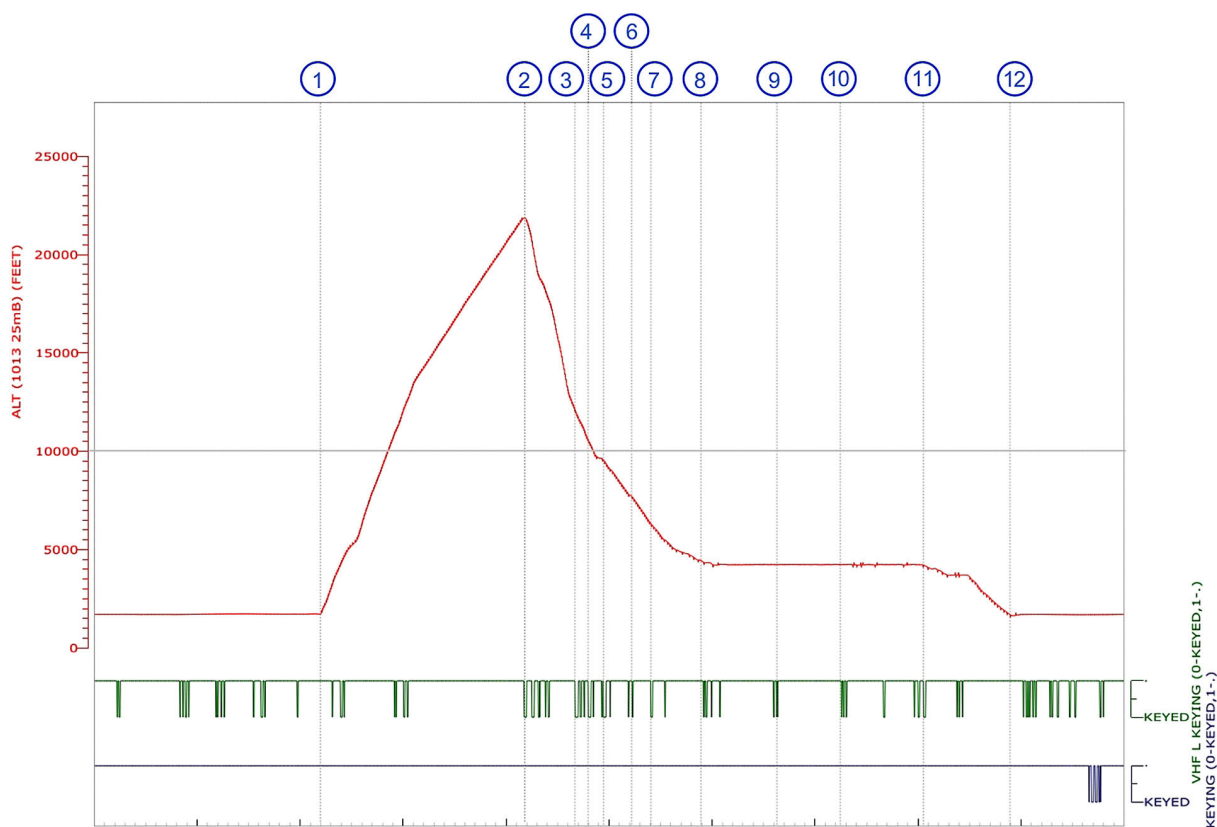
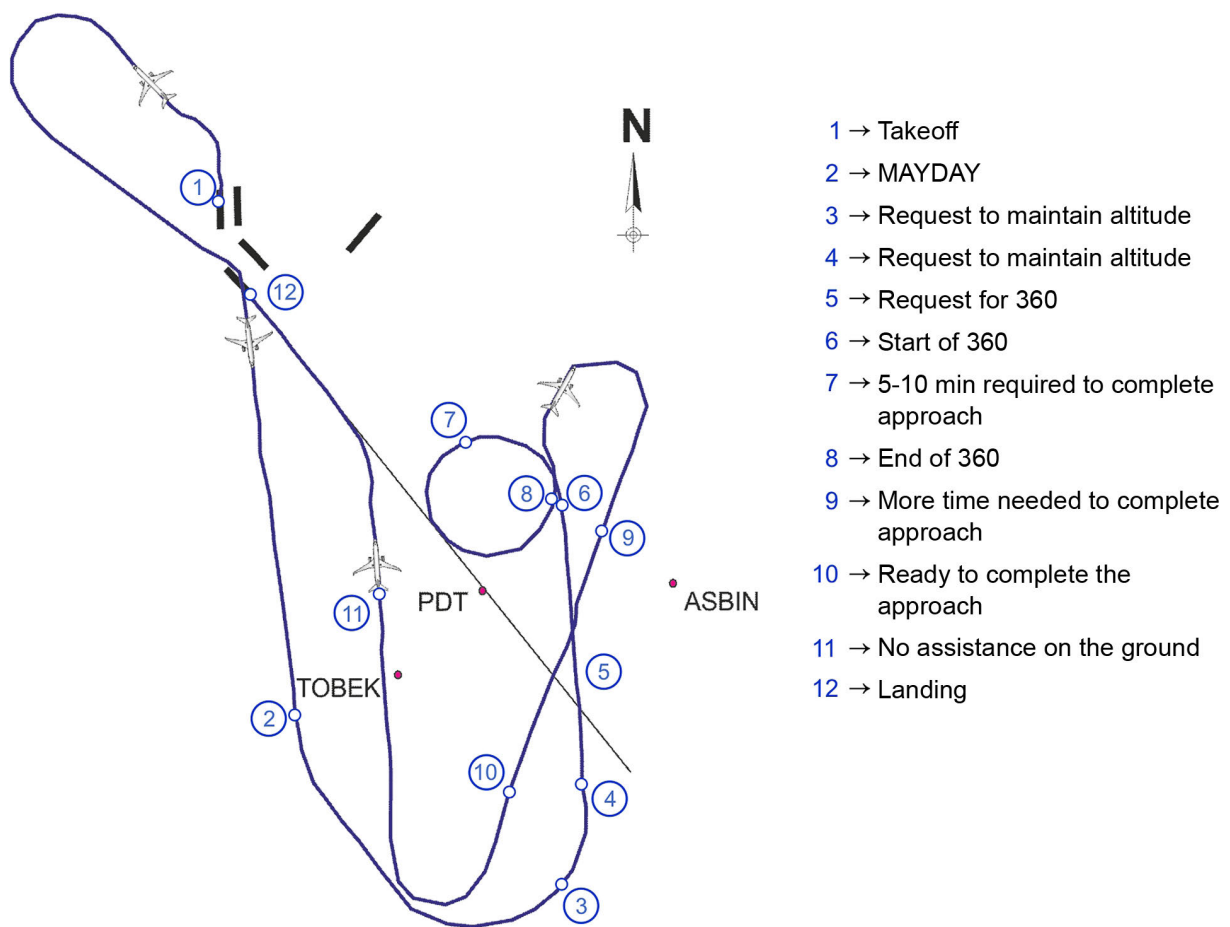
When they finished the 360°, at 07:52:25 (point 8 in figures 4 and 5), the controller cleared them to descend to 4000 ft and asked if they could turn right to heading 040. At 07:52:57 ATC again asked how much time they would need to complete the approach, with the captain confirming the 5-10 minute estimate. At 07:53:15 they were cleared to heading 200. At 07:56:22 (point 9 in figures 4 and 5) on heading 200, ATC again asked if they were ready to turn, with the captain again replying in a few minutes. At 07:59:50 (point 10 in figures 4 and 5), three minutes later, ATC again asked if they were ready to turn. This time the reply from the captain was affirmative, and ATC cleared them to turn to heading 010 and intercept and follow the runway 33L localizer.

Figure 4. Aircraft's altitude and crew's communications with ATC

Figure 5. Aircraft's flight path

At 08:03:59 (point 11 in figures 4 and 5) the captain informed ATC that they did not require assistance. This information was conveyed to the tower controller to which they would be transferred later. Despite this, said controller, after clearing them to land, again asked the aircraft if they requested any assistance and the nature of the problem. This was the first time that the crew reported the nature of the problem, which they described as a "depressurization". The landing took place at 08:08:37 (point 12 in figures 4 and 5).

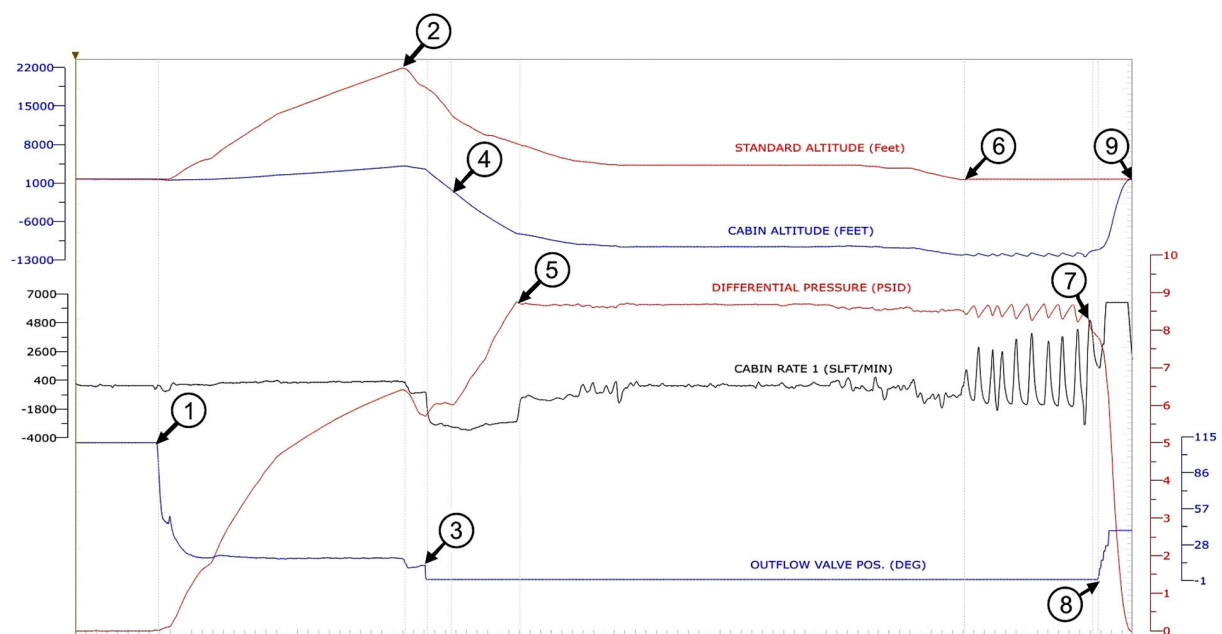
At 07:48:26 (point 5 in figure 6), with the aircraft at 8,968 ft, the cabin pressure was 19.613 psi and the differential pressure reached its maximum value of 8.75 psi. The opening of the relief valves caused the cabin rate to drop from -3,000 fpm to -1,000 fpm. From then until the landing, the differential pressure held at around 8.75 psi, with changes in the cabin rate being recorded due to the opening of the relief valves.

At 08:14:27 (point 7 in figure 6), after taxiing on the ground for six minutes, the cabin pressure was 22.59 psi and the captain complained of an ear ache. There had been a change in cabin rate of 5,000 slfpm. Two seconds later, at 08:14:29, the captain turned off the air conditioning packs.

At 08:14:42 (point 8 in figure 6), after a comment by the captain that the cabin pressure was over 10,000 ft³³, they started opening the outflow valve, which started to depressurize the cabin, a process that was completed at 08:16:09 (point 9 in figure 6), when the inside and outside pressures equalized. The valve did not open fully, only slowly opening to the 39° position.

During the cabin depressurization process, the maximum recorded cabin rate was 6,350 slfpm, which lasted 59 seconds.

Figure 6. Pressurization system parameters during the flight

It was then that the captain decided to turn off the air conditioning packs and operate the outflow valve to depressurize the cabin. This process lasted 1 minute and 27 seconds, a period in which the maximum cabin pressure change rate, 6,350 slfpm, was recorded by the system. It was this cabin depressurization process over this time period that caused the barotrauma in the passengers.
