**RESUMEN DE DATOS**

| Lugar | <b>Pista 28 del aeropuerto de Cuatro Vientos (Madrid)</b> |

| Matrícula | <b>EC-ICG</b> |
| Tipo y modelo | <b>PA-60-601P (Aerostar 601P)</b> |

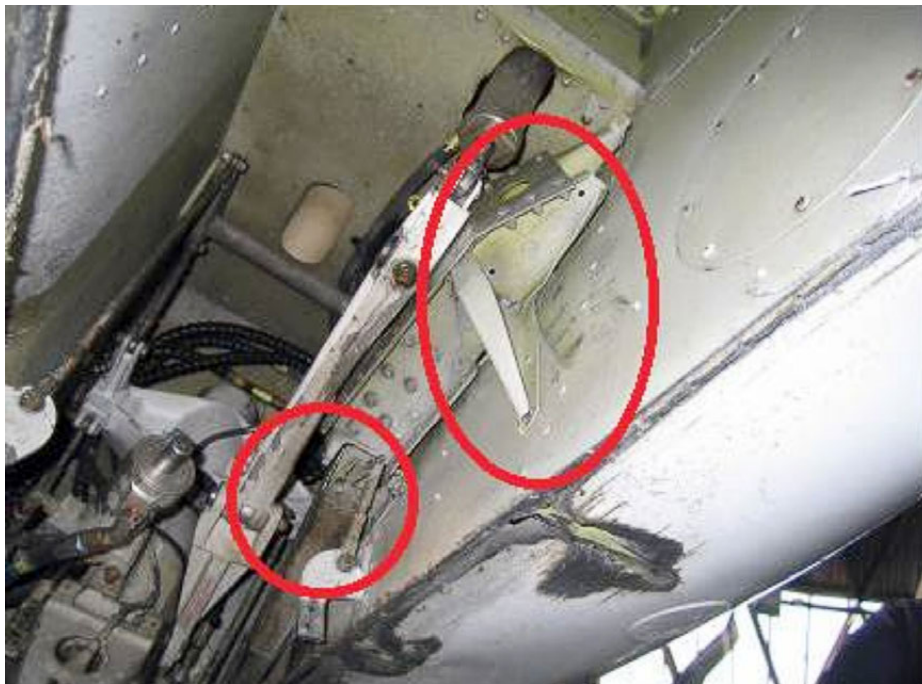
La chapa que se había utilizado para reforzar la zona donde se había detectado una grieta dos años antes, presentaba así mismo una grieta.

**Figura 3.** Pozo del tren delantero. Se observa la zona de fractura y la pérdida de remaches de la viga de sujeción del brazo de arrastre

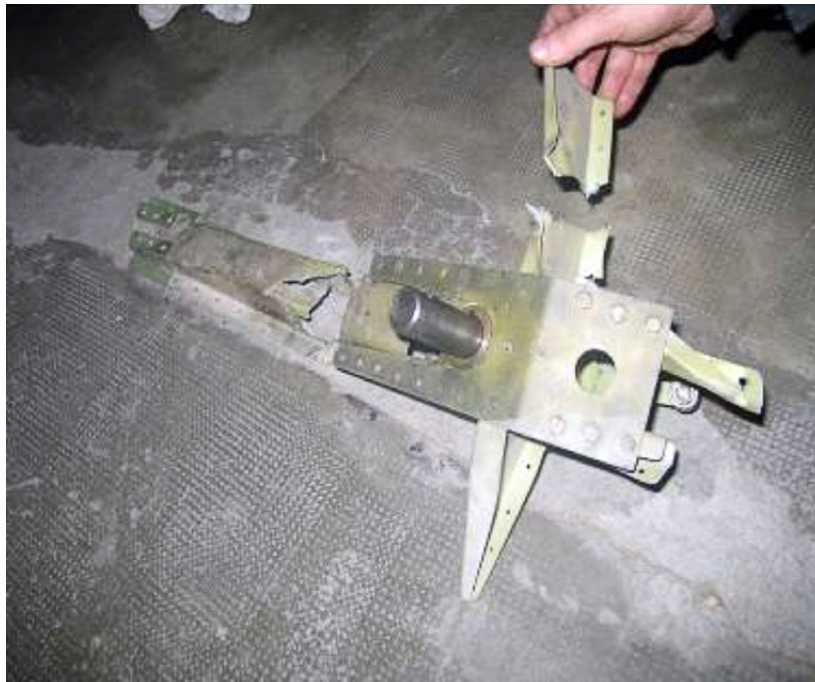
Figura 4. Viga una vez desmontada

Por un lado los orificios de los remaches en la zona delantera superior de la pieza presentaban una micro-morfología característica de un progreso de fatiga. Su incubación se desarrolló a través de un número alto de ciclos que se prolongaron a lo largo de un periodo relativamente largo como muestran los signos de corrosión encontrados. La zona del extremo de la pieza, que había sido reparada y el orificio del tornillo de sujeción marcado con tinte rojo también presentaban grietas por fatiga de la misma naturaleza.

Por el contrario la fractura de la zona central de la viga, que había partido la pieza en dos mitades, había sido producida por un mecanismo de desgarro dúctil, típico de este material cuando es sometido a un sobre esfuerzo. También los remaches de sujeción de la pieza al fuselaje más próximos a esa zona central rompieron por este mecanismo dúctil. De igual manera en la zona del brazo que permaneció unida al mamparo tanto en la fractura transversal del cuerpo del brazo, como en los remaches, se identificó una fractura por sobre esfuerzo.

El estudio del laboratorio concluyó que la probable secuencia de rotura comenzaría con la incubación y desarrollo del mecanismo de fatiga que se propagaría en forma de grietas en las zonas de la unión remachada. Una vez debilitadas estas uniones, la viga se vería sometida a esfuerzos de flexión, lo que provocaría la rotura de los remaches contiguos y en última instancia la rotura del cuerpo central y el brazo de la viga.

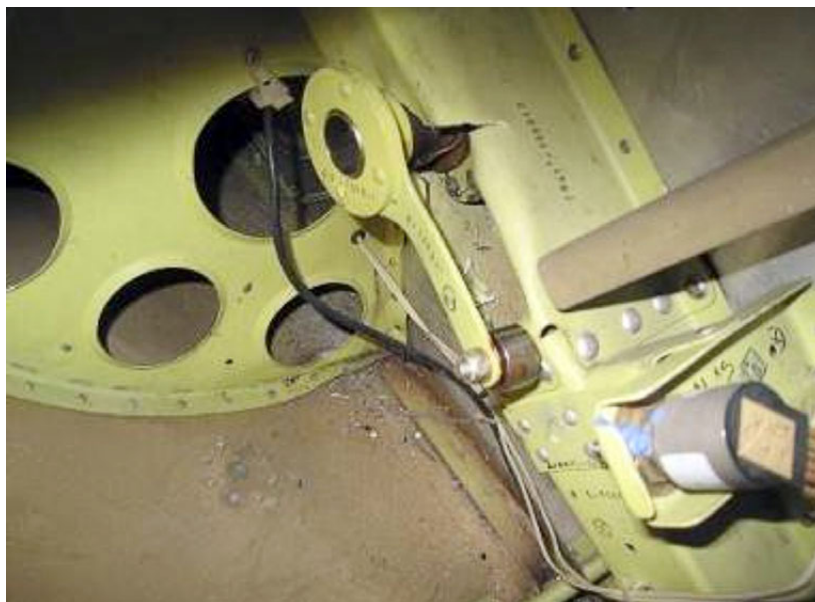
Figura 5. Leva y micro-interruptor de tren arriba

La viga que aloja la prolongación del eje del brazo al otro lado del mamparo también estaba rota de manera que el eje se había desplazado de su posición. Debido a este desplazamiento, con la pata en posición retraída, la leva adosada al eje y que hace contacto con el micro-interruptor responsable de enviar la señal de tren arriba, no alcanzaba su posición nominal y no llegaba a contactar con el micro-interruptor (Figura 5).

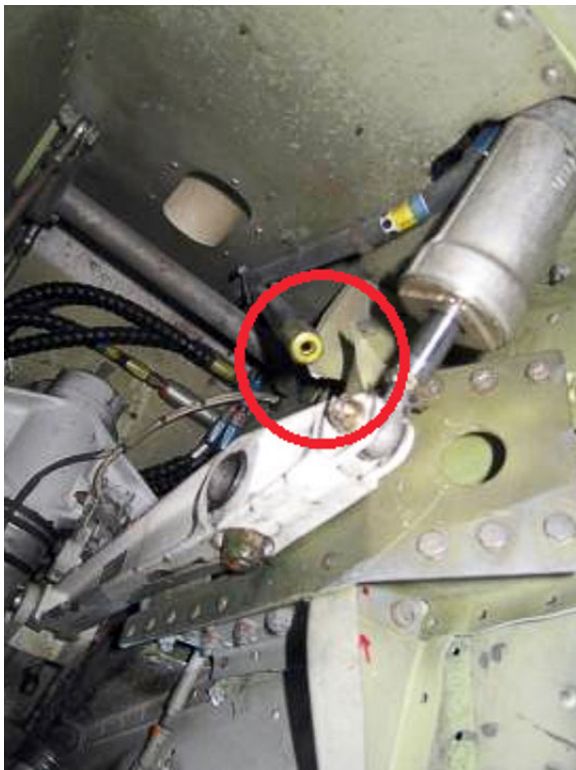
Sobre la viga se identificó una marca con tinte rojo junto a una grieta que comenzaba en el orificio de un tornillo de sujeción de la pieza al mamparo (véase Figura 6). El personal del taller no pudo aclarar su origen, indicando que probablemente ya existiera cuando el avión se llevó al taller por primera vez en 2007. Se contactó con otros dos talleres que realizaron tareas de mantenimiento en el avión con anterioridad sin que en ninguno de ellos se conservaran registros que evidenciaran la detección y seguimiento de esta grieta.

**Figura 6.** Retorno de la línea hidráulica que alimenta el actuador

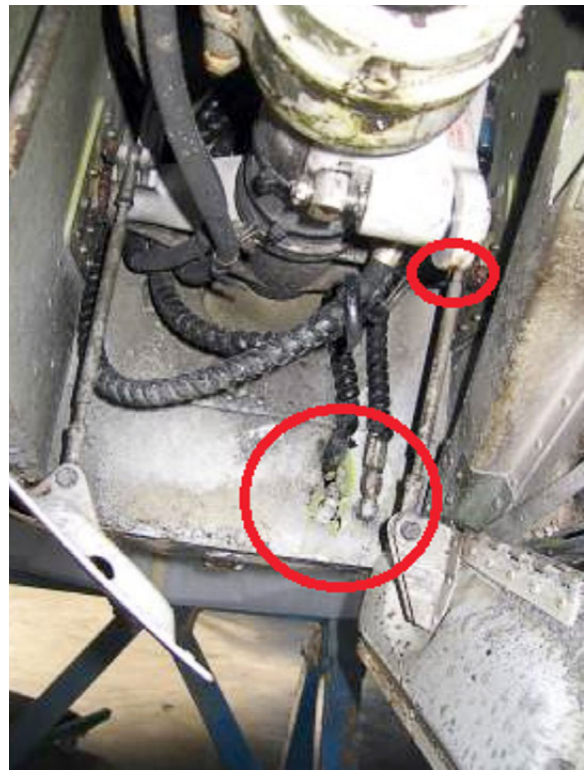
Como consecuencia de la pérdida de rigidez del sistema de bloqueo ocasionada por la rotura y desplazamiento de la viga, la pata basculaba en exceso hacia atrás de manera que su estructura entraba en contacto con el mamparo trasero del pozo del tren en el mismo punto en el que éste presentaba un impacto. En esta zona del mamparo se aloja un codo de la línea de hidráulico del sistema de control direccional de la rueda de morro que se había partido (Figura 7).

**Figura 7.** Impacto en el mamparo posterior y zona de la pata responsable del mismo

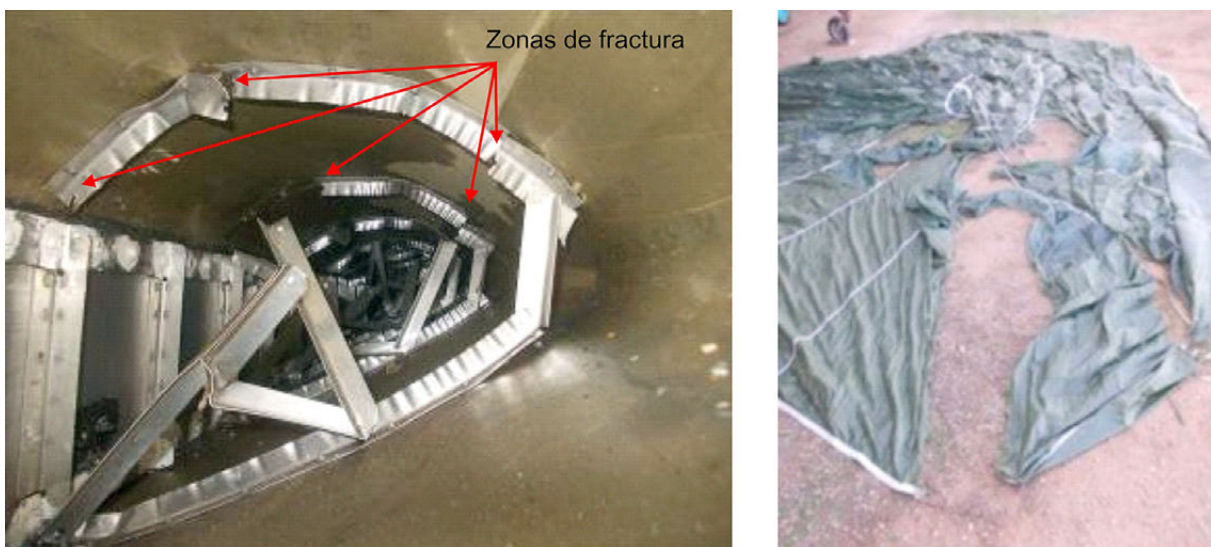
Por otra parte, advirtió que el paracaídas había sufrido daños de importancia, encontrándose rotas algunas de sus costuras (véase figura 2).

Posteriormente se desmontaron los planos, lo que permitió comprobar que la deformación que presentaba el plano izquierdo se debía a la rotura de varias costillas.

Figura 2. Fotografías del interior del plano izquierdo y del paracaídas

La rotura del paracaídas debió comenzar durante los primeros instantes tras su activación, y fue progresando durante el descenso, de manera que la disminución de su capacidad de retención fue paulatina, lo que permitió que la aeronave llegara al suelo con poca velocidad.

A fin de mejorar estas deficiencias, el piloto y constructor de la aeronave considera que debería reemplazar el paracaídas por otro de mayor capacidad, así como modificar su sistema de activación, con objeto de que simultáneamente actúe también sobre el motor produciendo su parada.

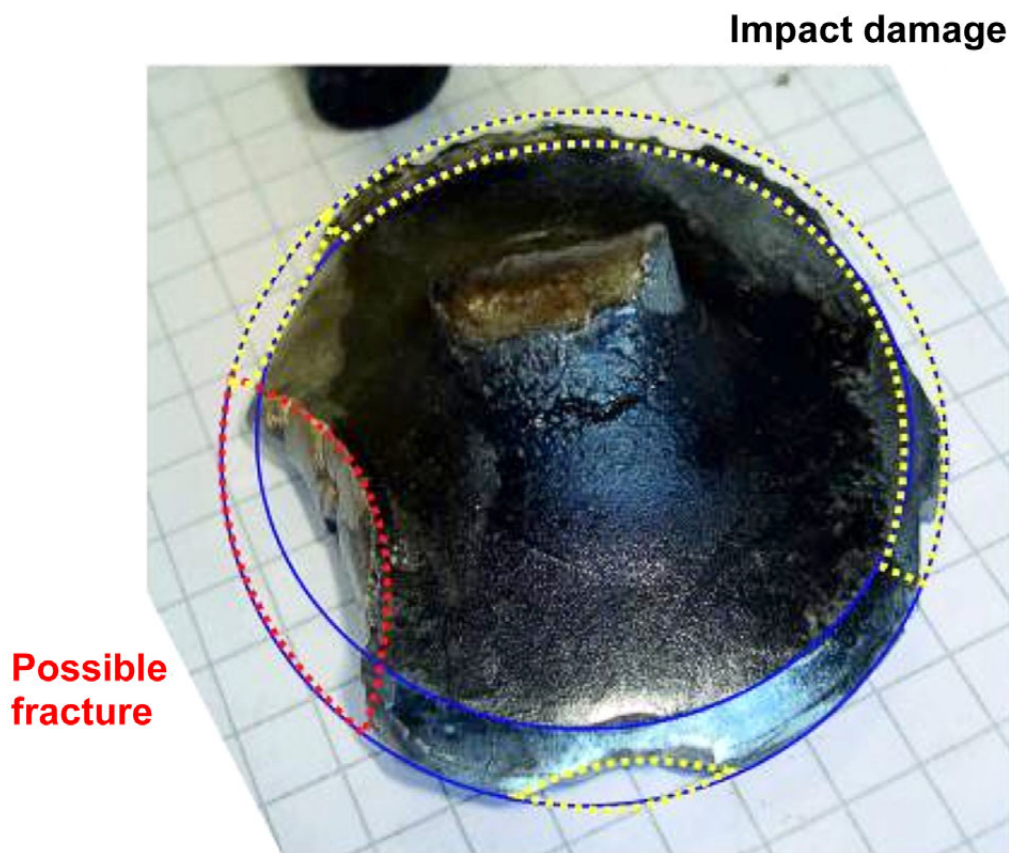
The head of the no. 3 cylinder exhaust valve struck the inside of the cylinder several times after it separated from the stem. This led to various deformations of the rest of the stem as well as of the entire circumferential perimeter. An analysis of the head showed a large groove on its skirt that seemed to have resulted from the partial fracture of the head before it broke off from the stem, as shown in Figure 3.

Figure 3. . Head of the valve on the no. 3 cylinder

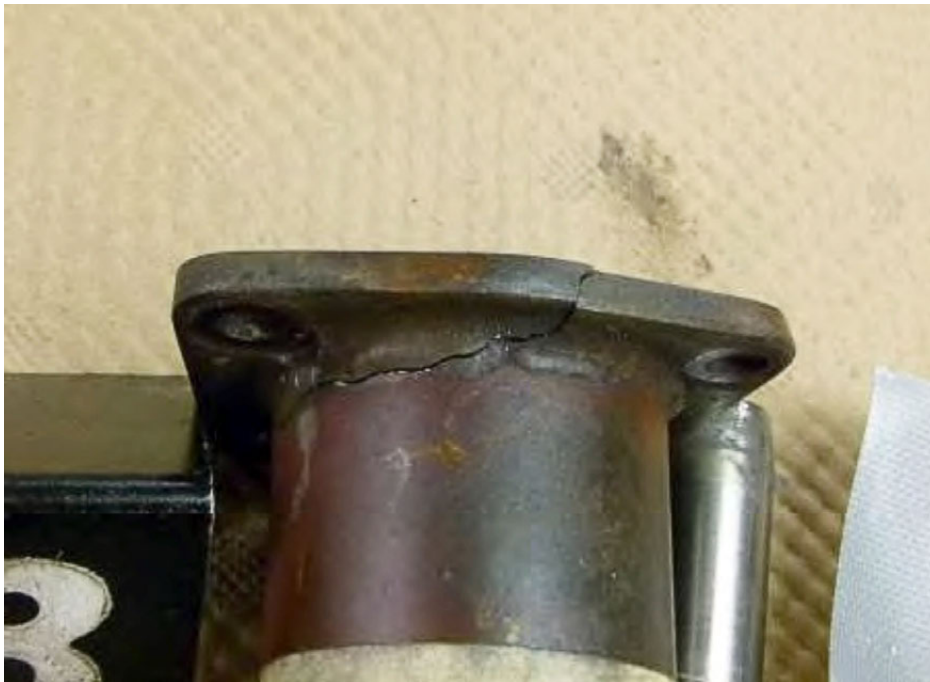
Figure 4. Cracks and signs of overheating in the no. 3 exhaust port.

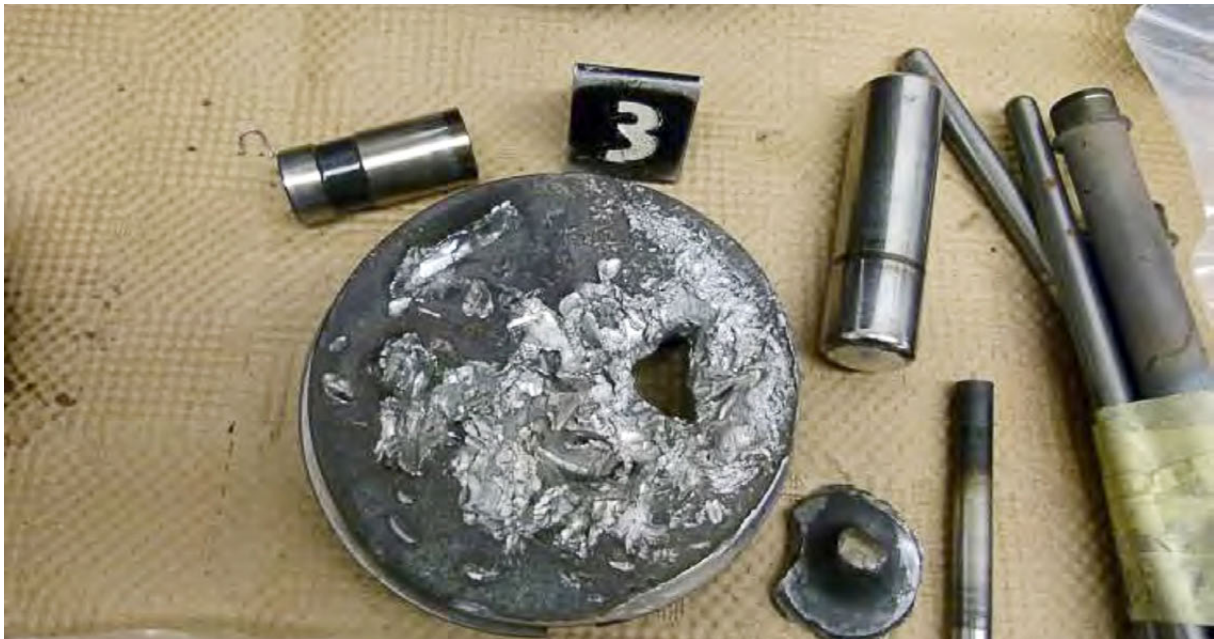
The no. 3 cylinder and its internal components, pistons, segments, pushrod, etc., showed heavy generalized damage.

Figure 5. Piston, valve and other components of the no. 3 cylinder

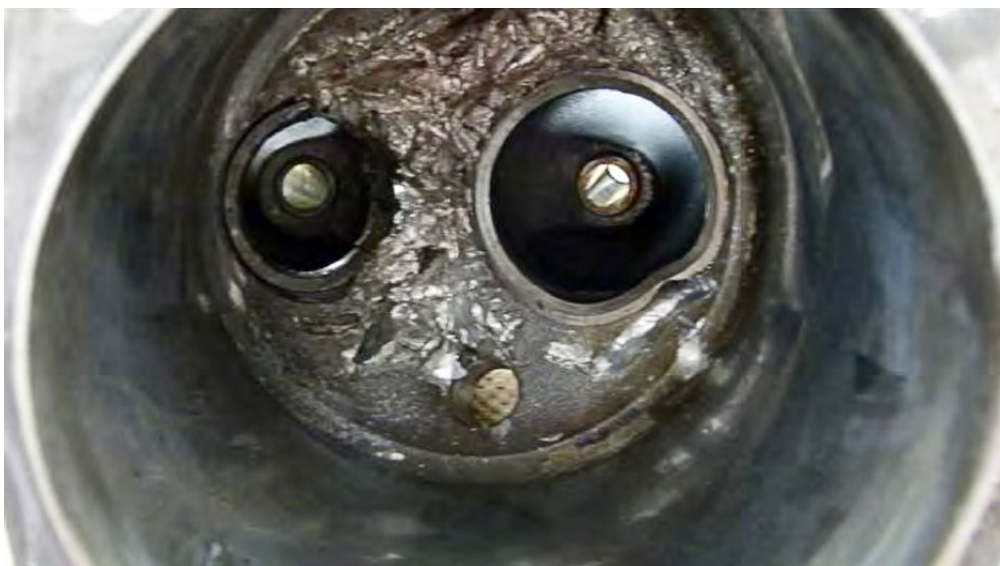
Figure 6. Interior of the no. 3 cylinder

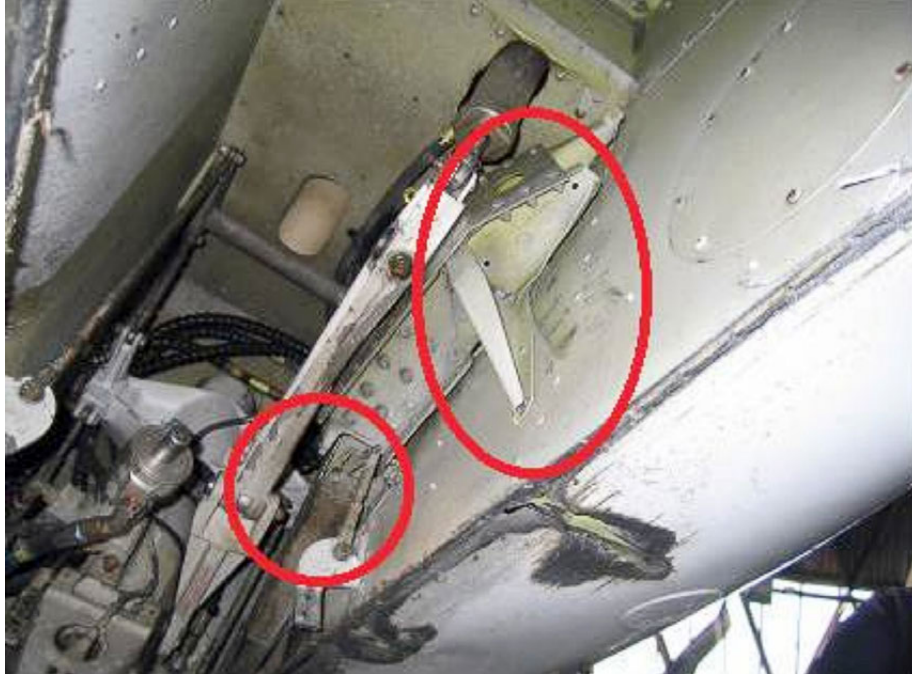
The U-beam that houses the axle on which the nose gear's upper drag link pivots was broken near the housing where the actuating rod that moves the front left well door shifts back and forth. The part of the beam forward of this housing had lost the rivets that attach it to the side bulkhead and was loose (Figures 3 and 4).

Figure 3. Forward gear wheel well showing the fracture area and the loss of the rivets that hold the drag link in place

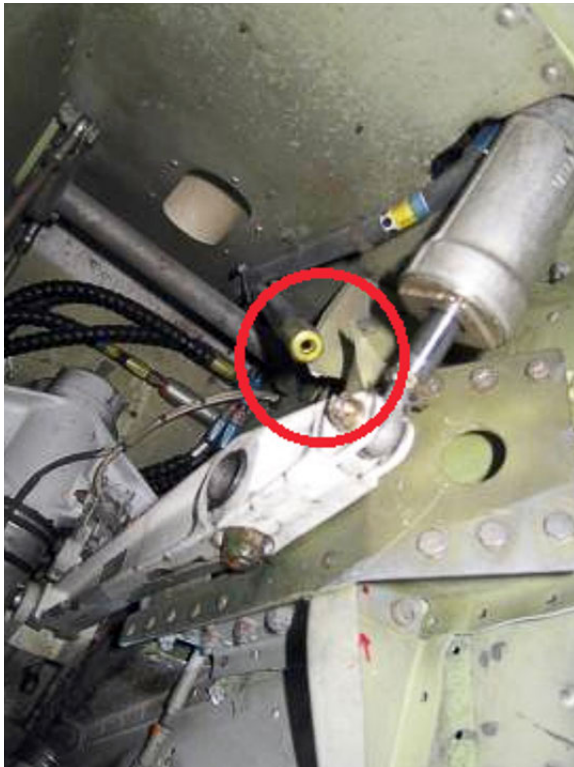
There was a reddish mark on the beam next to a crack that started in the hole for a screw that attached the part to the bulkhead (see figure 6). Workshop personnel could not ascertain its origin, indicating that it was probably present when the airplane was first taken to the workshop in 2007. Two other centers that had carried out maintenance on the airplane before were contacted, but neither one had records indicating that this crack had been detected and was being monitored.

The hydraulic return line from the actuator was broken, possibly as a consequence of the movement of the actuator itself when it was dragged by the locking arm when its axle moved (Figure 6).

**Figure 6.** Return of the hydraulic line that supplies the actuator

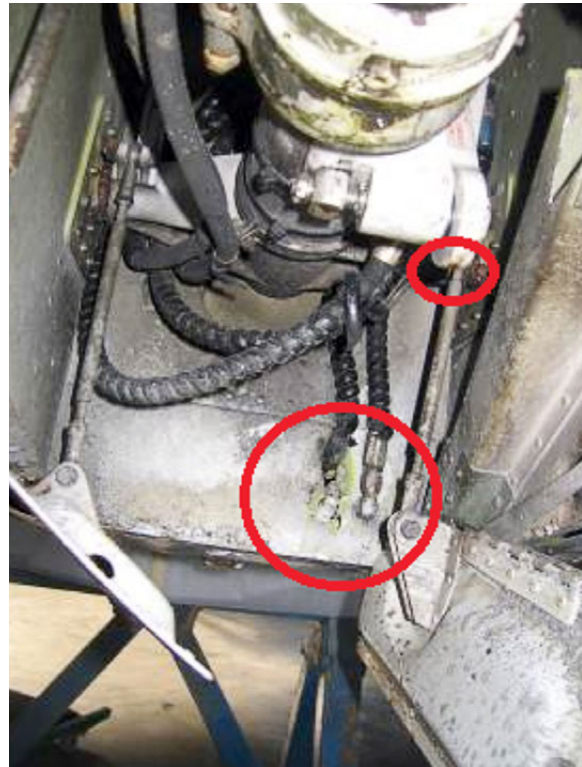
As a result of the loss of rigidity of the locking system caused by the fracture and motion of the beam, the leg swung excessively toward the rear, such that its structure made contact with the wheel well's rear bulkhead at the point indicated by an impact mark. This part of the bulkhead houses an elbow of the hydraulic line for the nose wheel steering system, which had broken (Figure 7).

**Figure 7.** Impact on the rear bulkhead and part of the leg responsible for the impact
