DATA SUMMARY

Date and time	Monday, 07 January 2013 at 02:45 UTC ¹
Site	Airway UN-873 (Canaries UIR), vicinity of point IPERA

Registration	CS-TOC	F-GSQJ
Type and model	AIRBUS A340-312	BOEING B777-328-ER
Operator	TAP – Transportes Aéreos Portugueses	AFR – Compagnie Nationale Air France

Date of approval	18 th December 2013
------------------	--------------------------------

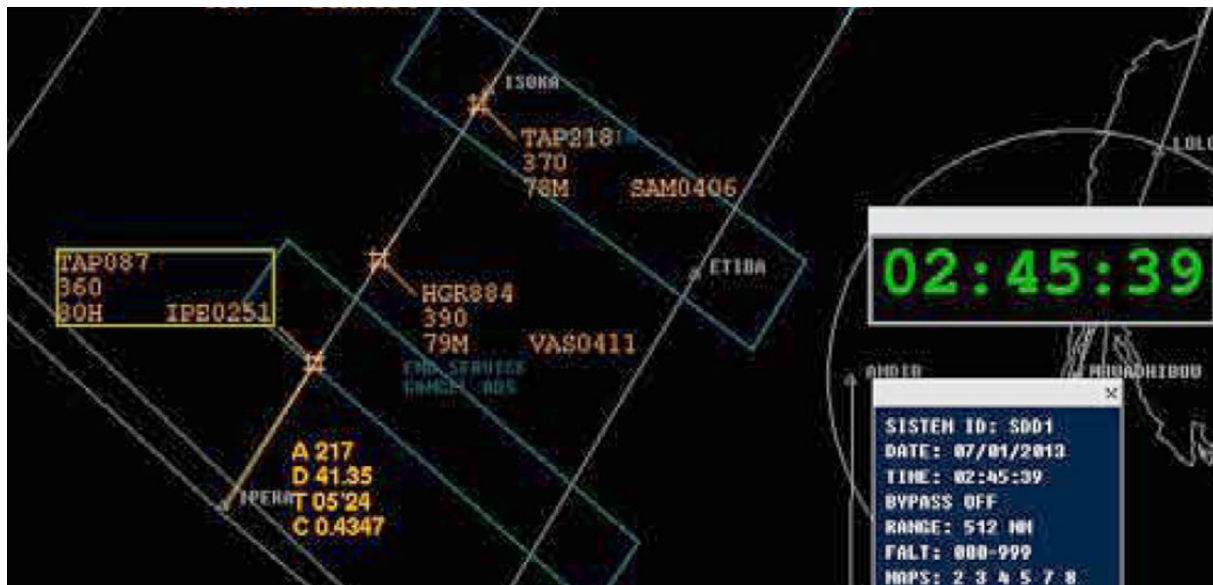
Figure 1. Image from the SACCAN system at 02:45:39

At 02:45:39, almost a minute after aircraft TAP-087 started to climb, based on its FDR data (it left FL340 at 02:44:42), the aircraft's pseudotrack showed it to be some 41 NM before waypoint IPERA. The SACCAN system still was not showing either a pseudotrack or an ADS track for aircraft AFR-457 (figure 1).

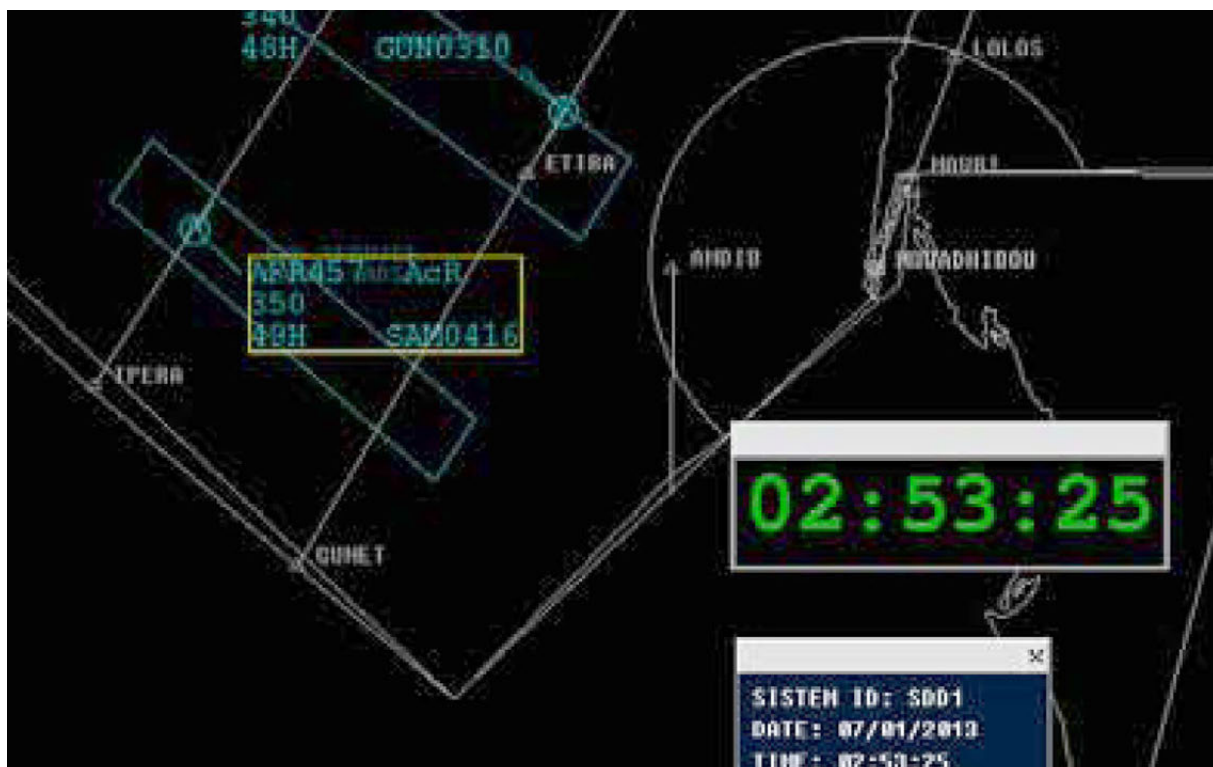
Figure 2. Image from the SACCAN system at 02:53:25

The SACCAN display did not show an ADS track for aircraft AFR-457 until 02:53:25, meaning the flight by then had connected to the system. The aircraft had already crossed the point of entry into the Canaries FIR, waypoint IPERA.

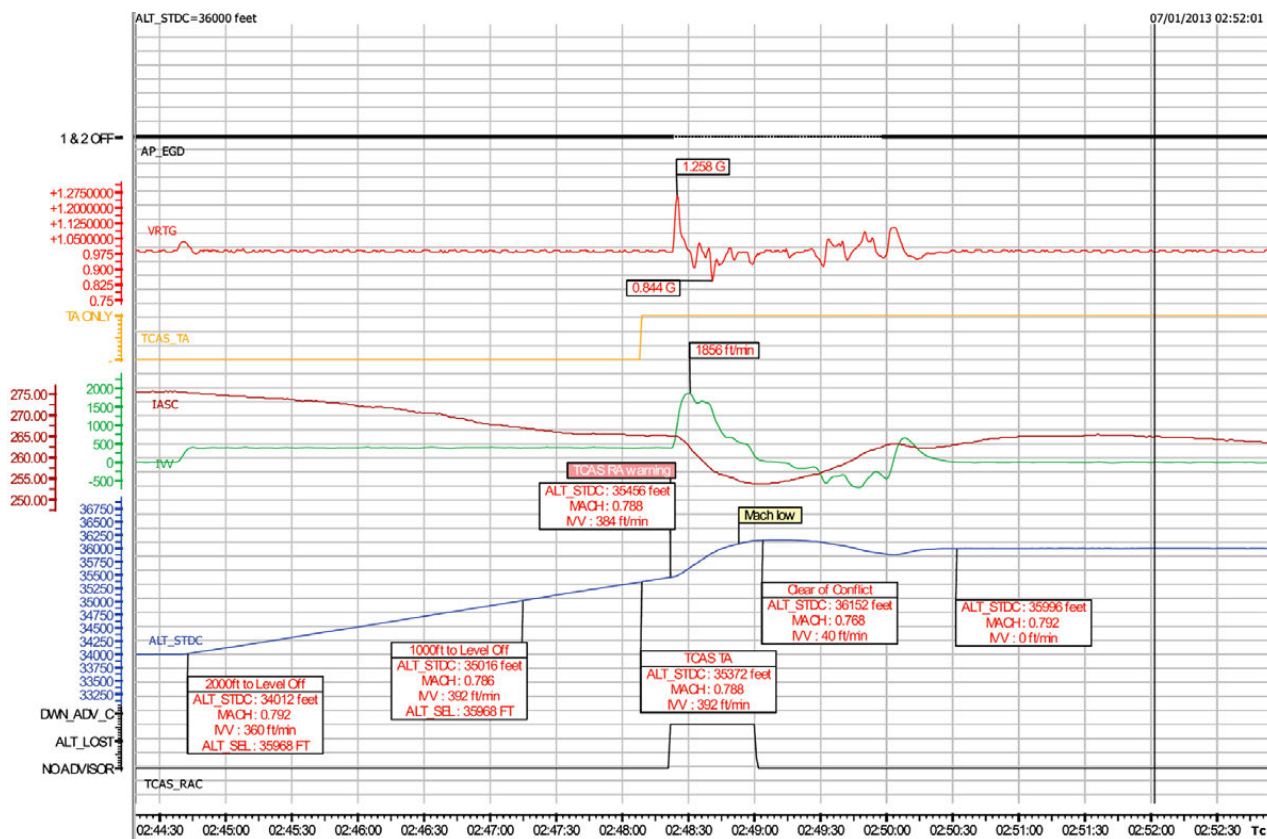
Figure 3. Image from the QAR data report for aircraft TAP-087

Based on this report, aircraft TAP-087 left FL340 at 02:44:42 en route to FL360. The aircraft's initial climb rate was 400 ft/min.

At 02:48:09 a TCAS traffic advisory was received, which twelve seconds later, at 02:48:21, became a resolution advisory. The crew then increased the climb rate to a maximum of 1,856 ft/min. The TCAS clear of conflict message was received at 02:49:03; by that time the aircraft was at an altitude of 36,152 ft. The flight data analysis revealed that at 02:48:54 a Mach low event had happened; this type of event does not issue any warnings to the crew. See figure 3.

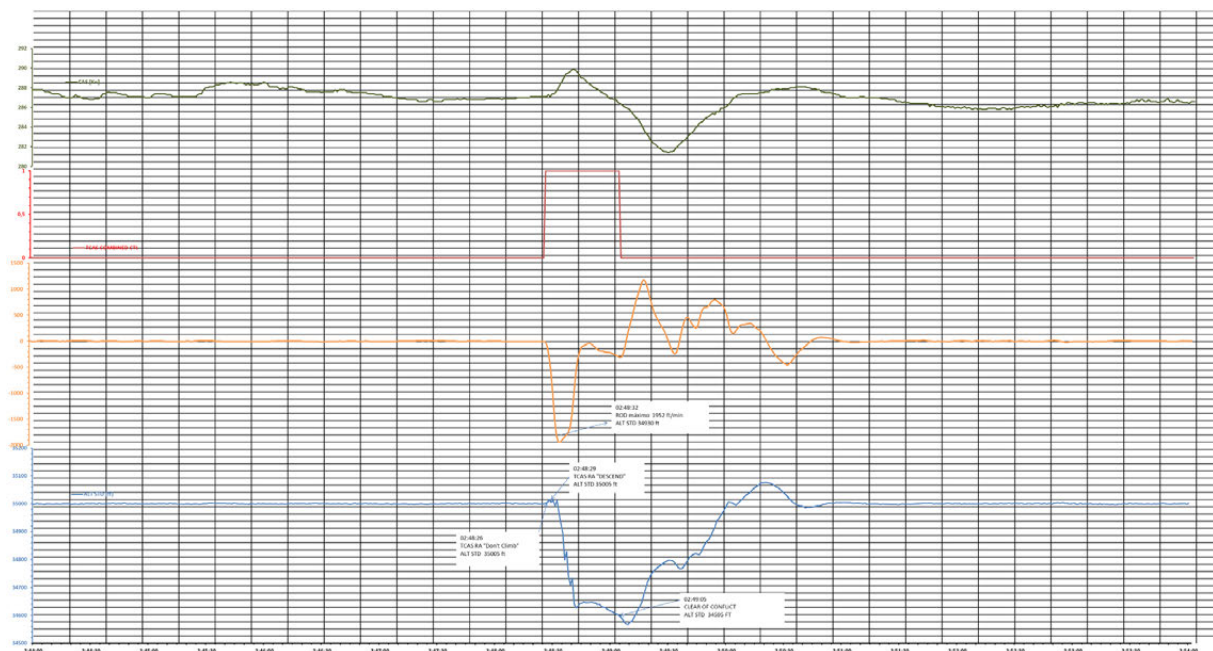
Figure 4. Graph of the QAR data from aircraft AFR-457

An analysis of these data revealed that a "Don't climb" resolution advisory was received on the TCAS at 02:48:27, followed by a "Descend" advisory three seconds later, when the aircraft was at 35,000 ft. The crew followed the TCAS indication, reaching a maximum descent rate of 1,952 ft/min. The clear of conflict message was received at 02:49:05, after the aircraft has descended to an altitude of 34,595 ft.

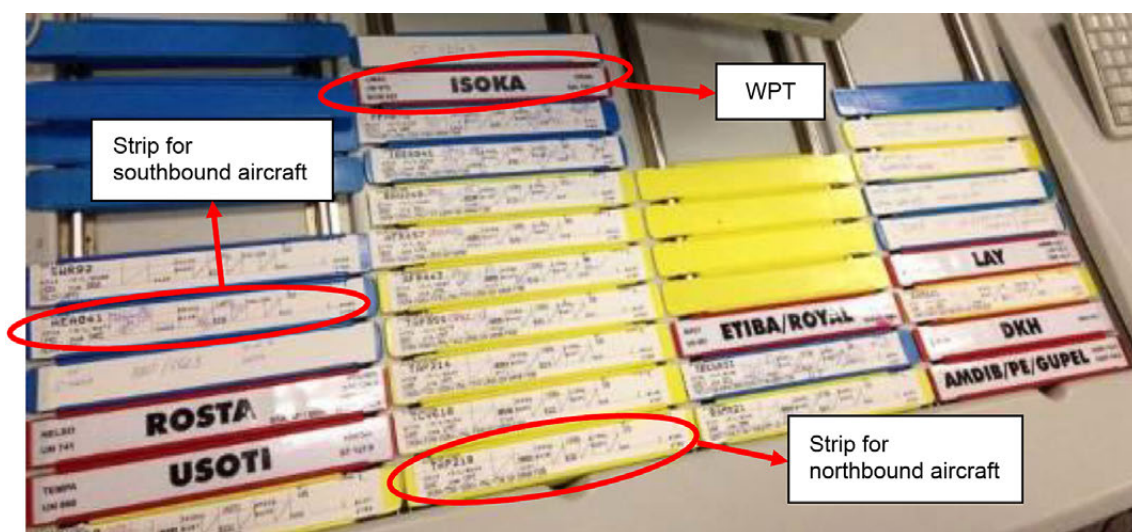
Figure 7. Flight progress board in Sector GCCC OCE

Later, while looking over the flight progress strips on the board, the controller noticed a yellow strip associated with waypoint BIPET (UN-857) and corresponding to a northbound Air France flight at FL350 (aircraft AFR-457). The strip was improperly positioned since it should have been in the airway associated with waypoint IPERA (UN-873). He did not know who could have placed the strip in the wrong place or when. He was not expecting this traffic since the SAL ACC controller had not mentioned it while they were coordinating the climb of aircraft TAP-087.

When aircraft TAP-087 reached waypoint ISOKA at 02:36:33, one of the Sector GCCC OCE controllers called the SAL ACC to coordinate its climb to FL360. The SAL ACC cleared the climb, not noticing the potential conflict with aircraft AFR-457, which was still under its control. The Sector GCCC OCE controllers, for their part, also failed to notice during their check of the board that aircraft AFR-457 was going to enter the Canaries FIR via waypoint IPERA some ten minutes later, at 02:47 as per the reported estimate, and thus conflict with the climb clearance of aircraft TAP-087. This failure to detect the immediate presence of aircraft AFR-457 on airway UN-873 occurred because its flight progress strip was not correctly positioned on the board.

Before the changes described in 1.8.8.1 were made, the manual did not require supervising the placement of strips on the board.
