**DATA SUMMARY**

Date and time	<b>27 March 2013 at 13:36 UTC<sup>1</sup></b>
Site	<b>Alicante airport (Spain)</b>

Registration	<b>EI-DLE</b>
Type and model	<b>B 737-800</b>
Operator	<b>Ryanair</b>

Operation	<b>Commercial air transport – Scheduled – International – Passenger</b>
Phase of flight	<b>Take-off</b>

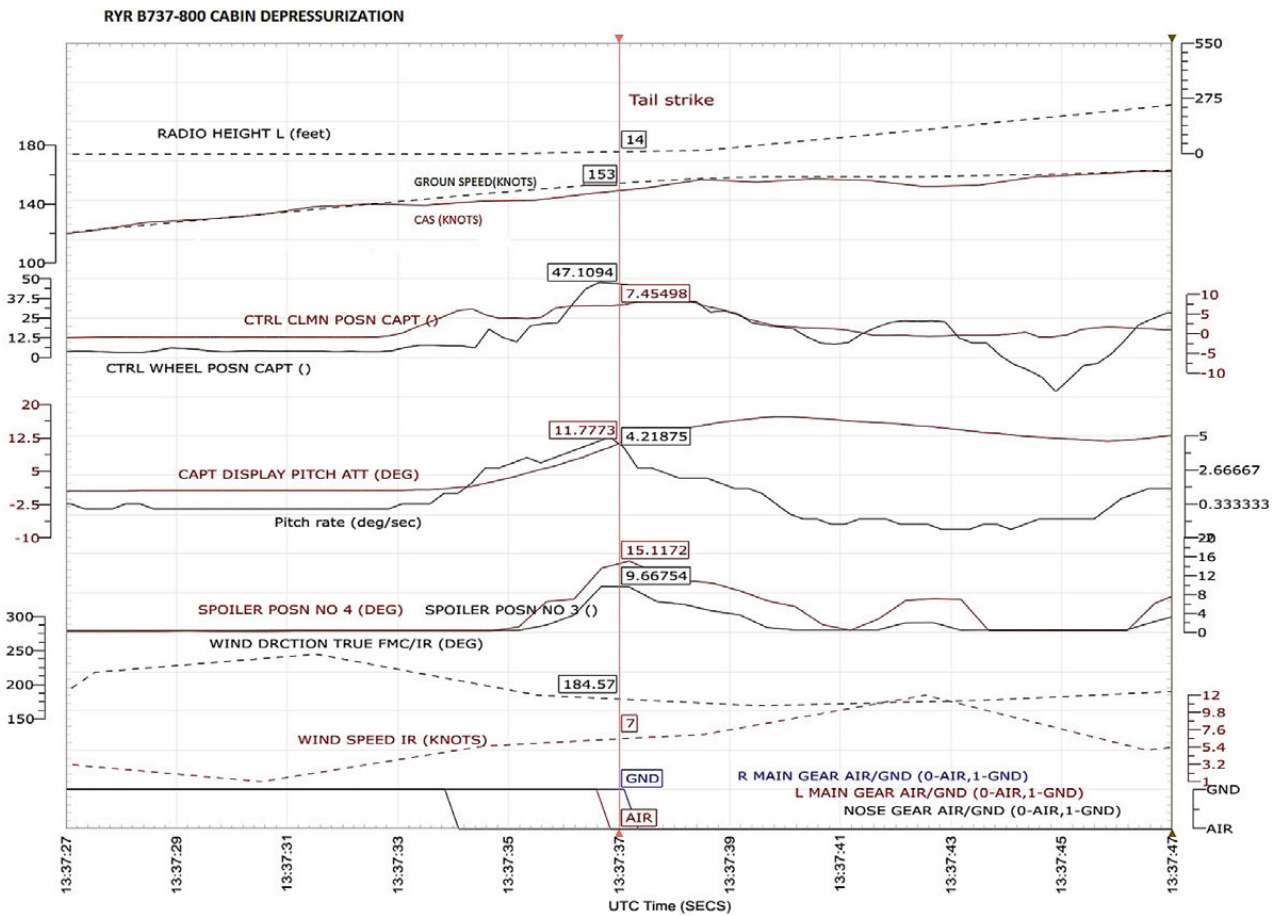
Figure 4. Relevant parameters during the take-off run and rotation

The airplane started the take-off run properly trimmed. Once the calculated rotation was reached (141 kt), the first officer started to rotate with a slight correction to offset the effect of the crosswind. This correction became more evident as the rotation progressed, probably as a result of the first officer's efforts to compensate for the effect of a gust of wind, which caused the left-side flight spoilers to deploy, with the ensuing loss of lift. This bank angle correction was accompanied by a second pull back on the control stick that increased the rotation speed above the maximum values recommended to ensure separation between the tail and the runway.

- During the rotation, the pilot flying applied a corrective input to the bank controls of up to 48°, which caused the left-side spoilers to deploy.
- The input to the control column caused the rotation rate to peak at 5°/s, above the recommended value.

The tailstrike took place during take-off as a result of an excessive rate of rotation during the final phase of this maneuver, accompanied by a partial loss of lift caused by rotation during a wind gust that contributed to a change in the headwind component and the deployment of the spoilers on the left wing, which deployed due to the magnitude of the control wheel by the pilot flying in an effort to offset the effects of the gust of wind.

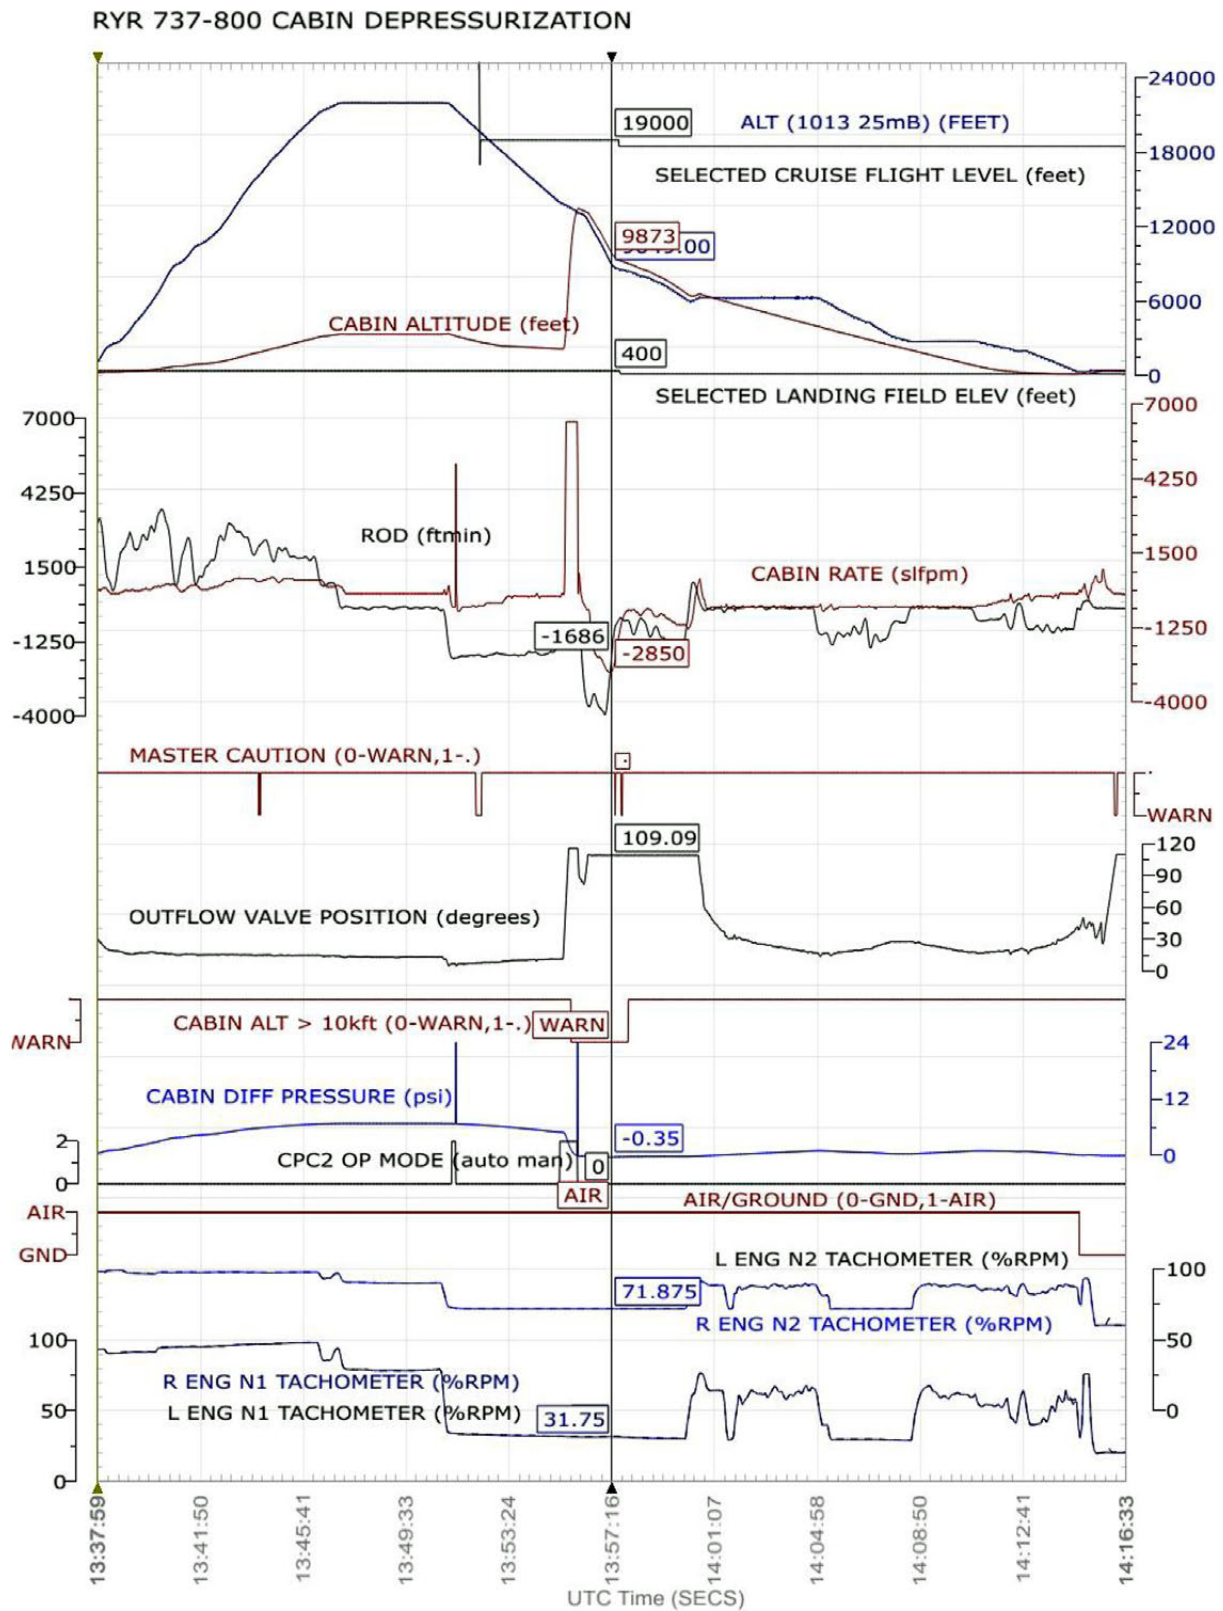
Figure 5. Relevant pressurization parameters

Forty seconds after manual mode was selected, the crew reverted to automatic mode. By then the cabin pressure had already equalized with the outside (zero differential pressure). The system initially commanded the valve to close to reduce the cabin altitude (from 13,000 ft at the time). The negative differential pressure was increasing as a consequence of the descent rate (about -3,000 ft/min and rising), which caused the protective measure to activate; namely, the valve returned to its automatic full open position, which allowed the pressures inside and outside the cabin to equalize. The activation of this protective measure overrode the measures that normally limit the cabin pressure gradient, such that this gradient reached a value of -2,900 slfpm. The delay in equalizing the pressures translated into a slight negative differential pressure whose maximum value was limited to -0.37 psi.

The checklist requests a full opening of the valve to equalize pressures as soon as possible. The captain completed the opening in 12 seconds without interruption. The cabin needed barely 12 additional seconds to equalize with the outside pressure, causing a change in the cabin pressure that surprised the crew and caused discomfort in the passengers. The purser was particularly affected due to a pre-existing condition.

Although from an aircraft structural integrity standpoint this action is of little consequence (the differential pressure barely reached  $-0.4$  psi during the fastest descent and  $+1$  psi during the remaining of the flight), it still serves to underscore the crew's disorientation, as they seemed to have forgotten the logic behind the depressurization contained in the checklist (avoid structural damage) and instead prioritized a secondary objective like minimizing the cabin pressure gradient, and thus the potential additional discomfort of the passengers during the rest of the descent.
