Report IN-021/2013

Incident on 4 July 2013,
involving an Airbus A-320
aircraft, registration G-OZBW,
operated by Monarch Airlines,
while on approach to the
Málaga Airport (Spain)

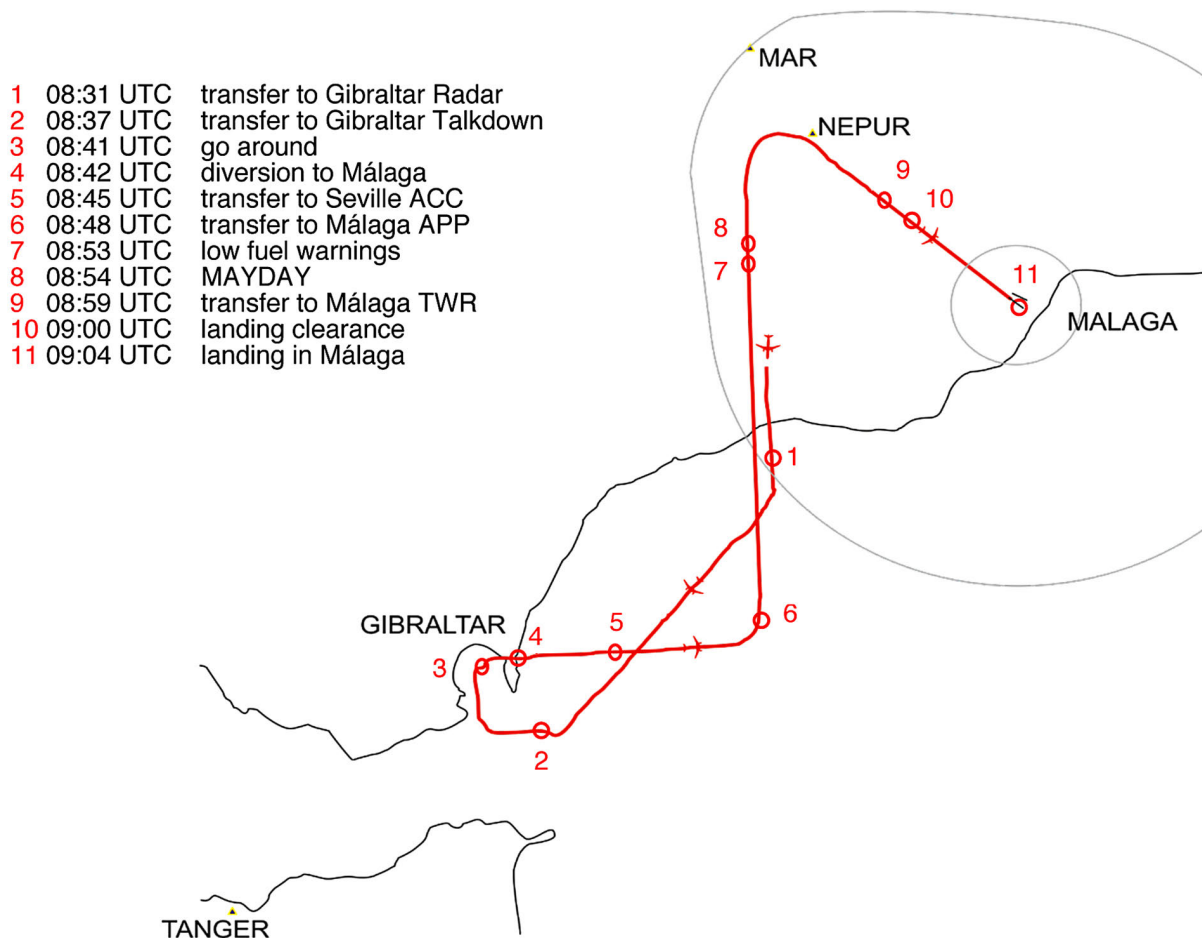
Figure 1. Approach to Gibraltar and diversion to Málaga

08:37:28 UTC: (Point 2, figure 1) Transferred to Gibraltar Talkdown. Aircraft southeast of the airfield at 1600 ft and flying west to join circuit south of the 6.0 NM point¹⁰.

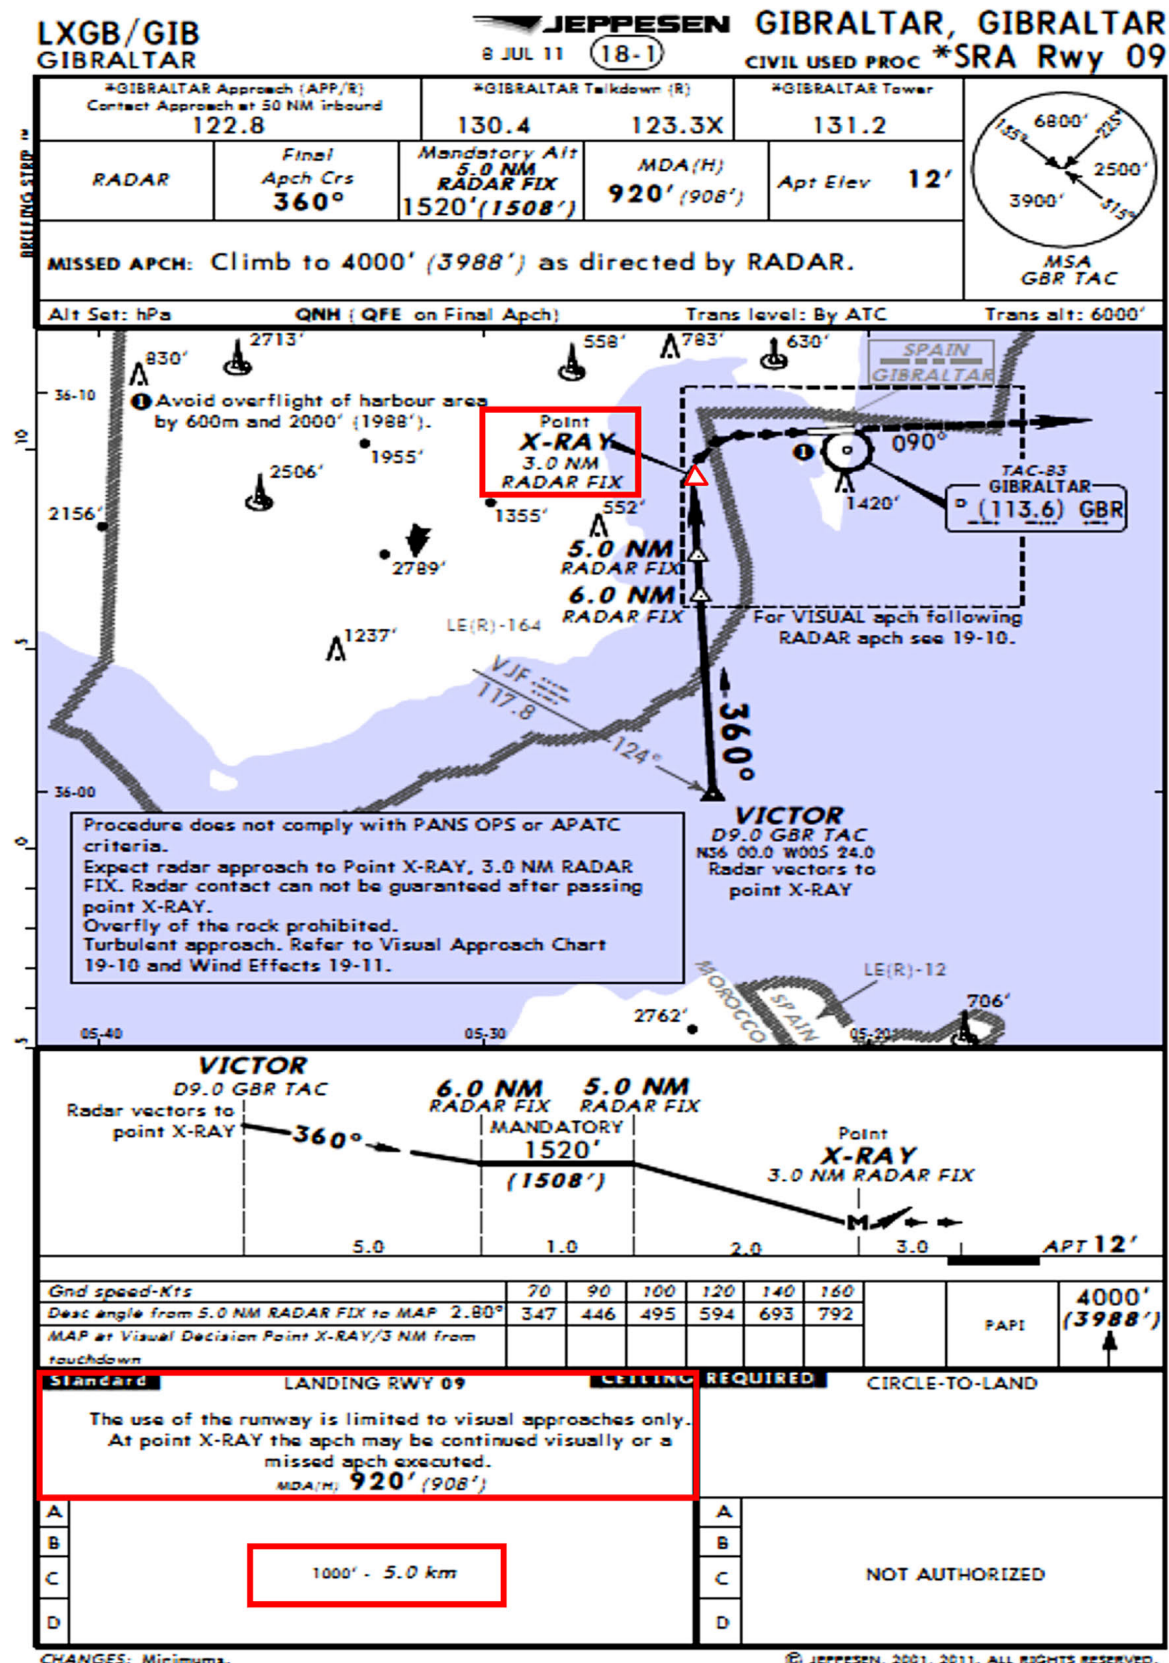
Figure 2. Approach procedure for runway 09 at the Gibraltar Airport

Figure 2 shows the surveillance radar approach (SRA) used by the aircraft on the incident flight¹².

The procedure¹³ begins with a radar approach that passes through three points located 6, 5 and 3 NM out (shown in figure 2). These points are called 6.0 NM, 5.0 NM and X-RAY on the approach chart. The controller leaves the aircraft at point X-RAY (3 NM), which is not lined up with the runway. From there, the crew must make a 90° right turn to line up with the runway. After X-RAY, radar coverage is not guaranteed and the approach continues visually. If the crew cannot establish visual contact with the runway, a missed approach must be executed. The minimum descent altitude published on the chart is 920 ft.
