## **Report IN-039/2013**

Incident on 8 November 2013  
involving a Boeing 737-800,  
registration EI-DPF, operated  
by Ryanair, while climbing  
after taking off from the  
Tangiers Airport (Morocco)

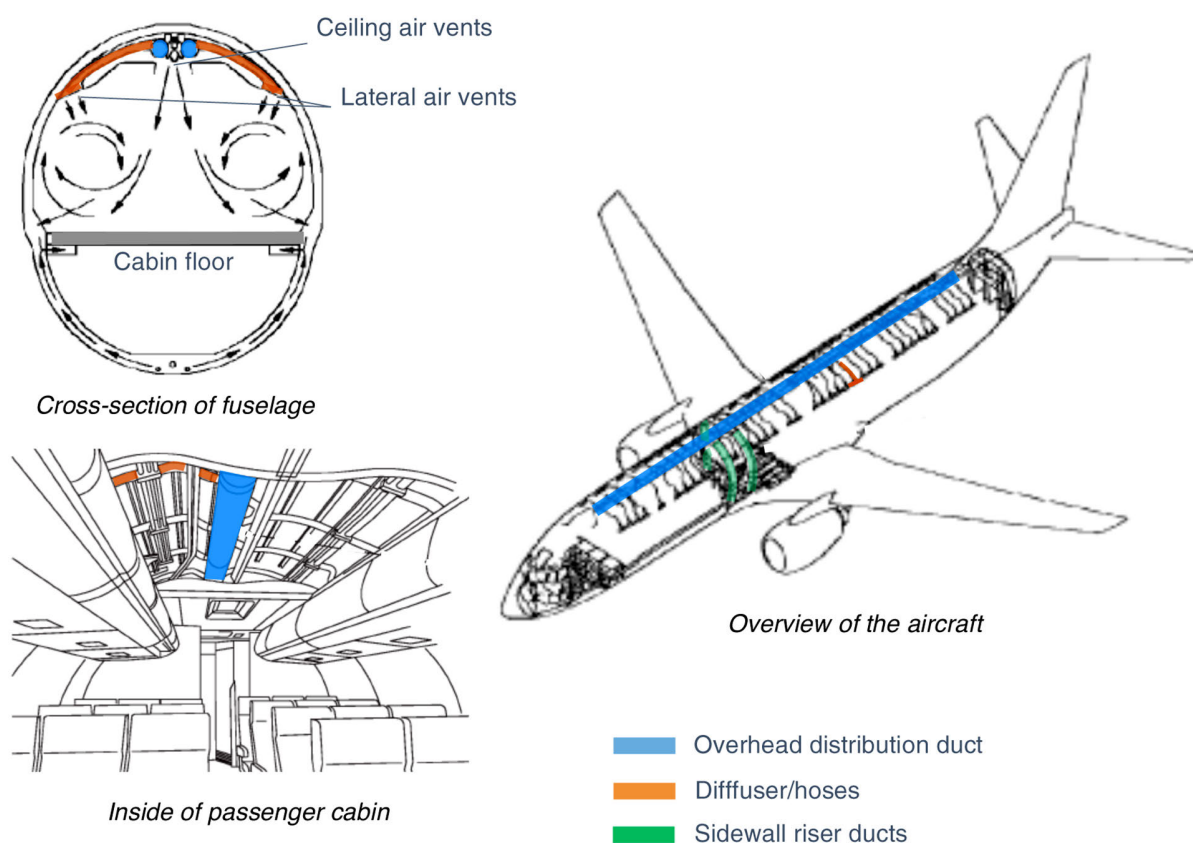
Figure 1. Air distribution in the passenger cabin

Air in the passenger cabin is distributed through a system of ducts and outlet vents located throughout the cabin. The part of the system of relevance to this incident is described below (figure 1):

- From the air conditioning packs, the air goes to the main distribution manifold.
- From the main distribution manifold the air flows through sidewall riser ducts (shown in green in figure 1), along the fuselage, to the overhead distribution duct.
- The overhead distribution duct (shown in blue in figure 1) is a cylindrical tube that runs the length of the passenger cabin in the overhead. All along this duct there are air outlets that connect to secondary hoses/diffusers (shown in orange in figure 1) that route air to the overhead vents and to the sides of the cabin.

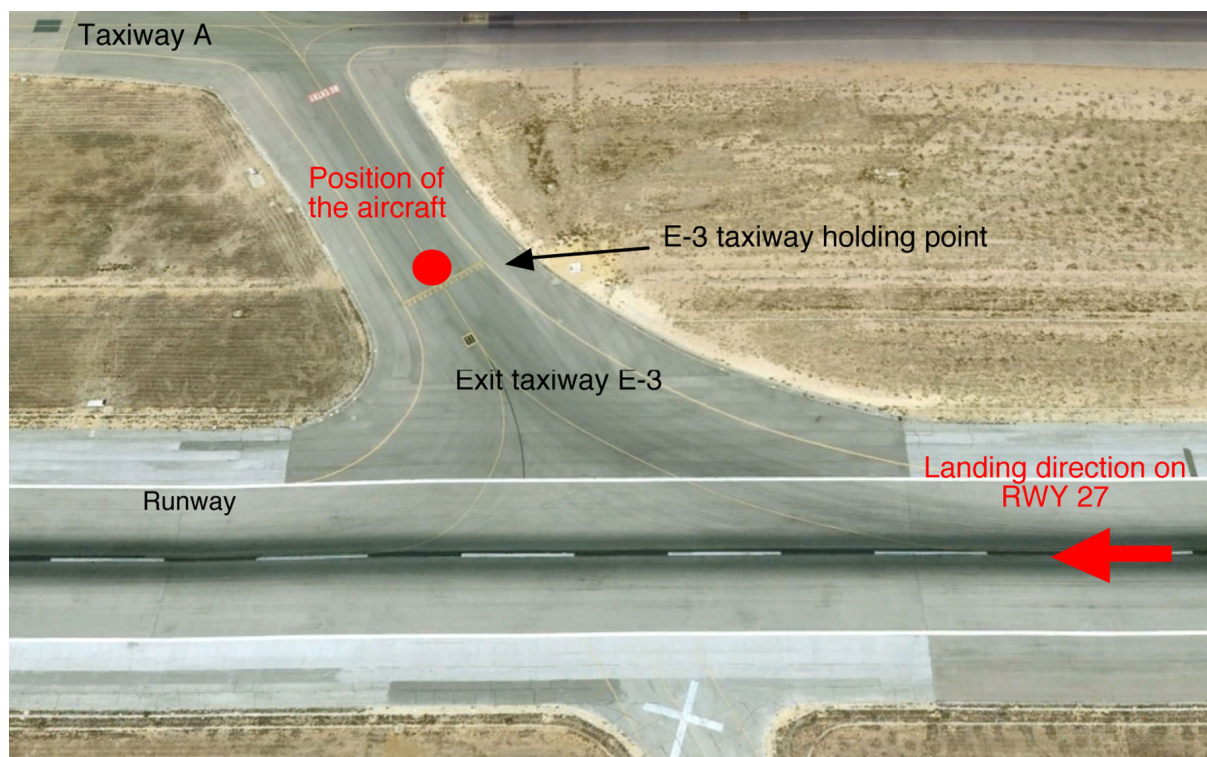
Figure 2. E-3 exit taxiway and aircraft's position

The Seville Airport<sup>11</sup> is some 100 NM north of the Tangiers Airport. It is at an elevation of 111 ft and it has a single 3,362 m long runway in a 09/27<sup>12</sup> orientation, with one taxiway (A) parallel to the runway. The operator had a base at this airport. When landing in runway 27, the exit taxiways are to the right. Exit taxiway E-3, where the aircraft stopped, is the second taxiway when landing on runway 27 and it has one holding point<sup>13</sup> located 90 m from the runway centerline<sup>14</sup> (figure 2).

When the airport was initially declared fully operational, neither of these two conditions was verified. First because the passengers were going to be disembarked on the taxiway, with all of the emergency and handling equipment deployed to that area, and second because the aircraft had not been verified to be beyond the runway safety distance.

**REC 57/15.** It is recommended that Aena-Seville Airport take the measures needed so that its personnel adhere to procedures and, when establishing the airport's level of operability, that they:

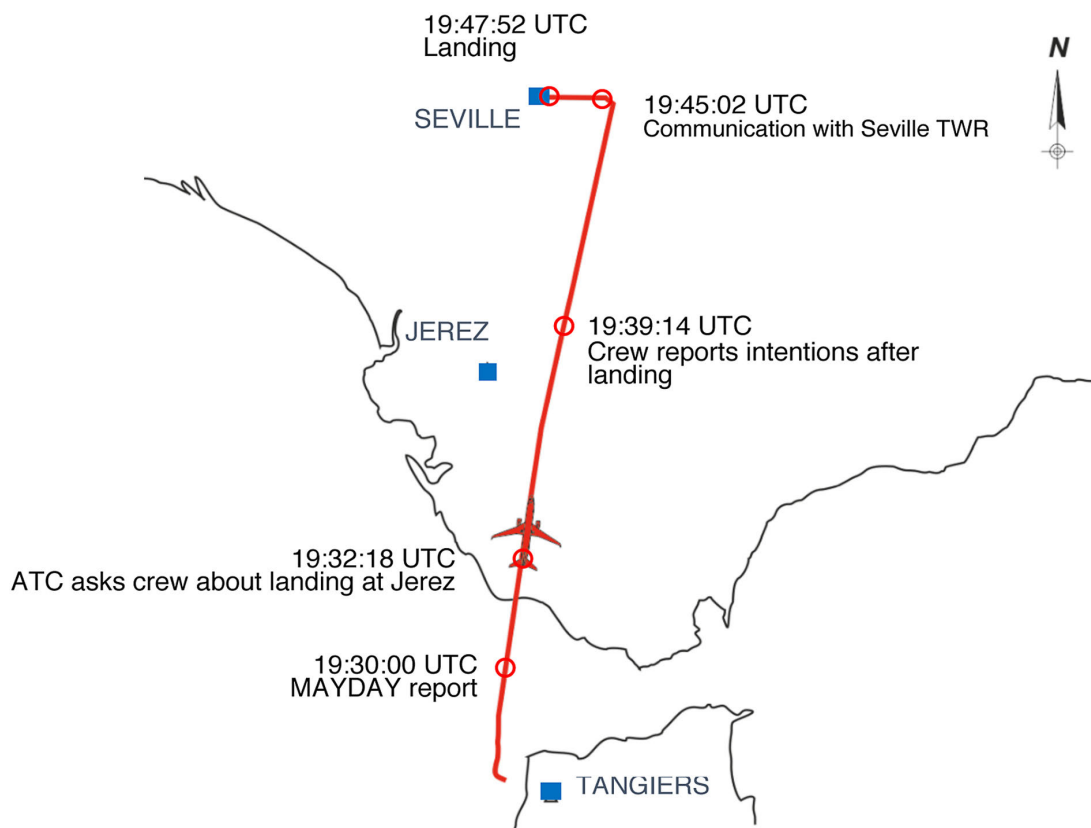
Figure 3. Flight path of aircraft EI-DPF

The total flight time<sup>16</sup> was 22 min 51 sec, and the flight path was as shown in figure 3.

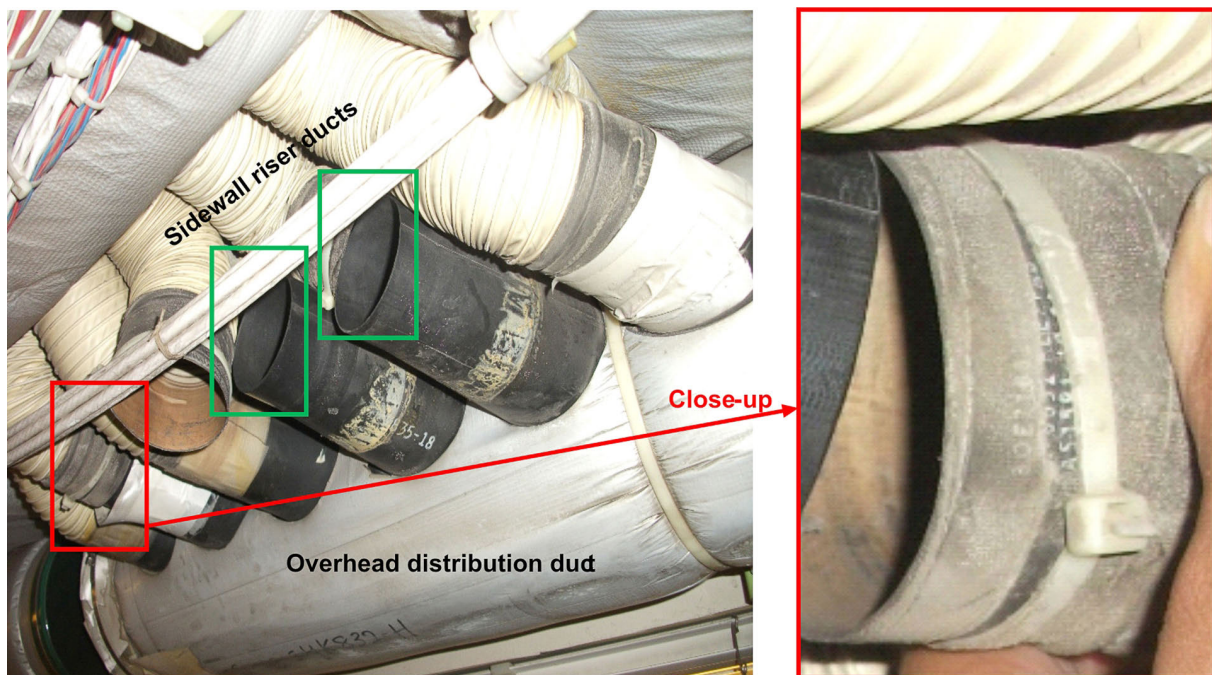
Figure 4. Detached conexions on the overhead distribution duct above row 12

The inspection of the aircraft after the incident showed that, above row 12, three sidewall riser ducts had detached from their connections to the overhead distribution duct. The strap and the tape were still attached to the hoses. Figure 4 shows the condition of the connections. Those joints found loose during the inspection are labeled.

Two of them (shown in green in figure 4) had the tape removed before the photograph was taken.

An inspection of the conexions above row 12 revealed that:

- There were two different types of adhesive tape (one was yellowish and the other white).
- The plastic tie strap could not be seen in the hoses in good condition, but it was evident below the adhesive tape.
- The marks left below the tie straps indicated that they had been installed directly on the hoses, and not on the tape, as specified in the Maintenance Manual. This installation, with the the strap directly on the hoses, is the same as current production configuration (see Section 1.16.9).

The ducts are attached by placing one inside the other and securing them together using fire retardant adhesive tape and a plastic tie strap. The tape was no longer adhering the ducts together due to a problem with the adhesive, and the hoses had come loose due to the air blowing through the hoses and to vibrations during the flight. As a result, the air leaking through this loose joint must have caused the dust that had built up on top of the ceiling panels to blow out into the cabin. This, along with possible condensation of the air upon leaving the hose, must have caused what the crew identified as a white smoke. The location of the loose hoses above row 12 matched the area where the smoke was reported during the incident.

The probable cause of the incident with aircraft EI-DPF was the bad condition of the fire-retardant adhesive tape used to attach three sidewall riser ducts to the overhead distribution duct. Because the adhesive on the tape was weak, the joints came loose and the air that was exiting at that point probably stirred up the dust that had accumulated above the overhead panels, producing what the cabin crew identified as a thick, white, odorless and cold smoke.

As recorded in the technical logbook, the joints were reinstalled using adhesive tape G50344 Nitto P-212HD. Once the hoses were attached, a leak test<sup>21</sup> was carried out, which was satisfactory. The aircraft did not reported any similar event after this incident.

**REC 56/15.** It is recommended that Ryanair takes the necessary measures in its fleet so that the installation of the connections between the overhead distribution duct and the sidewall riser ducts is verified to have been carried out in one of the following methods:
