## Report IN-038/2013

Incident involving a Bombardier  
CRJ900 (CL-600-2D24) aircraft,  
registration EC-JYA, operated by  
Air Nostrum, at the San Sebastian  
airport (LESO, Spain)  
on 25 October 2013

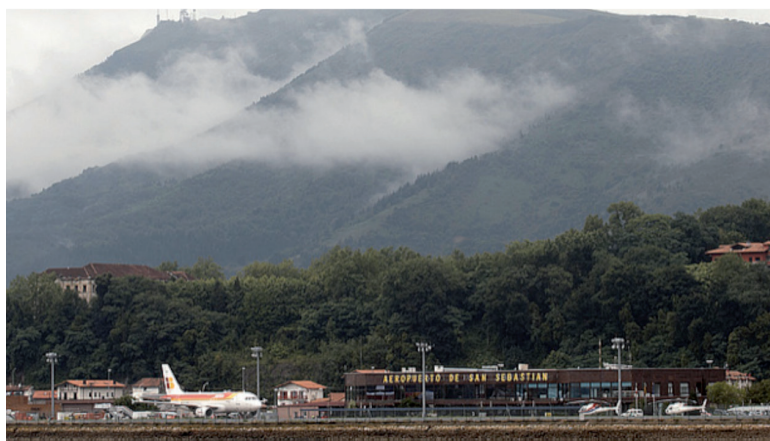
Located 1.5 NM northwest of the airport is Mount Jaizquibel, which is 545 m (1788 ft) high (see photograph below).

Photograph 2: Location of Mount Jaizquibel in relationship to the airport<sup>30</sup>.

- These tailwind conditions could have sped up the approach, forcing the crew to increase the sink rate.
- The location of Mount Jaizquibel favors the formation of turbulence downwind, in the approach area.

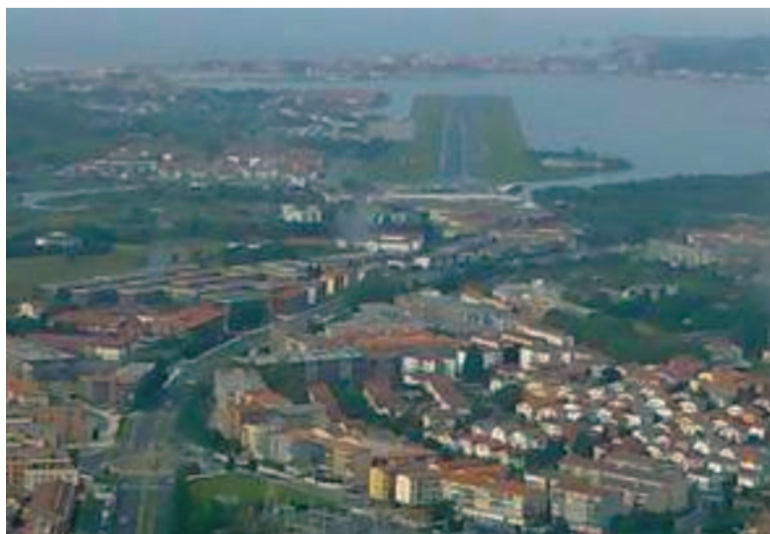
Photograph 3: Approach to runway 04

The presence of obstacles on the approach to runway 04, which has no RESA, forces crews to make an approach at an angle that is steeper than usual. Making this type of approach gives the impression that the runway is shorter than it is. In the operating conditions at San Sebastian, with its shorter runway, this illusion could affect how the aircraft is operated, forcing an approach to land on the runway threshold that uses a descent gradient higher than required for a normal glide slope.

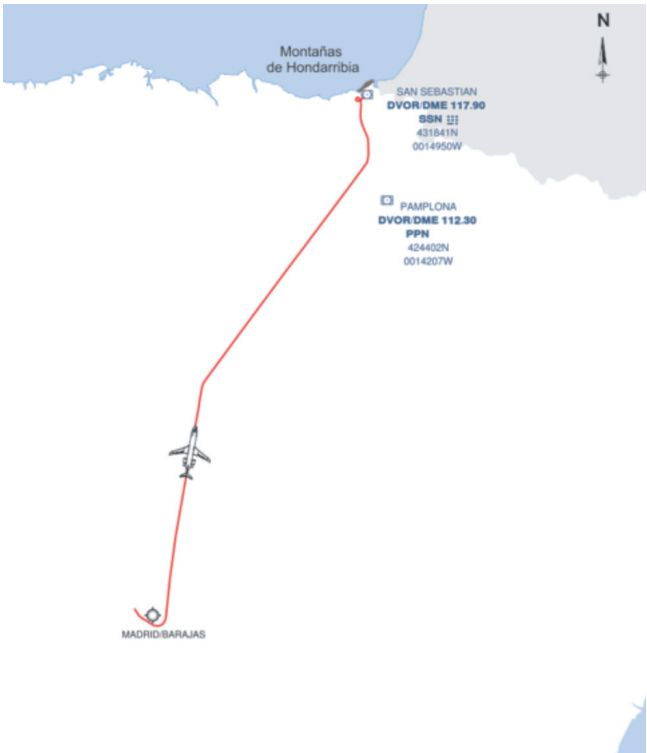
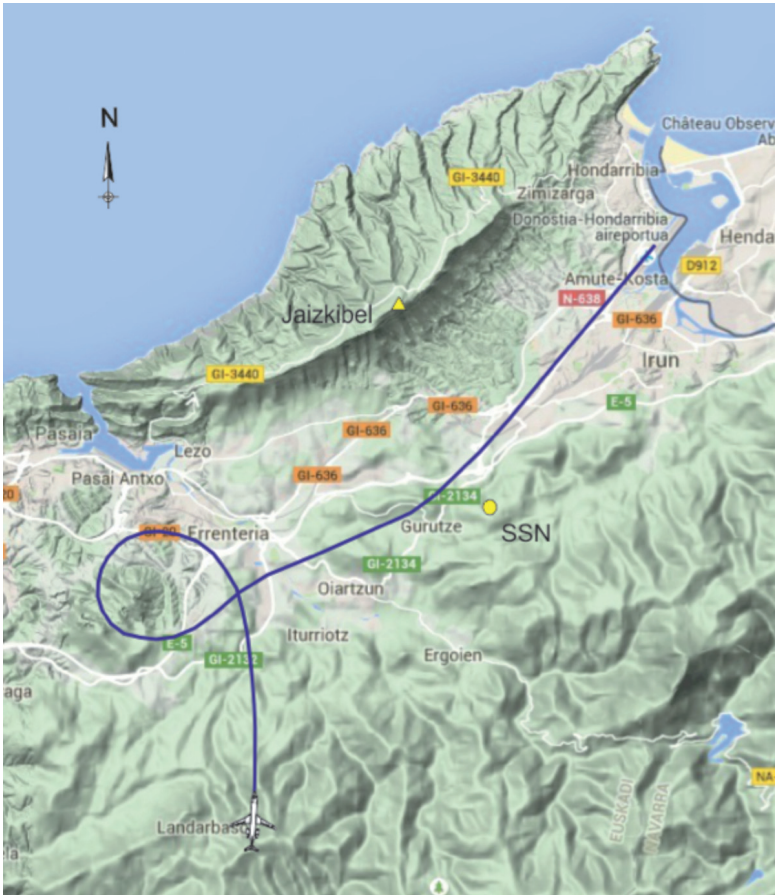
**APPENDIX A**  
**AIRCRAFT FLIGHT PATH**

During the approach, starting at about 2000 ft, the winds aloft recorded in the aircraft indicated a tailwind (180-190°) at an average speed of 27 kt. As a result of this tailwind, the ground speed (GS) was higher than the IAS (CAS). Below a QNH-corrected altitude of 426 ft (QNH 1019), the GS started to drop below the IAS, as the wind shifted from a tailwind to a headwind, a wind condition on the runway in use that was reported by the controller in the tower.

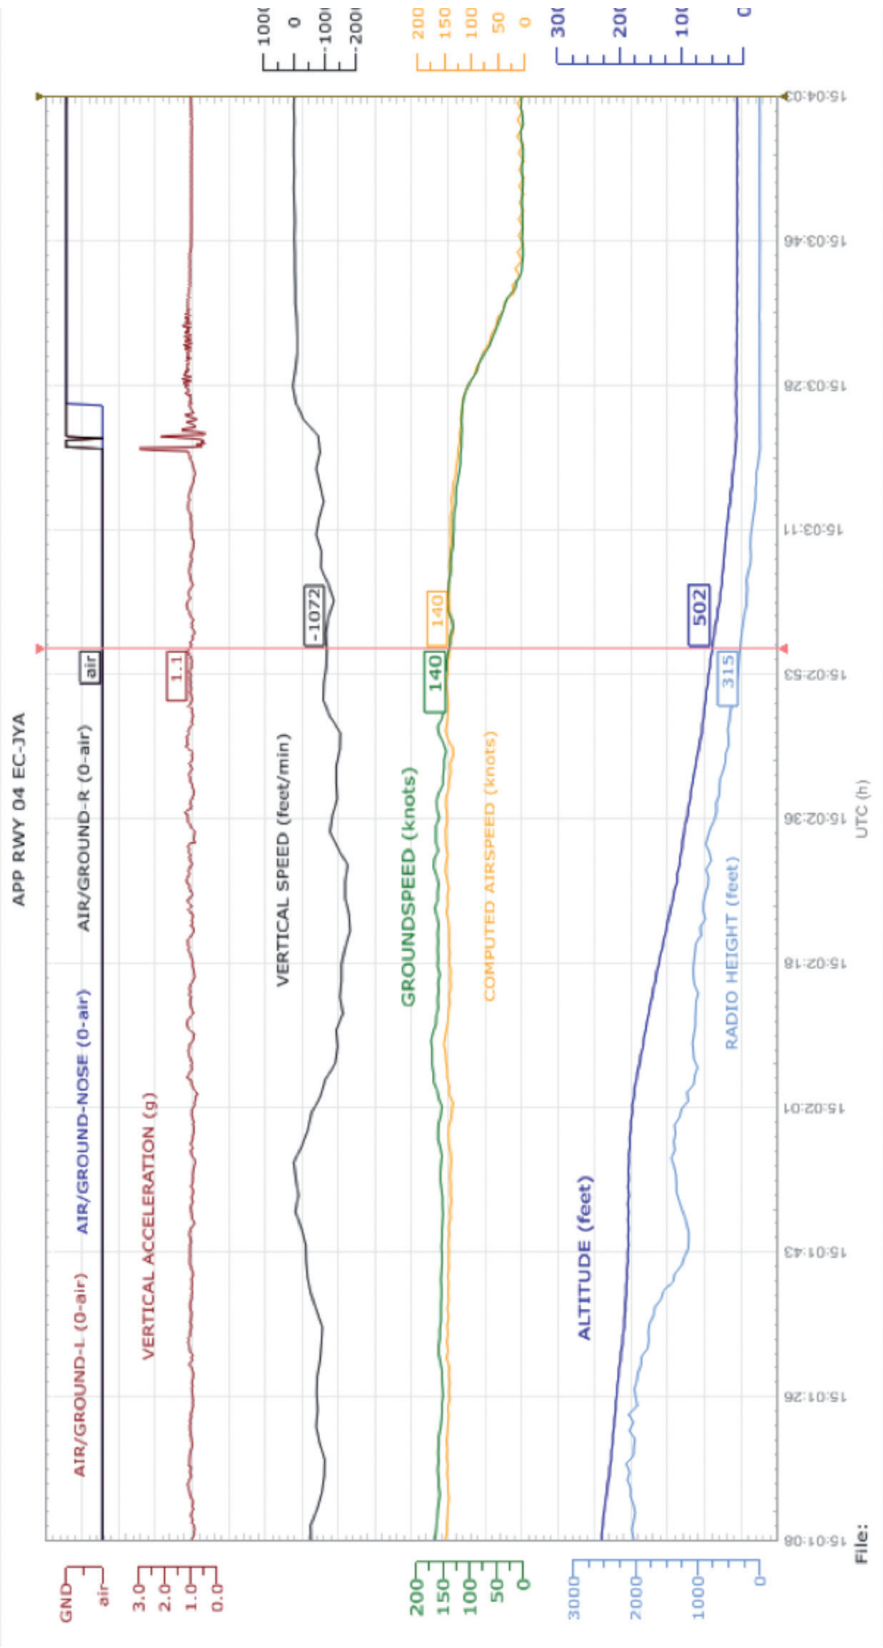
Based on the Flight Safety Foundation's definition of a stabilized approach, in VMC (below an AAL<sup>44</sup> of 500 ft), the criteria to be used are those presented in Section 1.18.2 *Stabilized approach criteria*. The DFDR data show that below 500 ft, the sink rate exceeded 1000 ft/min, reaching 1296 ft/min at 214 ft AGL. This may have been because the tailwind was making them approach the runway too fast, though the aircraft's speeds during the approach did not exceed the established criteria and were in keeping with the reduced reference speed specified in the special approach procedure for LESO.

Final approach

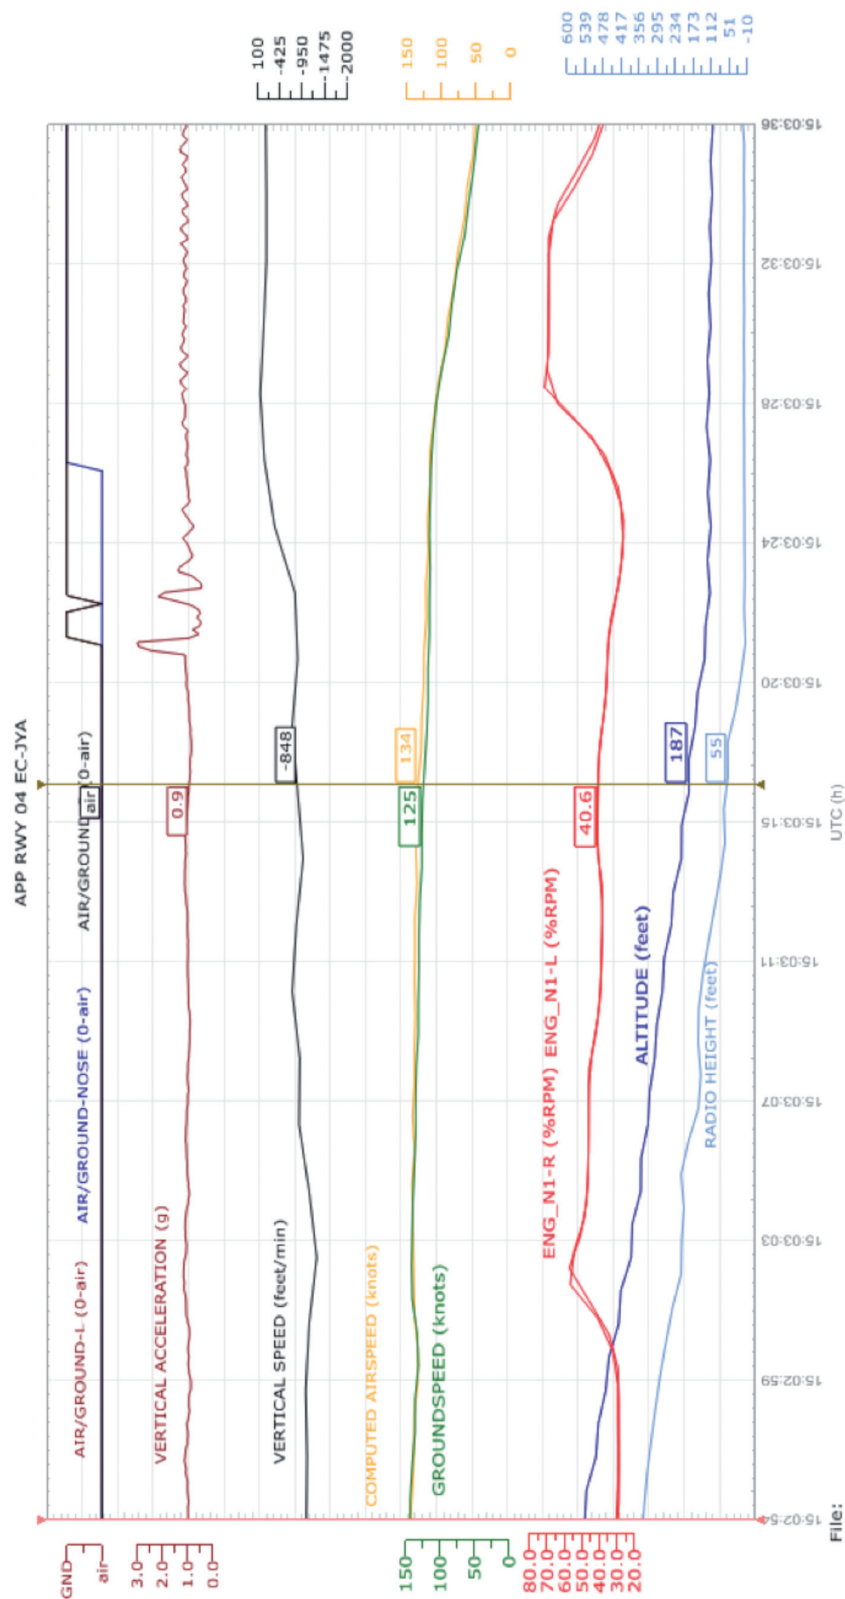
During the flare and the initial contact, the values of N1 exhibited values that differed from approach idle (35% versus 26%). This indicates that the levers were not in the idle position at first contact. Putting back the levers to such position after the first impact caused the ground lift dumping (GLD) system to deploy, resulting in a second hard landing. In keeping with the instructions in the FCOM, the crew should have gone around after bouncing or when they realized they had to apply thrust to make the landing.

- Based on the DFDR information, the crew did not start the flare until an altitude of 11 ft, reaching a pitch angle of 7° on touchdown.
- The manufacturer recommends flaring at an AGL of 20 to 30 ft and not to exceed a 5° pitch angle.

Landing
