## **Report IN-044/2013**

Incident on 11 December  
2013, involving an ATR 72-212  
aircraft, registration EC-LFA, while  
landing at the Tenerife-North Airport  
(Santa Cruz de Tenerife, Spain)

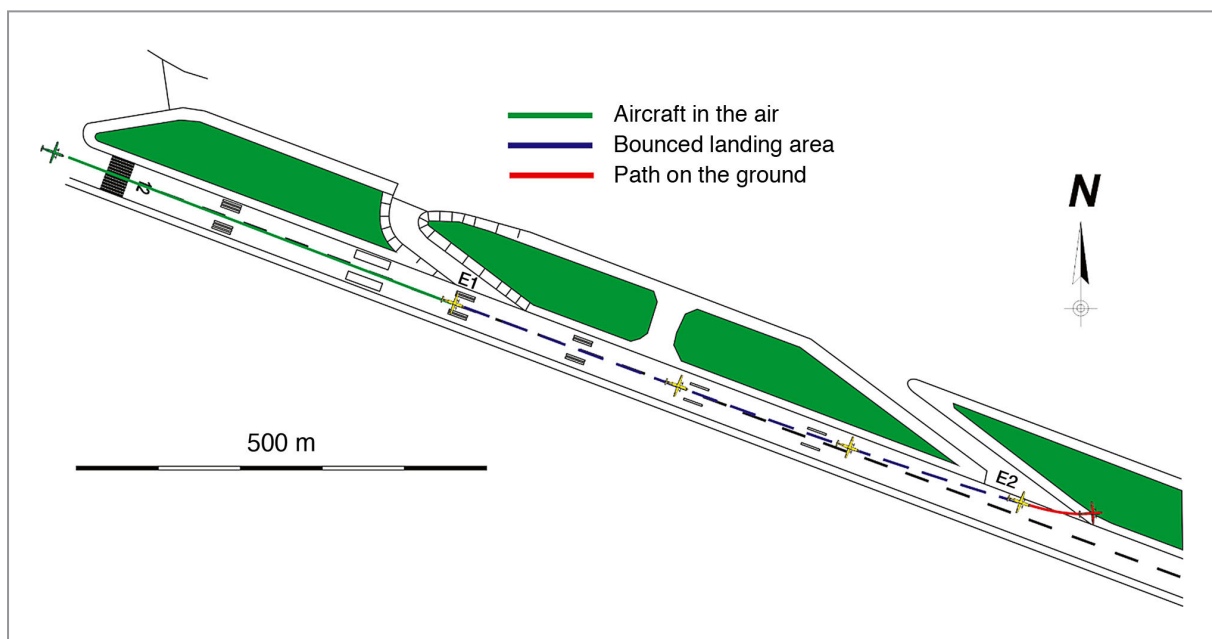
As the crew were close to touching down at the point on the runway near the E1 taxiway, their vertical speed was excessive, causing the aircraft to bounce several times and to divert to the left by the time they reached the E2 taxiway. Eventually the nose wheel departed the runway and rolled onto the grassy area to the left of runway 12 (see figure).

Figure 1. Diagram of the runway and aircraft's flight path (every element is to scale)

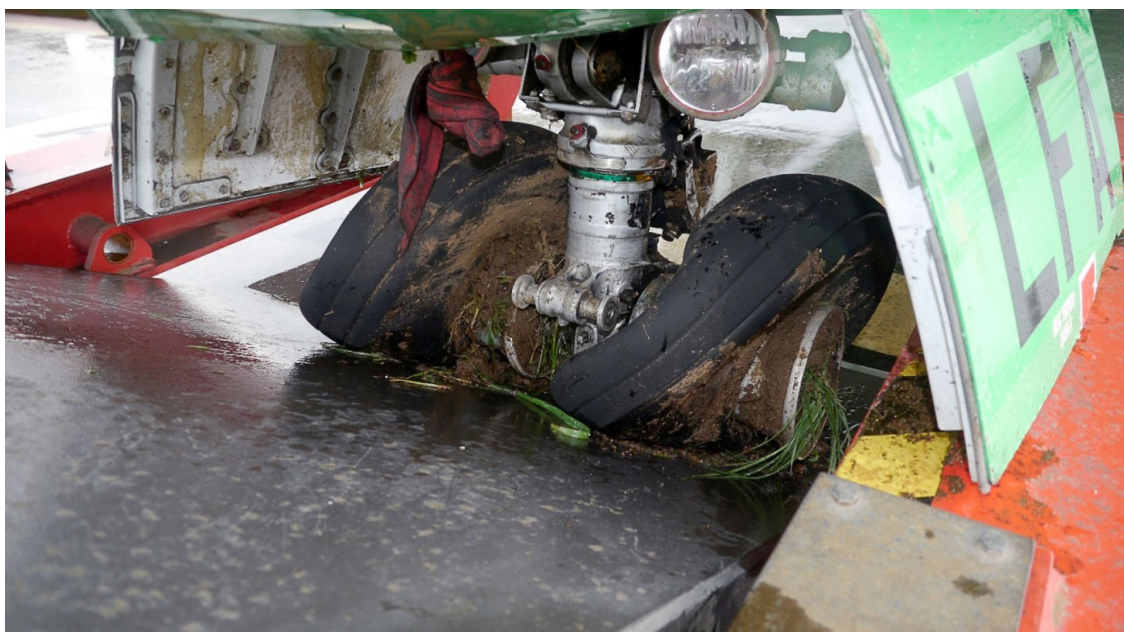
The aircraft's nose wheel was destroyed and there was damage to the main landing gear, specifically to the leg and strut on the left side.

Figure 2. Close-up of the nose wheel

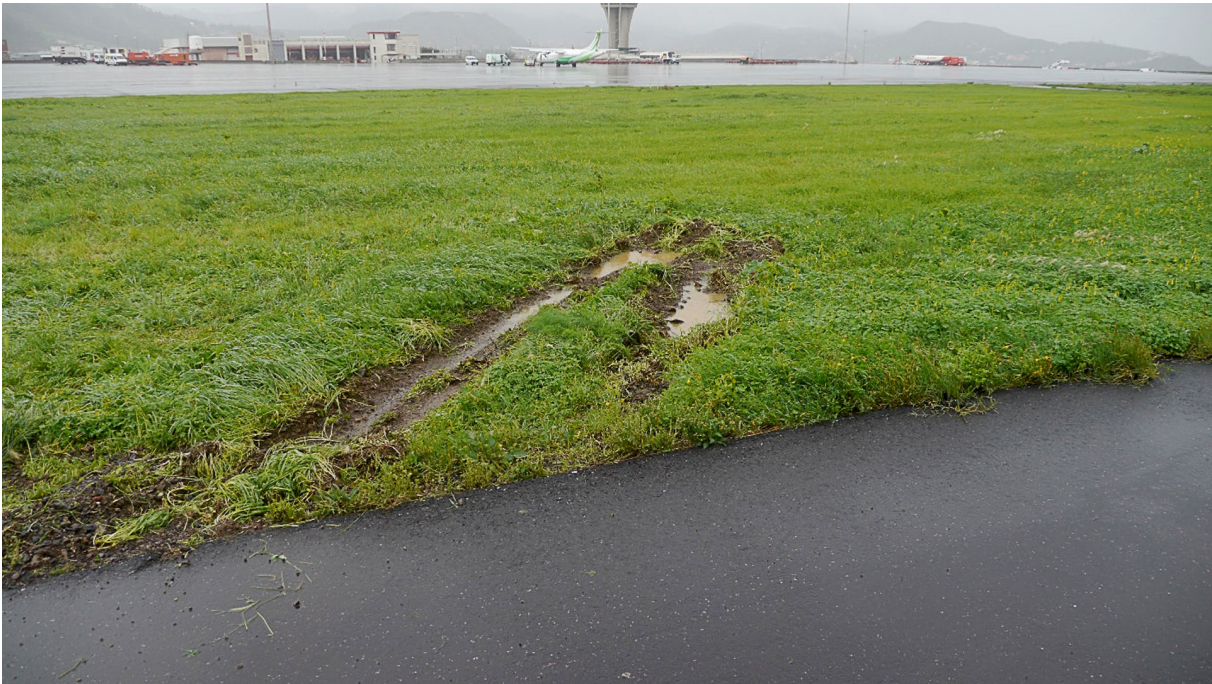
The aircraft sustained damage to its nose leg and to the left main landing gear only. During its landing run, the aircraft moved down the runway, with only the nose wheel exiting the runway and becoming stuck in a grassy area near taxiway E2.

Figure 3. Tracks left by the nose wheel on the ground

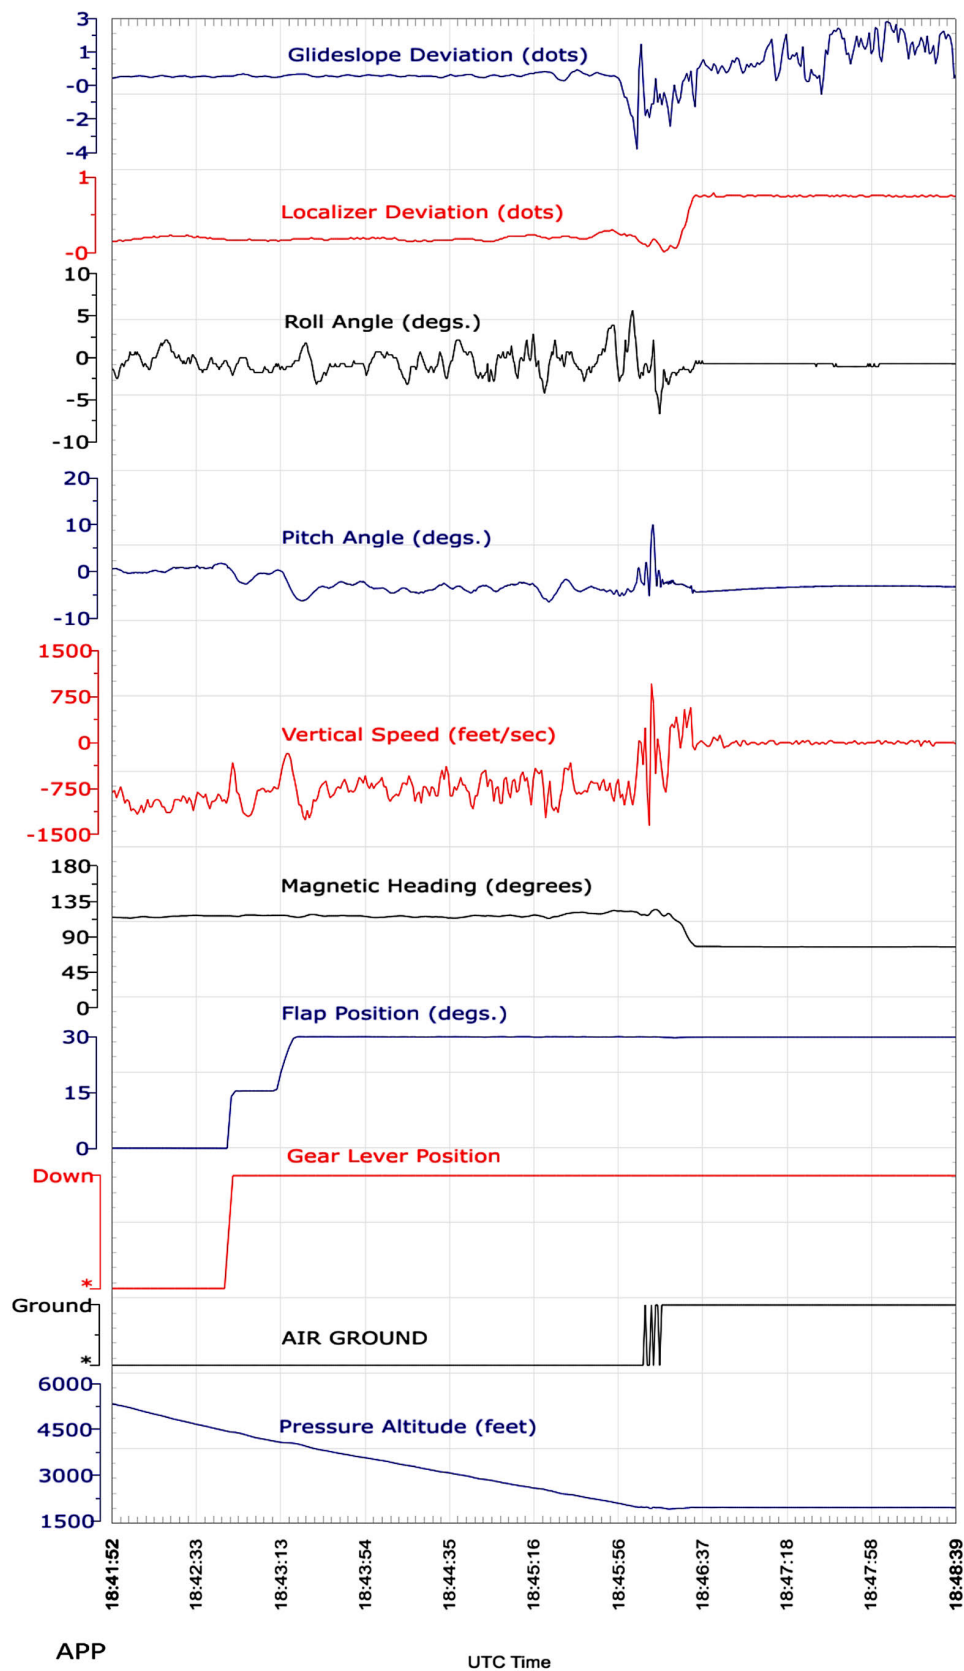
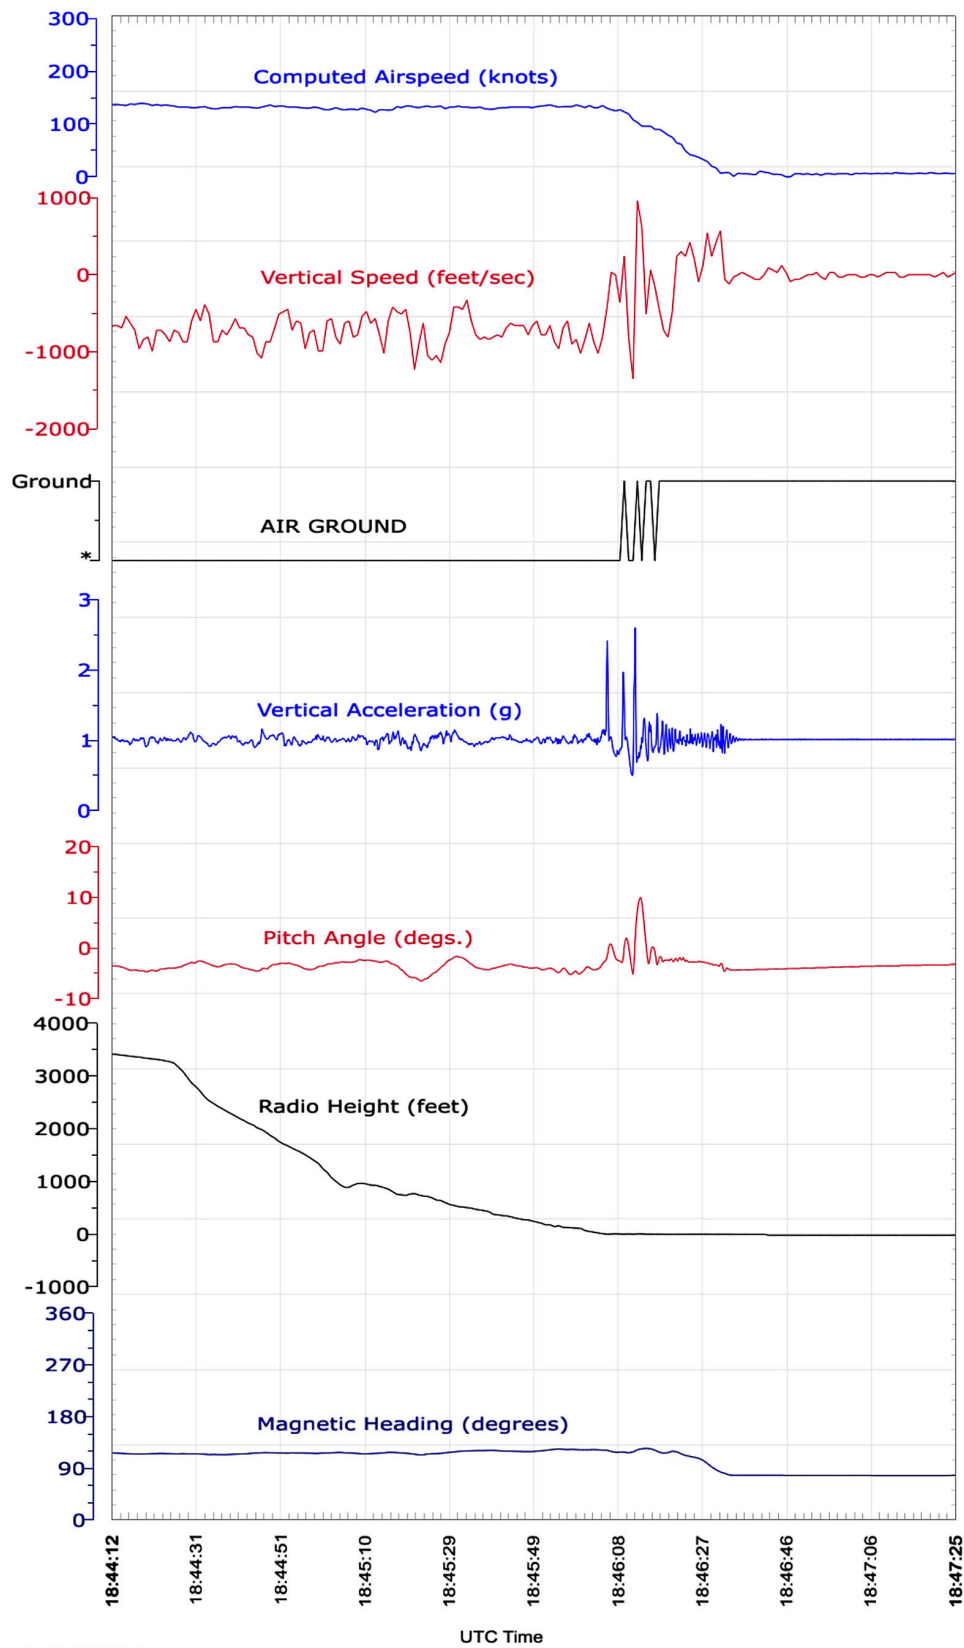
### **Flight data**

UTC Time	Remarks
18:45:19	At a radio altitude of 852 ft, the pitch angle went from +3° to -4° in six seconds.
18:45:59	Pitch angle -5°. Radio altimeter 114 ft.
18:46:04	Sink rate 1,200 ft/min. Pitch angle -5°. Radio altimeter 23 ft.
18:46:06	Possible contact with nose wheel. Vertical acceleration 2.41 g. Pitch angle -2°. Radio altimeter -2 ft. Sink rate 450 ft/min. Calibrated airspeed 130 kt.
18:46:10	Initial contact with main gear.
18:46:12	Maximum vertical acceleration 2.60 g.
18:46:13	Second contact with main gear.
18:46:14	Maximum pitch angle 10°.
18:46:15	Third contact with main gear.
18:46:18	Final contact.
