Report ULM A-005/2015

Accident involving an Air Creation
Kiss 450 GTE 582S aircraft,
registration EC-LGM, at the
Casarrubios del Monte aerodrome
(LEMT-Toledo, Spain) on 24 April 2015

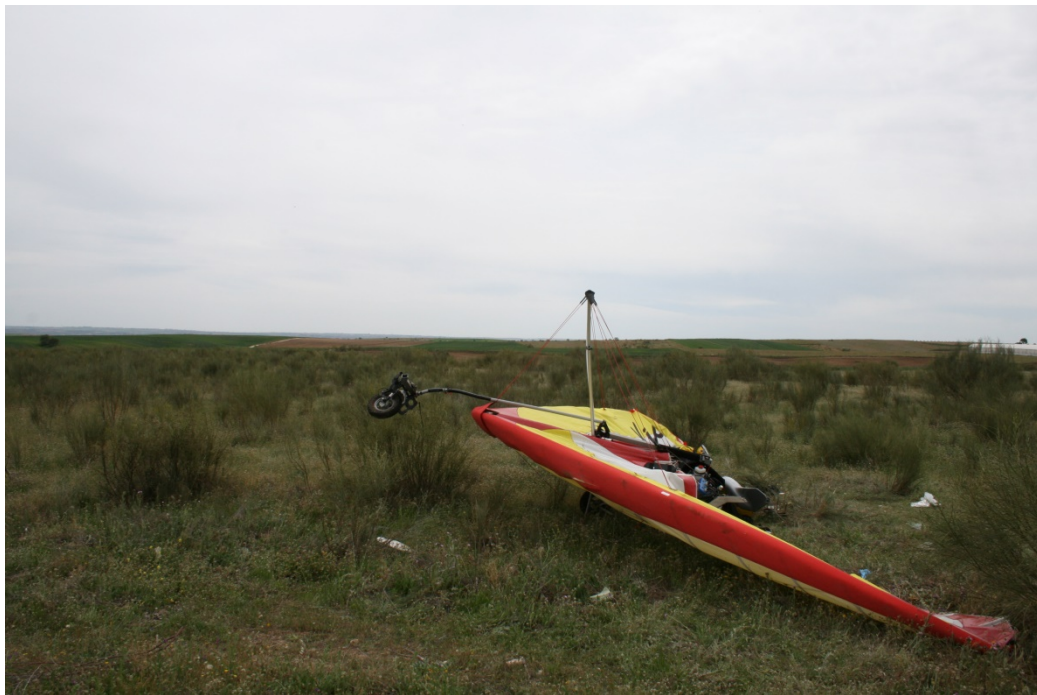
According to their statement, the occupants had been flying for about one hour practicing different maneuvers, since the following week (on Thursday, 30 April 2015) the student was scheduled to be tested. After these maneuvers, they did a touch and go on runway 26, and as they were climbing, they heard a noise and something they did not identify at first detached and struck the propeller blades. The student yielded control to the instructor (saying "yours") and the instructor attempted to fly straight to the end of the runway, where there were a few shrubs that he hoped would cushion the impact. Since they were just gaining height, he did not have enough speed to control the aircraft and the sail (the aircraft's wing) was not tensioned. Instead of continuing straight, and despite the instructor's efforts to steer the aircraft, it started turning left without gaining any altitude, until the main gear impacted some stacked metal sheets in an area where scrap metal was piled up. The aircraft then impacted the ground, seriously injuring the occupants. The aircraft was heavily damaged (see Photograph 1).

Photograph 1. Aircraft after the accident

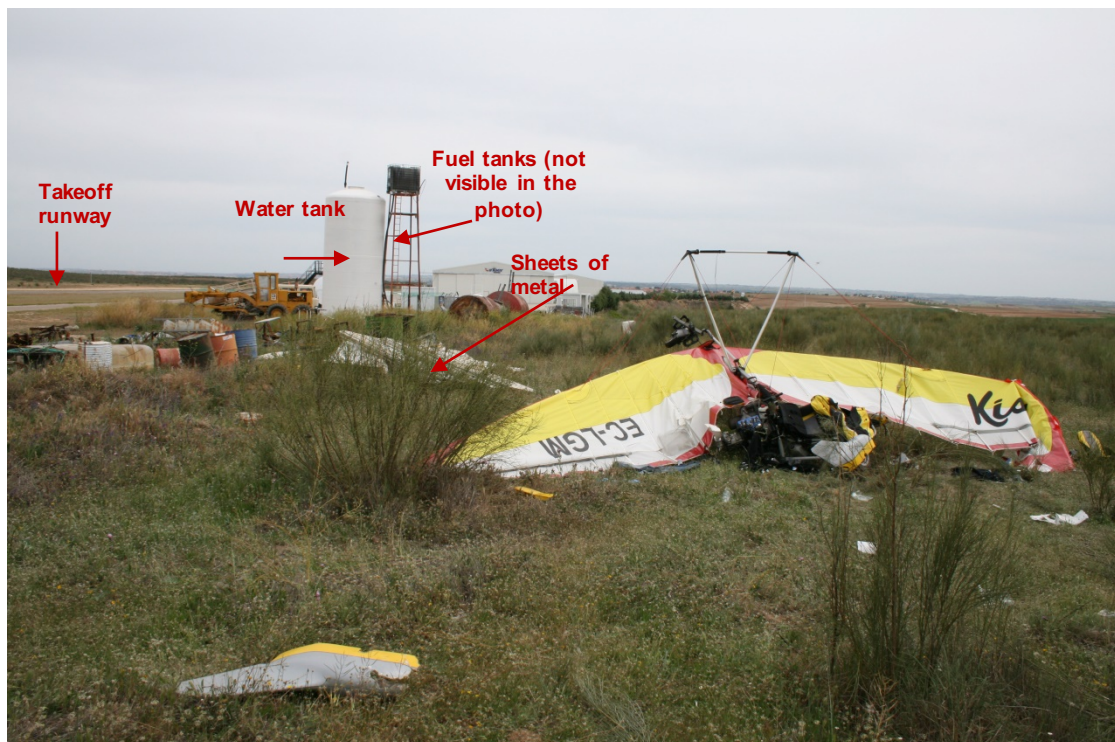
The accident aircraft was some 80 meters left of the runway 26 centerline (see Appendix A). During its takeoff run and a few meters off the ground the aircraft turned left and its landing gear impacted some stacked metal sheets, scattering them over the ground and causing the aircraft to flip (see Photograph 4).

Photograph 4. Condition of the aircraft after the accident

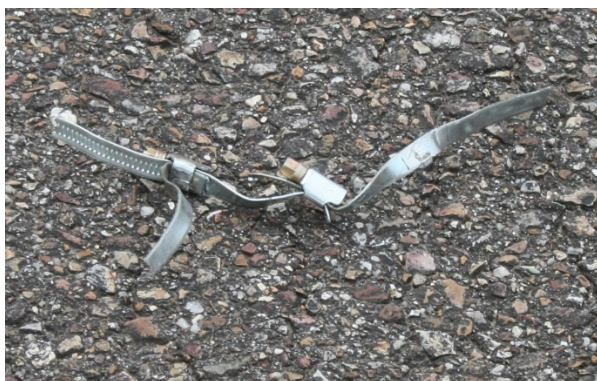
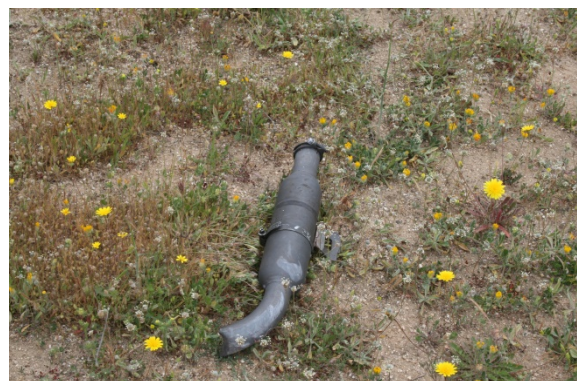
On the runway, one of the propeller blades and debris from the other blades were found starting at the displaced threshold markings (see Appendix A). Beyond this debris, at the edge of the runway and along the aircraft's likely trajectory, was one of the exhaust fastening clamps (consisting of two smaller clamps fitted together). The after-muffler was found between the runway and taxiway, with abrasion marks (see Appendix A and Photograph 5).

Photograph 5. Exhaust components found along the aircraft's path

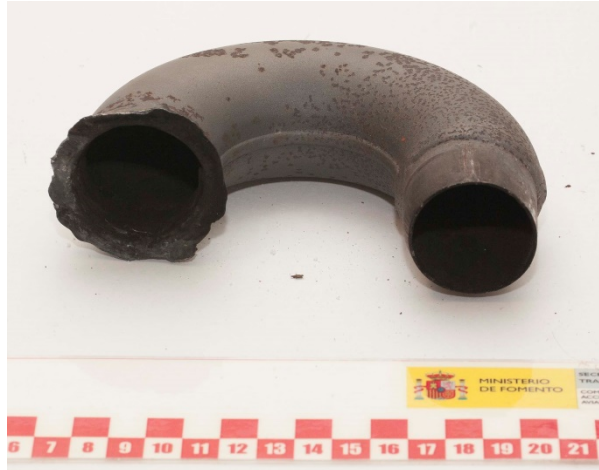
Aerodrome personnel turned in the elbow joining the muffler and the after-muffler, which was found in the taxi area adjacent to where the rest of the exhaust parts were found (see Appendix A and Photograph 6).

Photograph 6. Elbow from the exhaust system found by aerodrome personnel

The parts of the exhaust system that were broken were: the fastening clamp installed the day before (consisting of two clamps joined together), one of the wings from the butterfly-shaped fastening and support piece and the elbow where it welds to the muffler.

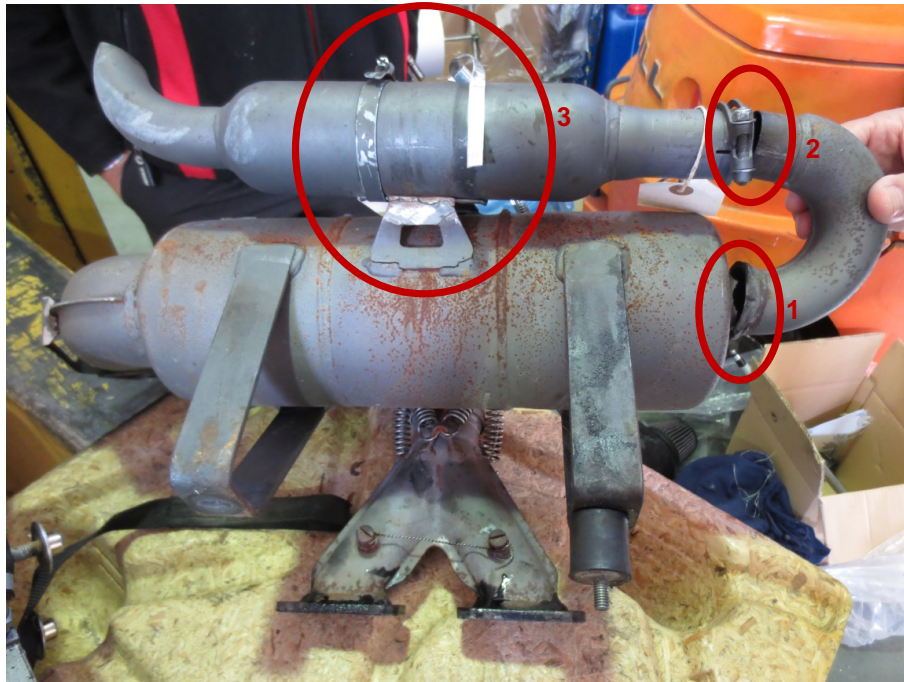
There was some evidence of leaks in the exhaust that suggested the absence of a good alignment between the engine block (cylinder outlet) and the exhaust.

When the exhaust system was checked as a whole, there were differences from the manufacturer's specifications (see Photograph 7):

Photograph 7. Reconstruction of the aircraft's exhaust system

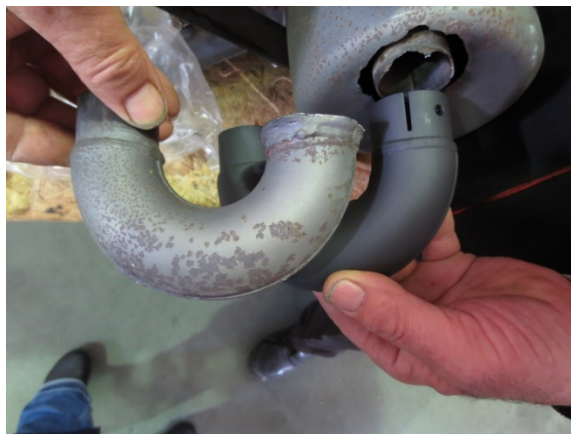
- The end of the muffler (1) was sheared and the elbow had been shortened where it meets the muffler. Instead of being attached using a clamp and pin, it had been welded directly.

Photograph 8. Comparison between the elbow on the accident aircraft's exhaust and a new replacement elbow

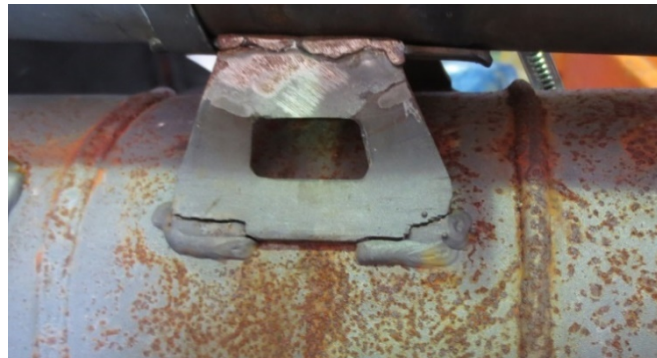
- The other end of the elbow, where it attaches to the after-muffler, was not secured using the pin, nor had it been drilled as described by the engine manufacturer (2).
- The butterfly-shaped part which supports the muffler and the after-muffler was welded to the muffler and supported by the after-muffler, to which it was attached using clamps (3).
- One of the wings on the butterfly had recently been sanded, prepared and welded again (3) presumably during last overhaul. According to expert personnel this welding has been properly done.

Photograph 9. Close-up of the recently prepared (sanded) and welded butterfly wing

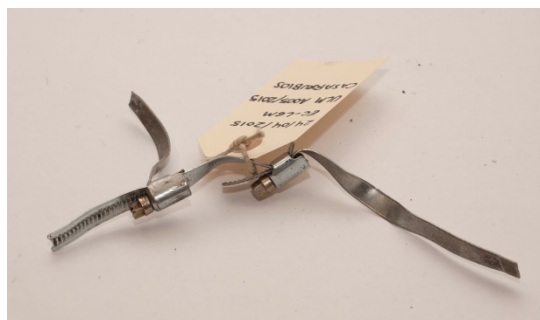
- The clamp holding the after-muffler to the butterfly that had been installed the day before and that had broken during the accident consisted of two smaller clamps joined together.

Photograph 10. Close-up of the cable tie replaced the day before the accident

- The school was not very active and only had the accident aircraft.
- The previous afternoon an exhaust system clamp was found to be missing, and was replaced with two shorter clamps.

- The combination of these clamps was not approved by the manufacturer of the aircraft.
- A crack in a weld for the butterfly-shaped part was also detected and largely ignored.

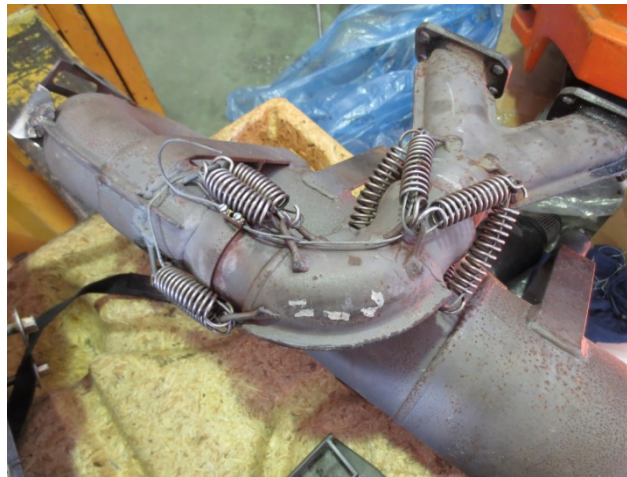
- There was twice the number of springs specified by the engine manufacturer in the part where the outlet of the engine block is connected to the muffler. There was also a wire connecting all the springs.

Photograph 11. Close-up of the multiple springs and the wire connecting them

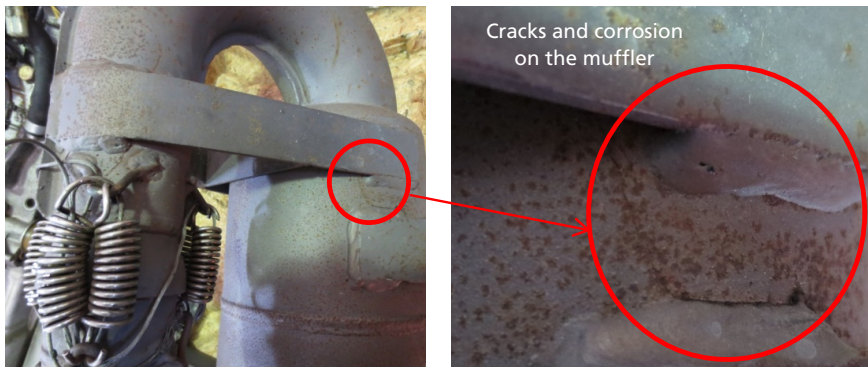
- There were cracks and signs of corrosion in the muffler.

Photograph 12. Close-up of the cracks and corrosion on the muffler

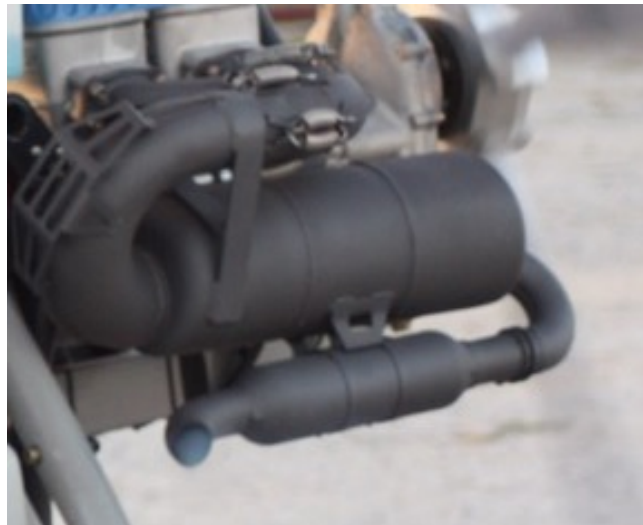
Photograph 13. Exhaust system on the aircraft just after it was purchased

The arrangement of the exhaust components was verified to be the same, though it was different from that specified by the manufacturer. The distributor said that the aircraft were assembled and tested in France, and in Spain they only underwent a test flight prior to being registered.

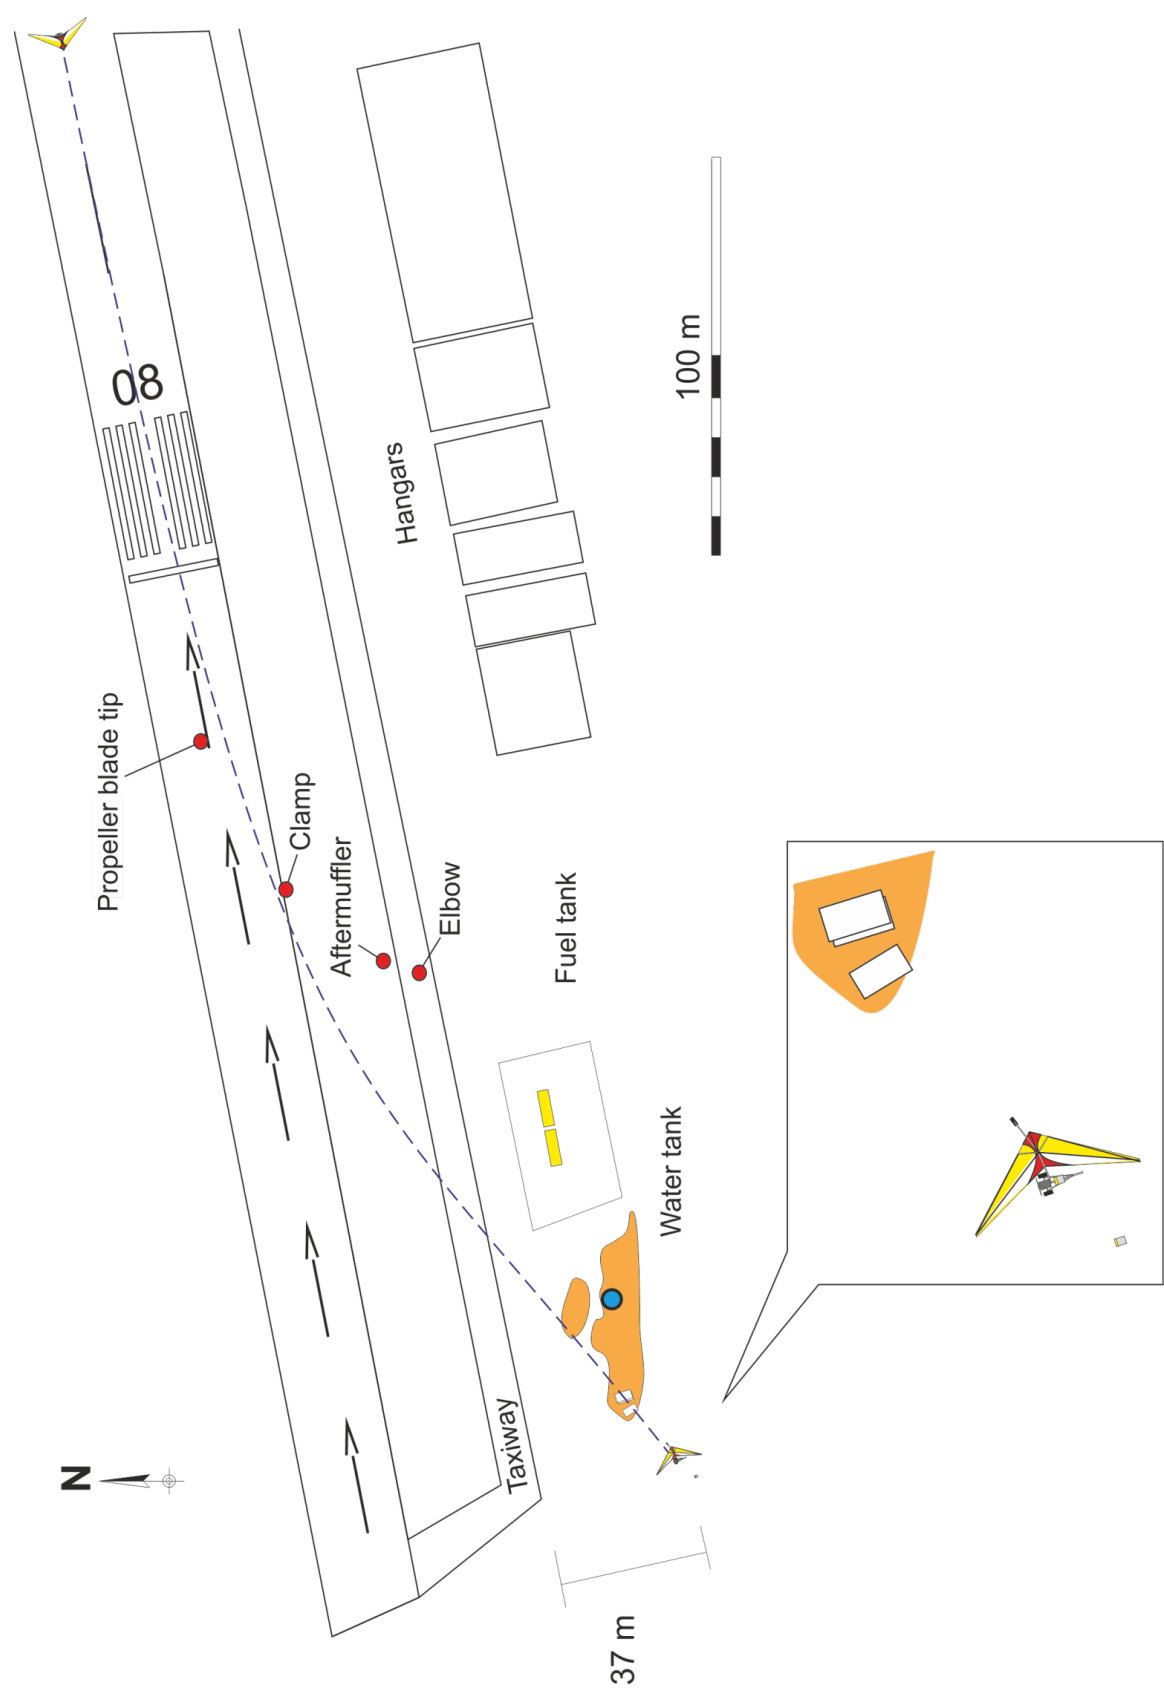
FLIGHT PATH AND MARKS LEFT ON IMPACT

During the onsite investigation, the recently replaced clamp and the after-muffler were found on the ground between the runway in use and the taxiway. Aerodrome personnel picked up part of the exhaust system² on the taxiway. All of the components were found along the route presumably taken by the aircraft (see Appendix A).

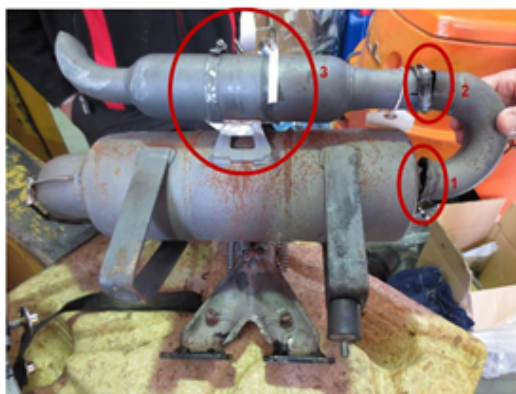
1 : Criques possibles au niveau des soudures du coude à la sortie du silencieux principal

2 : Collier de serrage maintenant le silencieux additionnel sur le coude

- Vérifier le système d'échappement et ses fixations avant tout vol.
- Pratiquer des inspections périodiques soigneuses comme indiqués dans les manuels (Air Création GTE503/582 notice d'utilisation et Rotax.582 manuel de maintenance).

Dans le cas où des criques sont détectées, arrêter les vols et contacter notre service après-vente pour la réparation ou le remplacement des pièces.
