Report A-014/2015

Accident involving a Hughes 369D aircraft,
registration EC-LXF, operated by
HELITRANS PYRINEES, in the ocean
3 NM east of Pinedo (Valencia, Spain)
on 19 May 2015

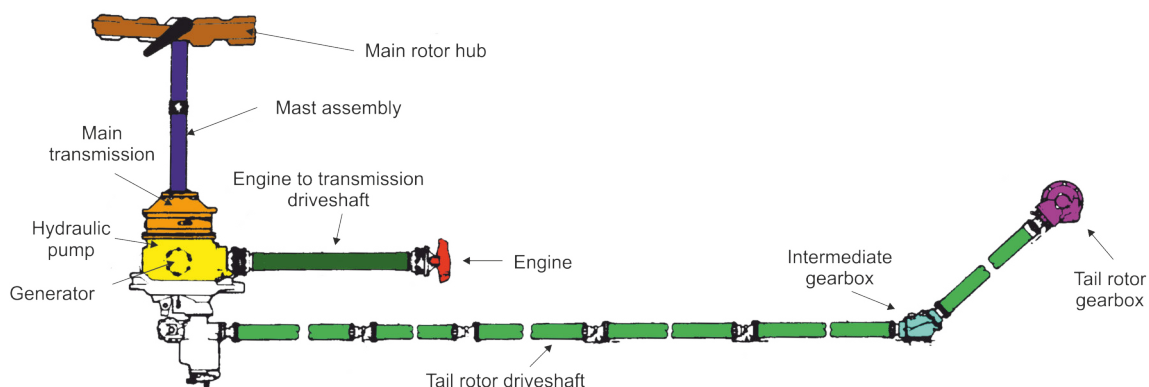
Figure 1. Diagram of the helicopter's transmission system

The engine power is sent to the main transmission through a shaft. This power is in turn transmitted to the tail, or countertorque, rotor via another shaft. There is a freewheel located on the shaft through which the engine supplies power. This freewheel rotates in one direction and prevents the main transmission from dragging on the main engine in the event of an engine stoppage, thus allowing the helicopter to autorotate.

The engine's power is transmitted to the main transmission through a shaft connecting the two. Based on the information provided by the helicopter's occupants, it is likely that the transmission of power from the engine to the main transmission through the shaft connecting them was interrupted. Since the helicopter wreckage could not be inspected, the cause of this interruption in power could not be determined.

The most probable cause of the accident is an interruption in the transmission of power from the engine to the main transmission through the shaft that joins them.

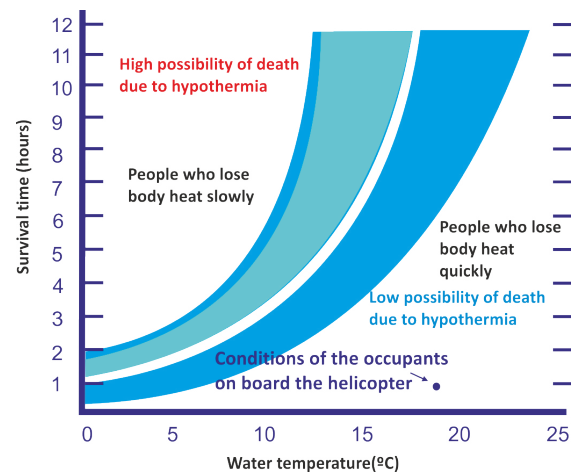
Figure 3. Hypothermia graph

On its website, Marine Rescue states that one of the main obstacles to surviving in water is hypothermia, which is when the body temperature falls below 37.5°. The same website contains a graph relating water temperature to survival time in hours (see Figure 3).

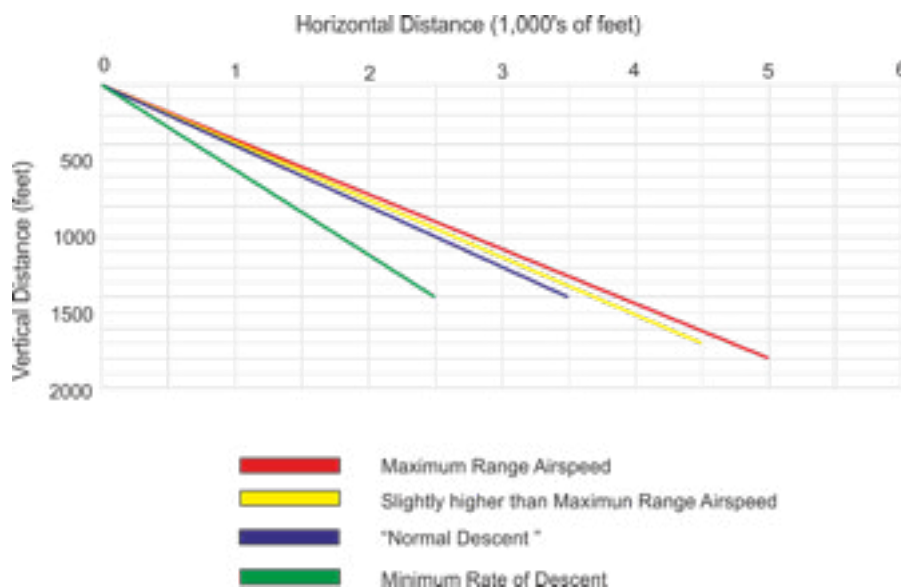
Figure 4. Descent angles

Figure 4⁷ shows an example of descent angles for several speeds, ignoring the effect of the wind; in other words, the horizontal distance that the helicopter could travel for a given initial altitude using the autorotation technique.

According to the helicopter's radar return, it was flying 700 ft over the ocean surface, which in the figure translates to a horizontal distance of between 1300 and 2000 feet, depending on the speed. This is equivalent to between 0.2 and 0.33 NM. The wind and the individual characteristics of each helicopter model can alter this calculation, meaning these data are only approximate.

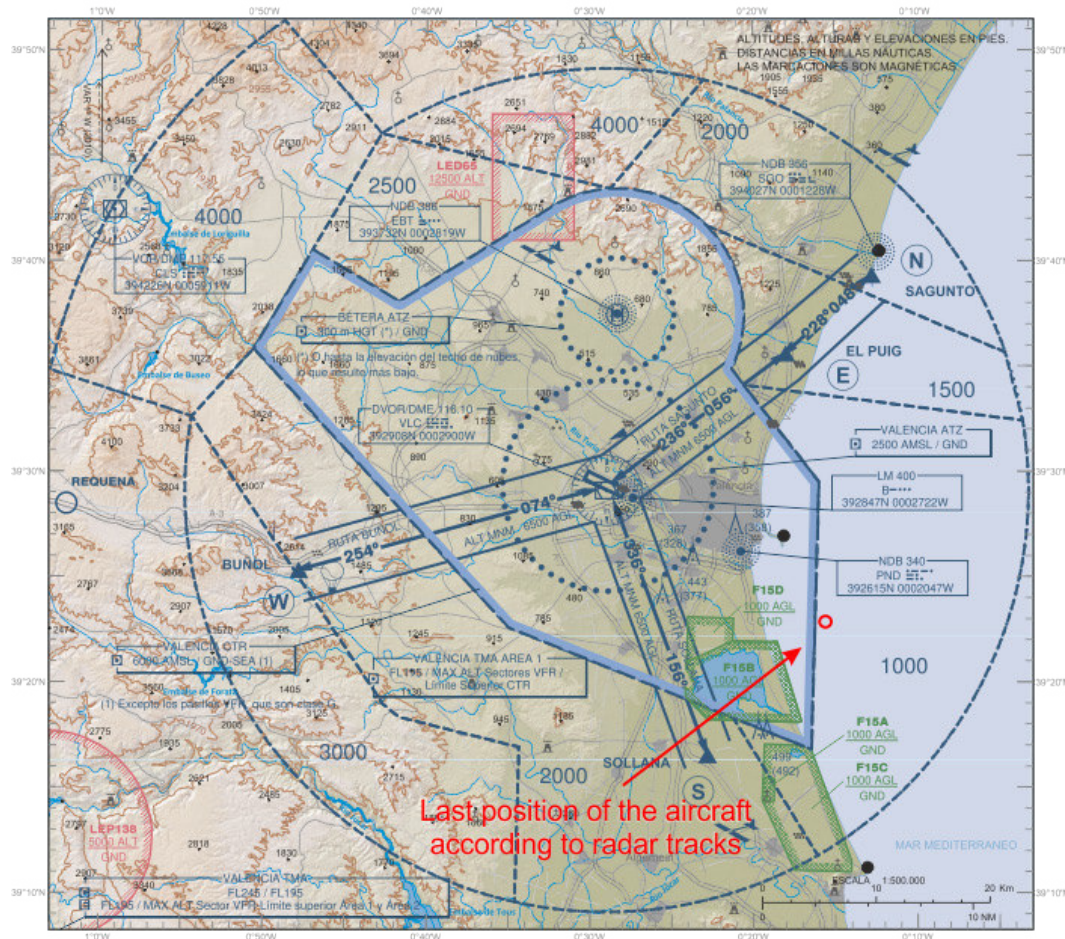
The chart in Figure 5 shows the approximate location of the helicopter based on its last known radar position. The visual sector in which the helicopter was flying at the time had a maximum altitude of 1000 ft. The radar return showed that the helicopter was flying at an altitude of 700 ft at the time of the failure.
