Report A-017/2015

Accident involving a TECNAM P2002JR
aircraft, registration EC-KQG, at the
Griñón airfield (Madrid) on 30 June 2015

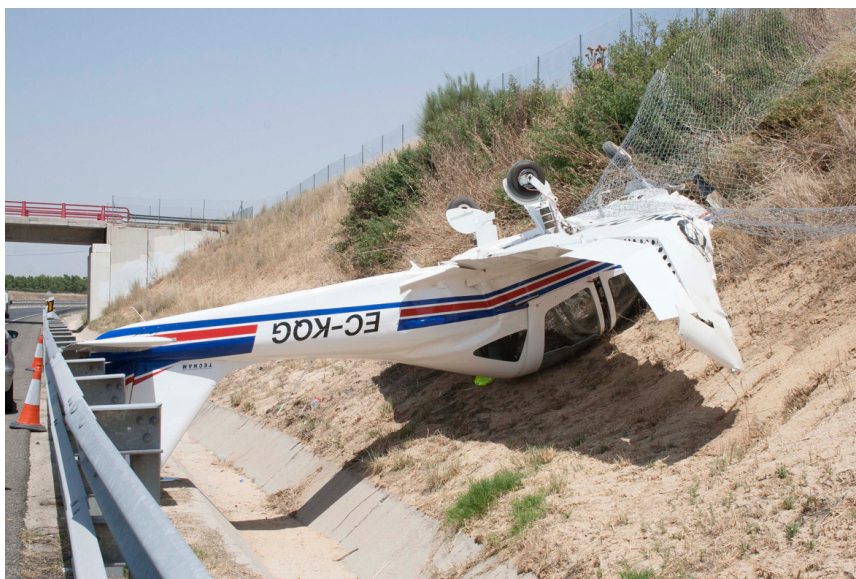
Photograph 1. Aircraft after the accident

The aircraft sustained heavy damage (see Section 1.12., Wreckage and impact information).

The investigation team reported to the accident site immediately. The aircraft was overturned on the side of the road, behind the guard rail with the tail assembly

resting on the rail. The nosewheel was caught on the perimeter fence, between the ditch and the embankment at the side of the road. The tip of one of the propeller blades was also caught on the fence. There were two notches on it and it was cut halfway along its length. The other blade was intact. The flaps were deployed about 30° (halfway between the takeoff (15°) and landing (40°) flaps positions). The Hobbs meter reading was close to 44.6.

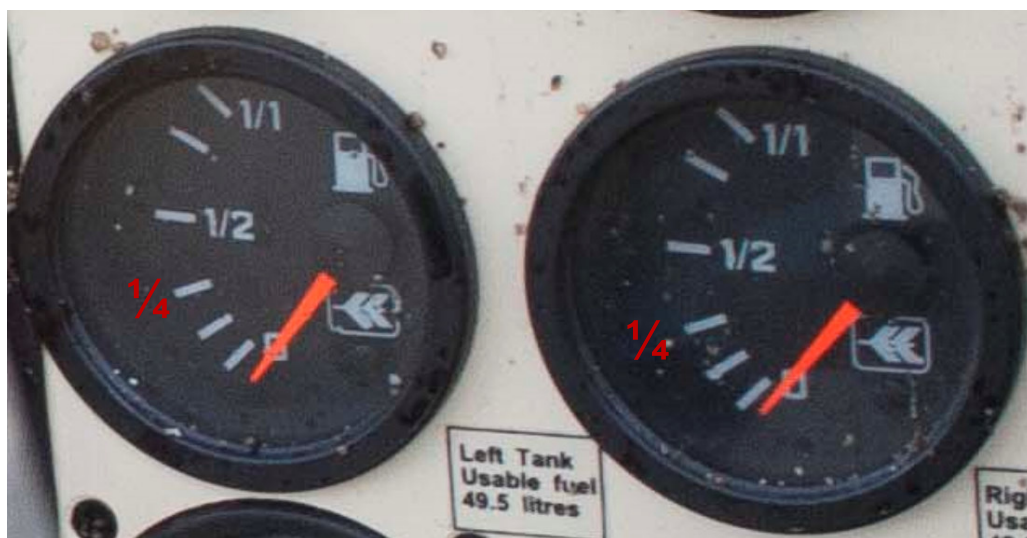
Photograph 3. Cockpit fuel gauges

Based on this information, and if the $\frac{1}{2}$ mark corresponds to 25 l, the second mark between 0 and $\frac{1}{2}$ would correspond to $\frac{1}{4}$ full, or 12.25 l (+/- 5 l), as per the manufacturer's information.

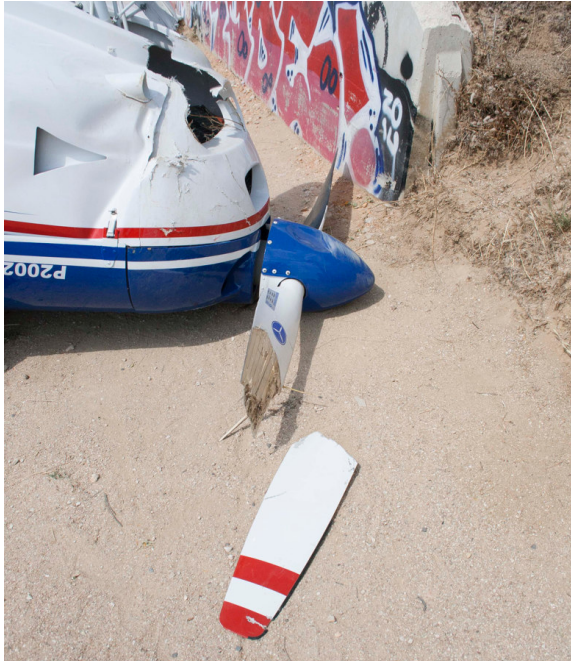
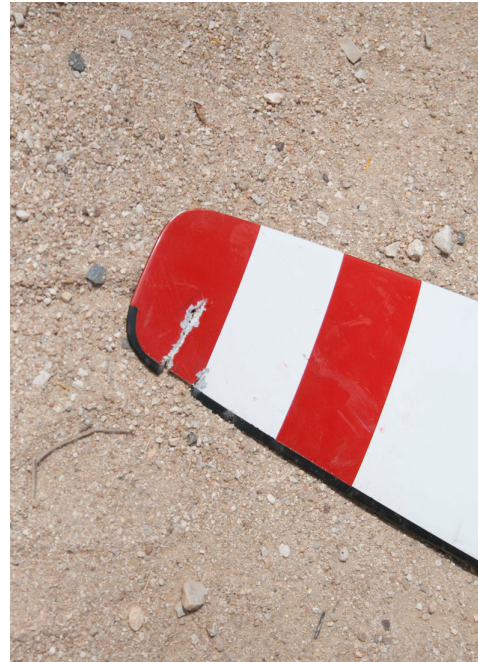
Photograph 5. Propeller after the accident

It was not possible to determine if the engine behaved strangely at some point in the flight, though it is not thought that it stopped completely since it would have been at idle during the final phase of the landing.

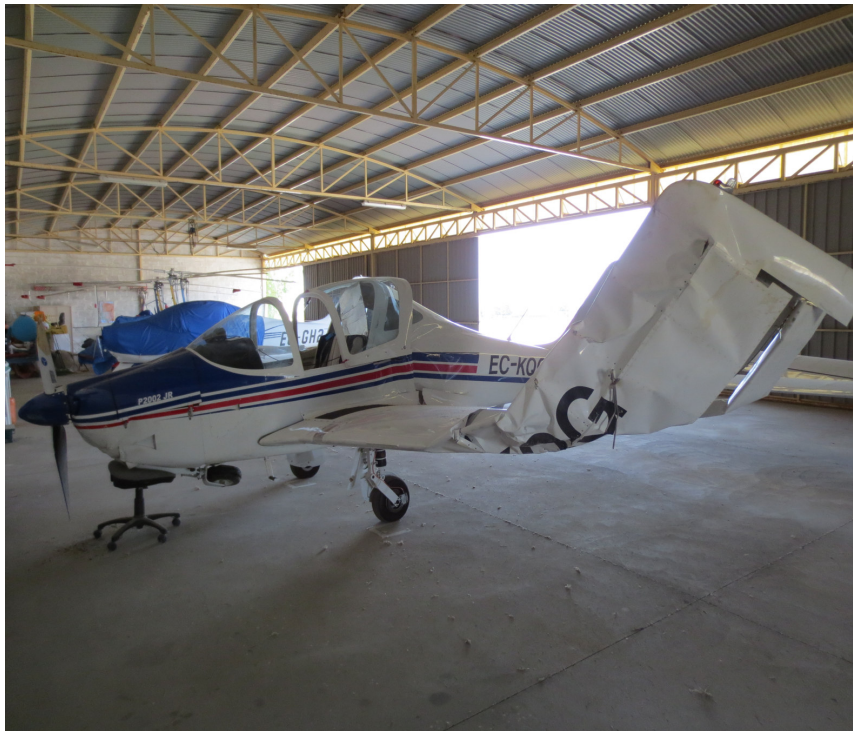
Photograph 6. Inspection of the aircraft in the hangar

The fuel tanks were inspected once more to search for possible leaks. Both tanks were empty. The three drains (from which the fuel samples had been drawn at the accident site) were still closed, as were the access plugs to the tanks. Since the tank in the left wing was deformed (see photograph 7), the inside of the wing was checked visually with a flashlight to ensure that the damage had not reached the wall separating the tank and the rest of the wing. The vents and overflows at the wingtips were in good condition with no obstructions.

fuel on it. They checked for potential leaks. All three fuel drains (one in each wing and one in the filter underneath the engine) were closed tight. The access plugs on the tanks were also closed. The vents and overflows on the wingtips were in good condition with no obstructions. The fuel tank selected in the cockpit was the right tank. The electric fuel pump was not on. The investigators then proceeded to draw samples. They got almost no fuel from the right tank and about 20 cl from the left tank. No contaminants were visible in either sample. The overflow fuel in this aircraft is routed to the left tank. In this case the pilot had selected the right tank, meaning that all the overflow fuel went to the left tank, which was found with more fuel in it. Only a few drops fell from the engine drain. Since the tank in the left wing was deformed, it was checked visually using a flashlight. A subsequent inspection of the inside of this wing revealed that the damage had not affected the wall separating the tank and the rest of the wing, meaning no fuel had been lost from that tank.

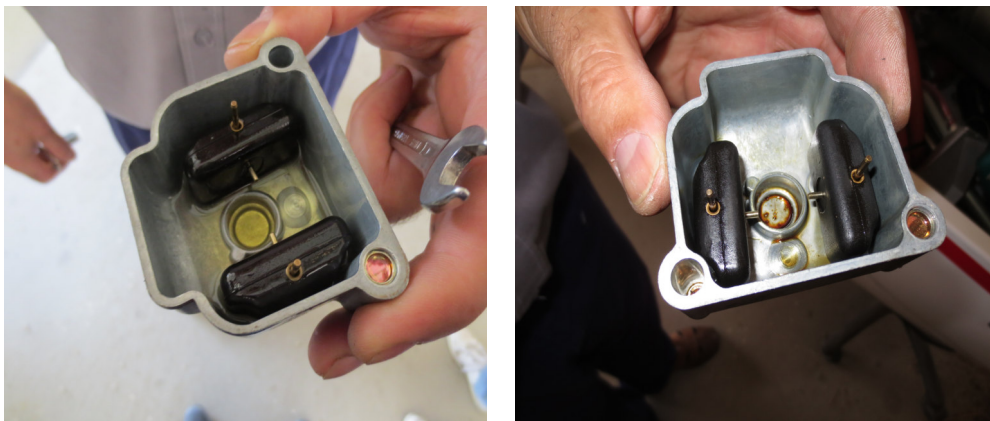
Photograph 7. Left (LH) and right (RH) carburetors

The fuel system was inspected. Both pumps were in good condition and had fuel. The left carburetor (as seen looking forward) had some fuel. The right carburetor did not have any fuel and it had deposits. The right carburetor is the one that was inspected during the field inspection, at which time it had some fuel, meaning it probably evaporated during that inspection.

Any overflow fuel in this aircraft is sent to the left tank. In this case the pilot had the right tank selected, meaning that all the overflow fuel filled the left tank, where investigators found about 20 cl of fuel.

The fuel system was inspected during a subsequent inspection. Both fuel pumps were in good condition and they had fuel. The left carburetor (as seen looking forward) had some fuel. The right carburetor had no fuel and some deposits. This is the tank that had been checked during the field inspection, when some fuel was found inside it, meaning that the fuel probably evaporated following that inspection. In both cases, the amount of fuel present was lower than would be considered normal.

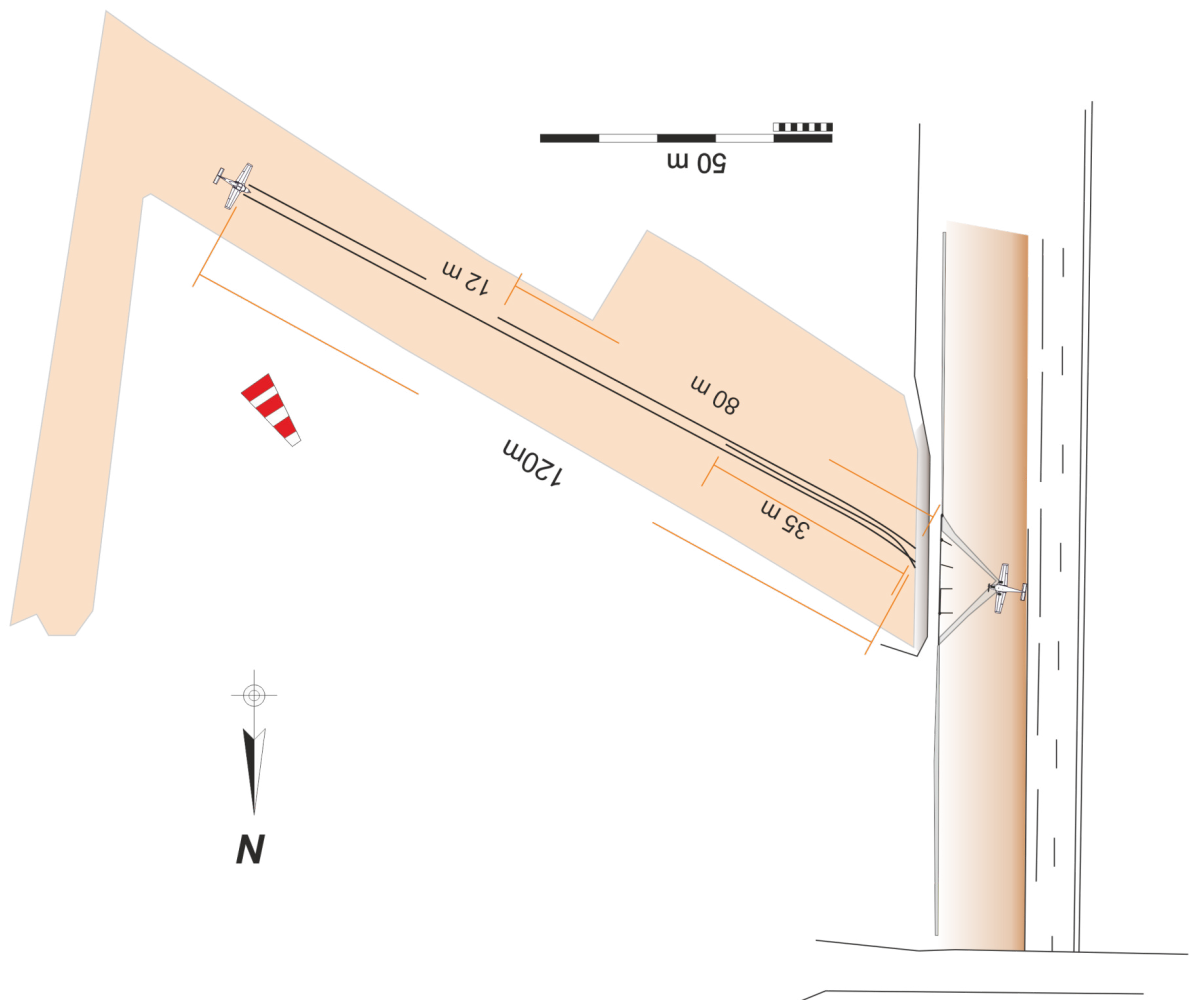
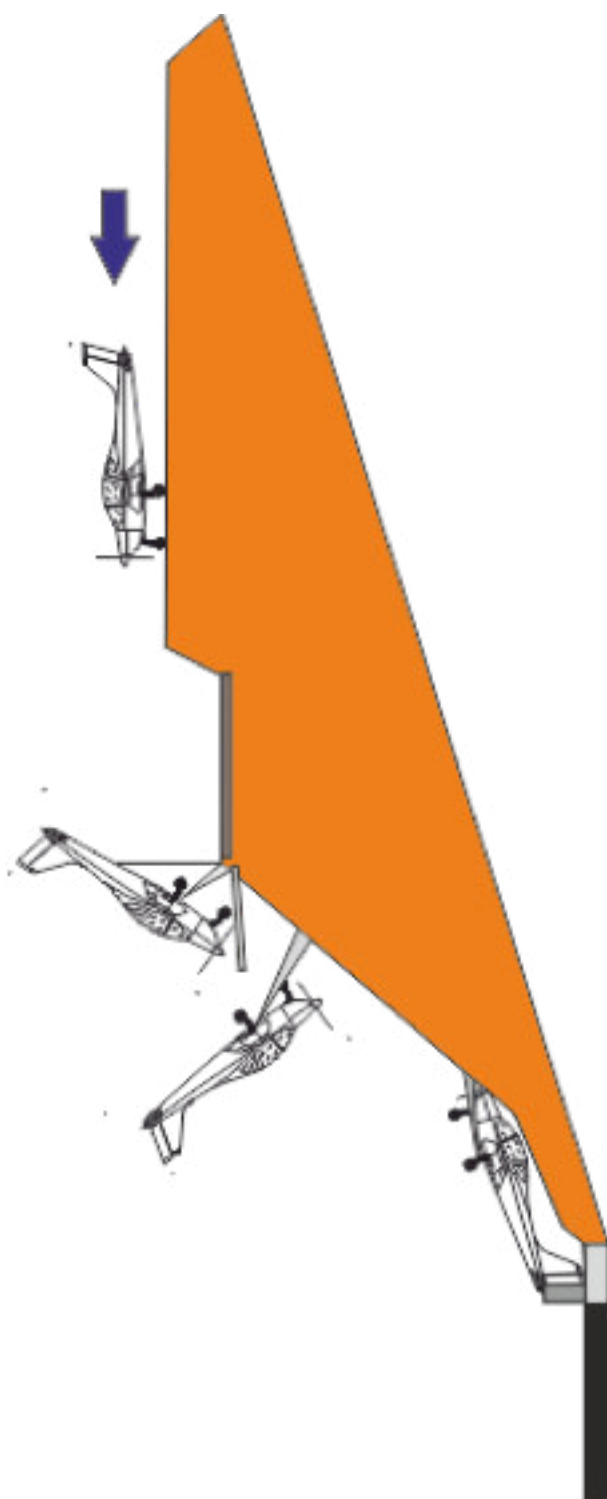
PATH TAKEN ON THE GROUND AND MARKS LEFT

The tracks left on the runway during the landing were measured and confirmed to start some 120 m before the end of the runway (see Appendix A).

- The landing distance for the altitude and temperature conditions present was 334 m.
- The distance traveled by the aircraft before running out of runway was 120 m.
