Report IN-033/2015

Incident involving an Airbus A-330-300,
registration EC-LZX, operated by Iberia,
and a Boeing B-777-200,
registration N758AN, operated by
American Airlines, at the Adolfo Suárez
Madrid-Barajas Airport (Spain)
on 6 December 2015

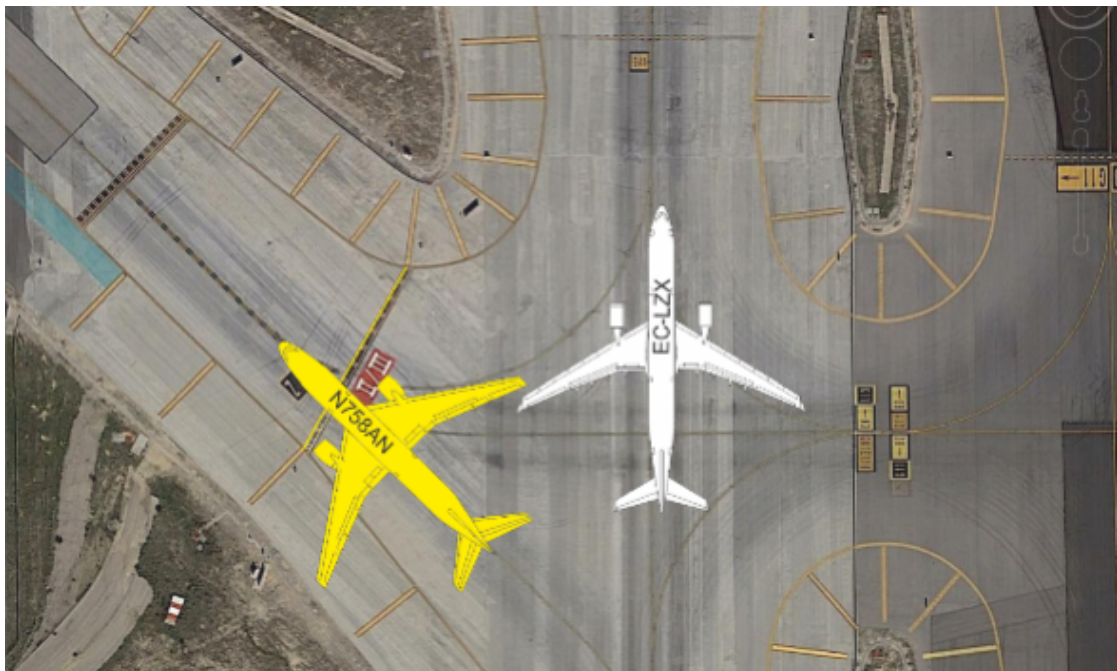
The Airbus A-330-300, registration EC-LZX, operated by Iberia, had landed on runway 32L inbound from the Miami Airport (United States) on flight IBE6118. Its crew had been instructed to taxi on standard route B to gate 12. As it reached the intersection of taxiways B2, B3 and Z1, the left wing on the A-330 struck the right elevator on the B-777, registration N758AN, which was stopped at Z1, causing a crack on its lower surface. The A-330 continued taxiing and moments later a second impact took place, as the left winglet on the A-330 struck the trailing edge of the right wing on the B-777. The winglet penetrated about halfway into the wing until it broke off, with the detached winglet component becoming embedded in the wing of the B-777.

Figure 1. Diagram of the aircraft positions at the time of the impact

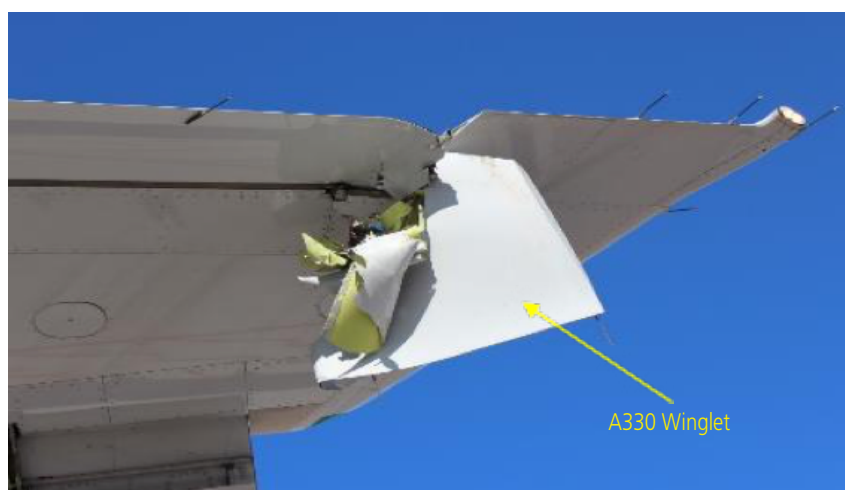
Figure 2. Right wingtip of the B777 with part of the embedded A330 winglet

The B777 aircraft, registration N758AN, sustained minor damage to its horizontal stabilizer and right elevator, as well as to its right wing.

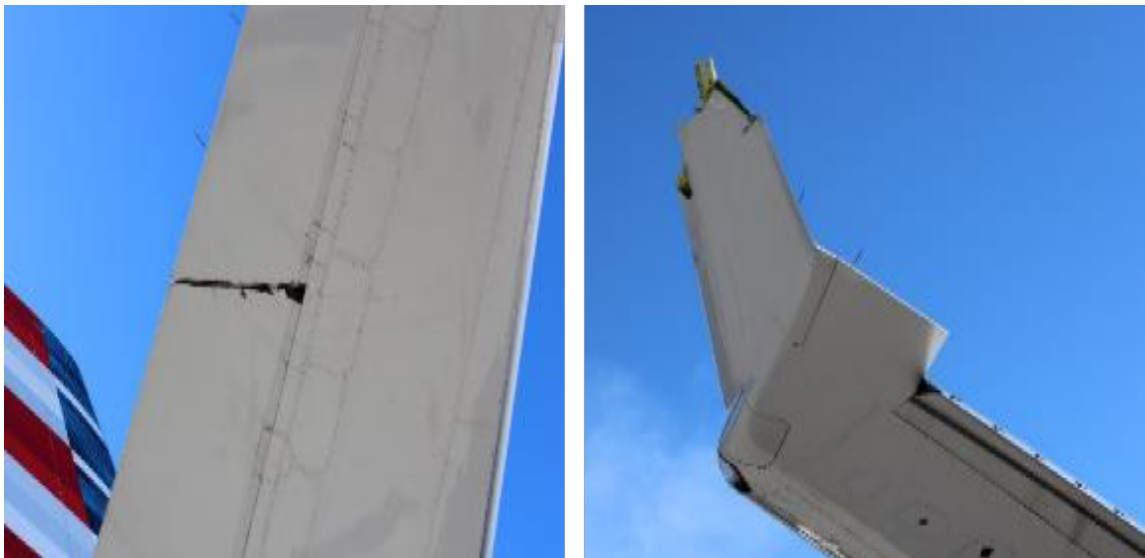
The aircraft's left winglet was broken by the impact against the right elevator and wing of aircraft N758AN.

When the winglet was removed from the left wing, it was noted that the wing's support structure had sustained minor damage which required repairs.

Figure 3. Photograph of the cut in the right elevator of aircraft N758AN (left) and of the left wingtip of aircraft EC-LZX (right)

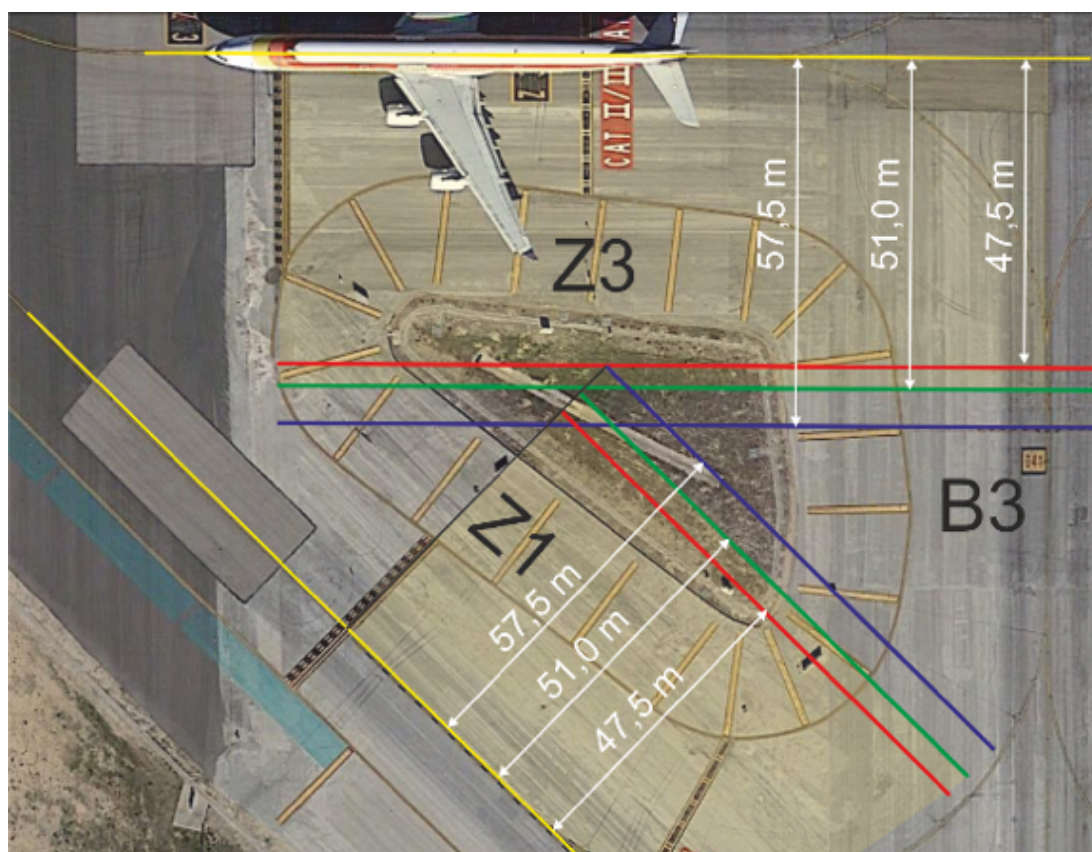
Figure 4 contains an aerial photograph of the 36L threshold area, which shows the length between the edge and the middle of the strip for taxiways Z1 and Z3 for the purpose of seeing if there is any interference or overlap.

Figure 4. Photograph of taxiways Z1 and Z3, showing the distance from the edge to the centerline associated with codes E (as per RD 862/2009) and F (as per RD 862/2009 and CS-ADR-DSN)

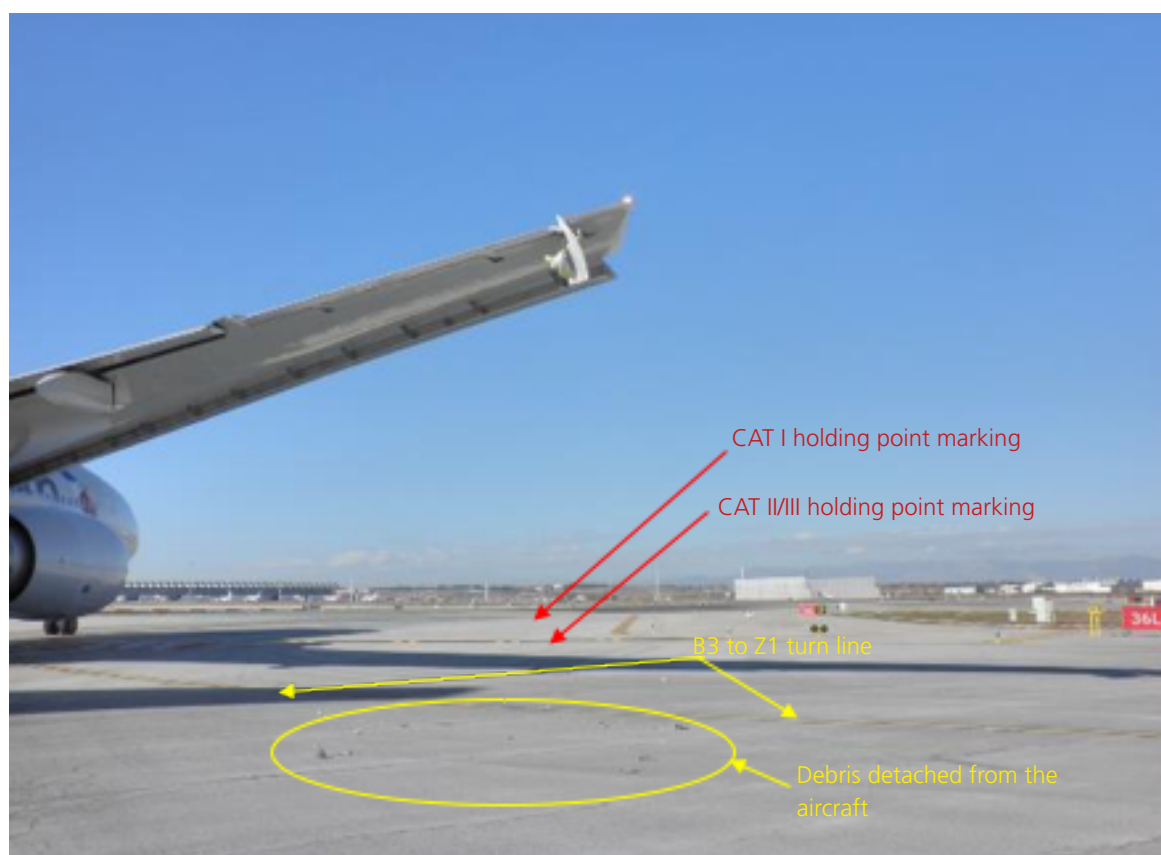
Figure 14. Photograph of aircraft N758AN on taxiway Z1, taken before it was moved and after being impacted by aircraft EC-LZX

Figure 14 shows a photograph of aircraft N758AN, taken at the site where the impact occurred before it was moved after the incident.

As noted in point 1.12, the photograph of the aircraft taken before it moved reveals that its nosewheel was a few meters beyond the category II/III holding point marking. The fragments that detached during the event were found on the pavement in the vicinity of the place where the B3 to Z1 turn line and the extended right edge line for taxiway Z1 would intersect.

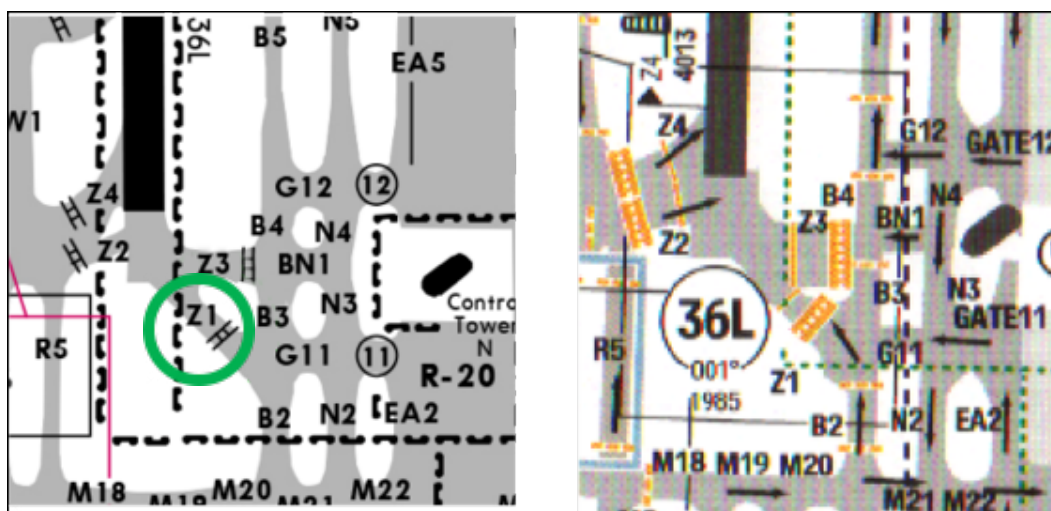
The documentation available to the crew of the incident aircraft was inspected. It was noted that on pages, 10-9C, "taxi routings", and 10-9E, the Z1 holding point is shown with a single holding point marking, as the crew of the American Airlines aircraft had stated (see 1.16.1.2).

Figure 16. Portion of page 10-9C of the Jeppesen documentation (left) and of the AGC North chart from the LIDO documentation LIDO (right)

REC. 15/17. It is recommended that Jeppesen review the information published in the AIP-Spain that is not included in its documentation, and that it incorporate which could be operationally important, such as the note in the airport chart indicated in this report.

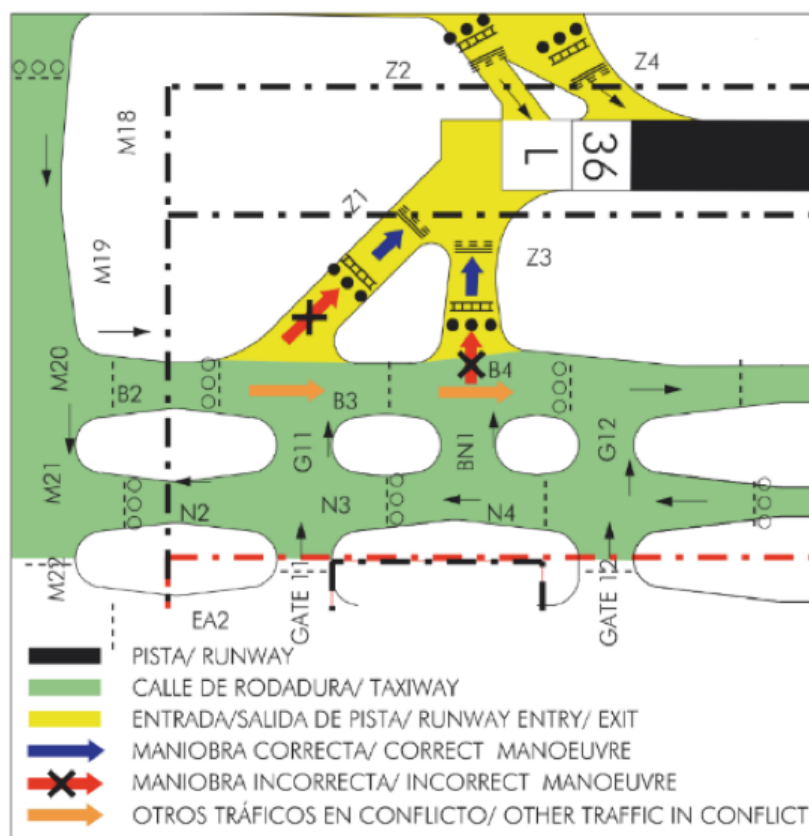
- Measures adopted:
 - o Modification to holding points (approved in October 2015). The existing CAT II/III holding points on the four runways will be removed, due to their

exclusive use. The CAT II/III holding points for runway 18L-36R will be removed in the spring of 2017. The actions involving the remaining points to be removed will be carried out in subsequent years. There are no detailed plans as of the writing of this report.

Figure 19. Information on the hotspot for holding points Z1 and Z3 published in AIP-Spain

- o Until the holding points are modified, the holding points LA, LB, Z1 and Z3 will be included in the listing of hotspots in the AIP.

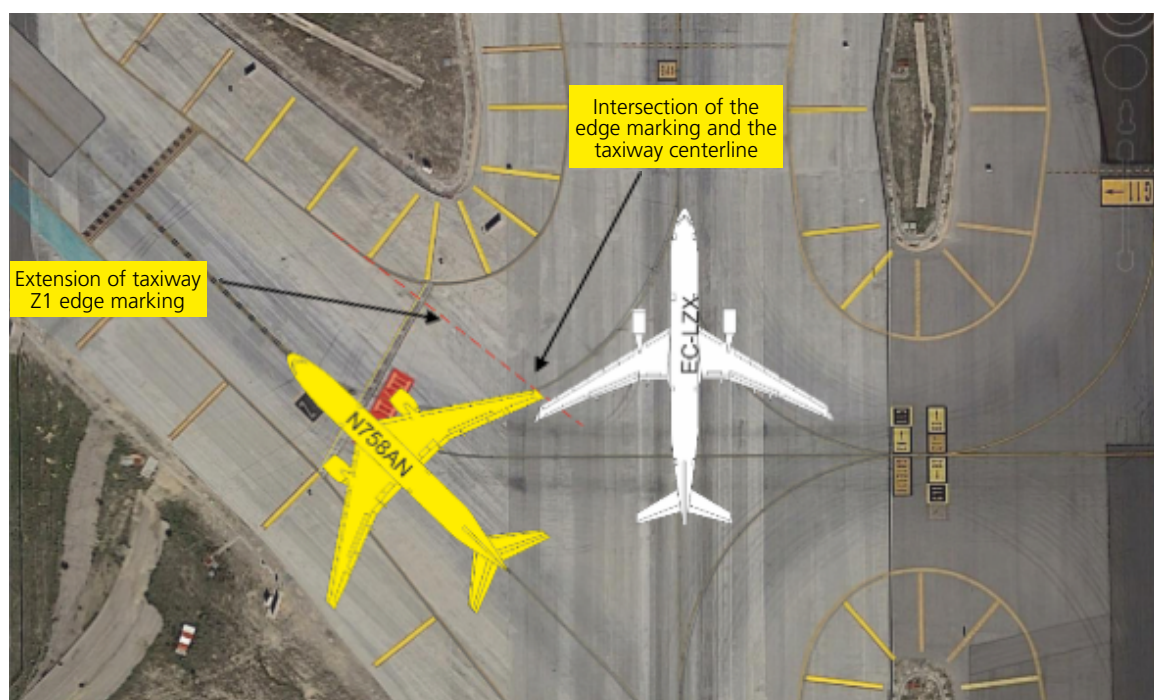
This same figure shows aircraft N758AN such that its right wingtip is over the intersection of the markings specified in the above paragraph. In this position, the front part of the aircraft would be some 40 m away from the holding point marking.

Since the CAT I and CAT II/III markings are 60 m apart, it follows that under these conditions, the front of the airplane was 20 m forward of the CAT II/III marking.

Figure 20. Diagram of the probable positions of the two aircraft at the time of the collision

The nosewheel is 5.89 m behind the front tip of the aircraft, meaning that under the conditions in question it would have been 14 m forward of the CAT II/III marking.
