**COMISIÓN DE
INVESTIGACIÓN
DE ACCIDENTES
E INCIDENTES DE
AVIACIÓN CIVIL**

Report IN-034/2015

Incident involving two Cessna 172 S aircraft, registrations LY-BCF and D-EXAH, both operated by Aerojet Baltic, in the vicinity of the Valencia Airport (Spain) on 9 November 2015

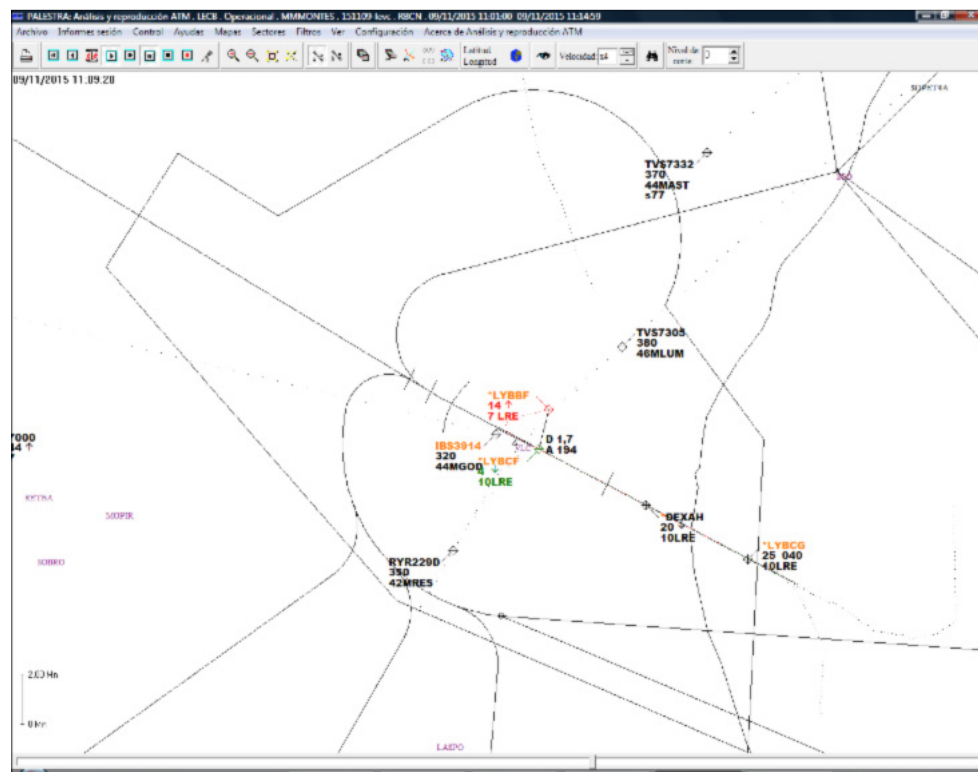
Figure 1. Positions of the aircraft at 12:09:20

By 12:09:20, LY-BBF had already made its low approach to the Valencia Airport. LY-BCF was descending to make its low approach and D-EXAH was approaching runway 30, followed by LY-BCG. It was then that the horizontal separation between LY-BBF and LY-BCF was lost, the two aircraft being 1.7 NM apart horizontally. Their vertical separation was 1000 ft.

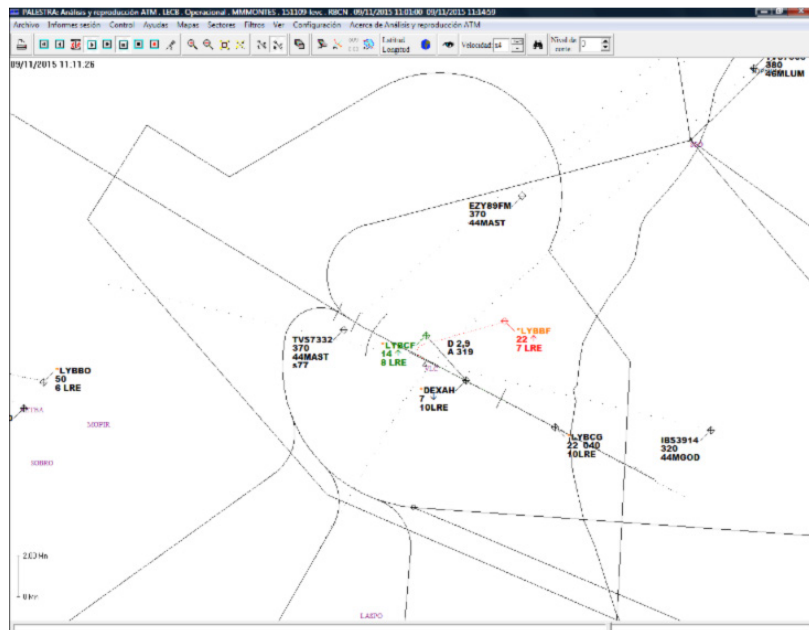
Figure 2. Positions of the aircraft at 12:11:26

At 12:11:26, LY-BCF was climbing after making its low approach and D-EXAH was continuing its approach to runway 30. At that moment, the aircraft were separated by 2.9 NM horizontally and 700 ft vertically.

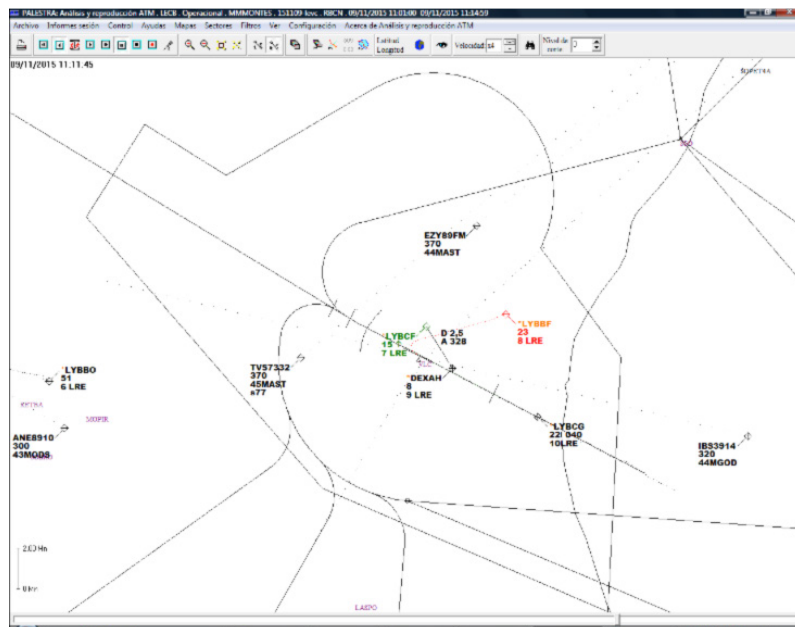
Figure 3. Positions of the aircraft at 12:11:45

At 12:11:45, LY-BCF was still climbing, while D-EXAH made a right turn to interrupt its approach to runway 30 when it was approximately 1 NM away from the threshold at an altitude of 700 ft. The horizontal separation at that time was 2.5 NM, and the vertical separation was 700 ft.

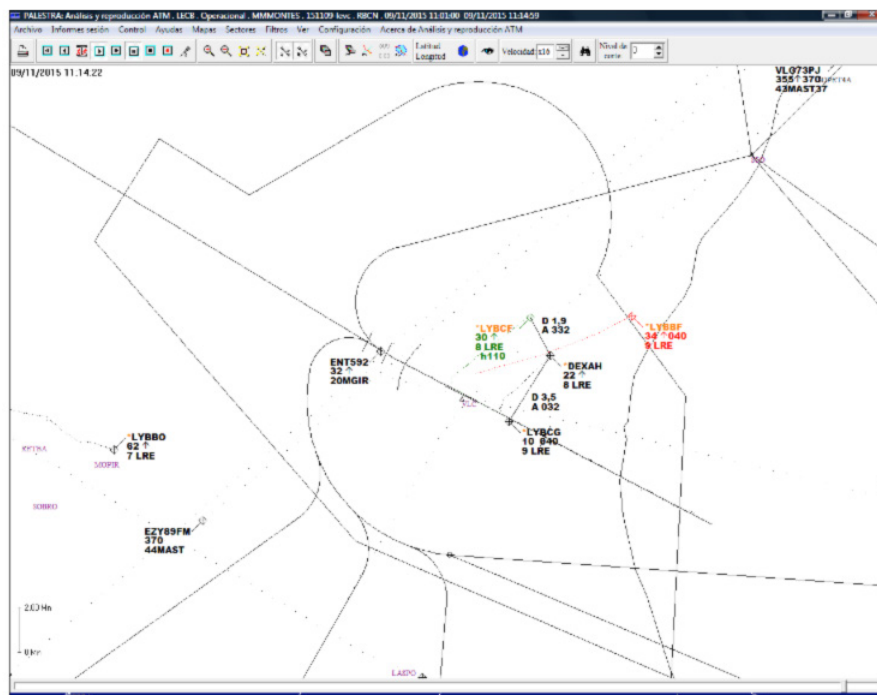
Figure 4. Positions of the aircraft at 12:14:22

At 12:14:22, the aircraft were 1.9 NM apart horizontally and 800 ft vertically. The commercial air transport aircraft (ENT592) was already taken off,

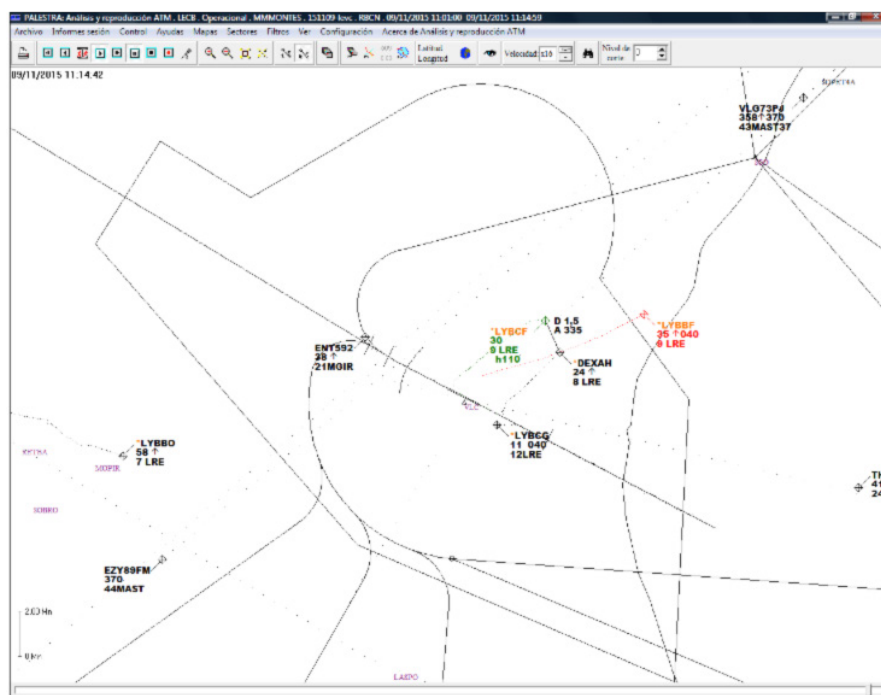
Figure 5. Positions of the aircraft at 12:14:42

At 12:14:42, the aircraft were 1.5 NM apart horizontally and 600 ft vertically.
