**COMISIÓN DE
INVESTIGACIÓN
DE ACCIDENTES
E INCIDENTES DE
AVIACIÓN CIVIL**

Report A-006/2016

Accident involving a Cessna 172 P,
registration EC-LSY, in Las Muelas,
Segura de la Sierra (Jaen, Spain)
on 9 February 2016

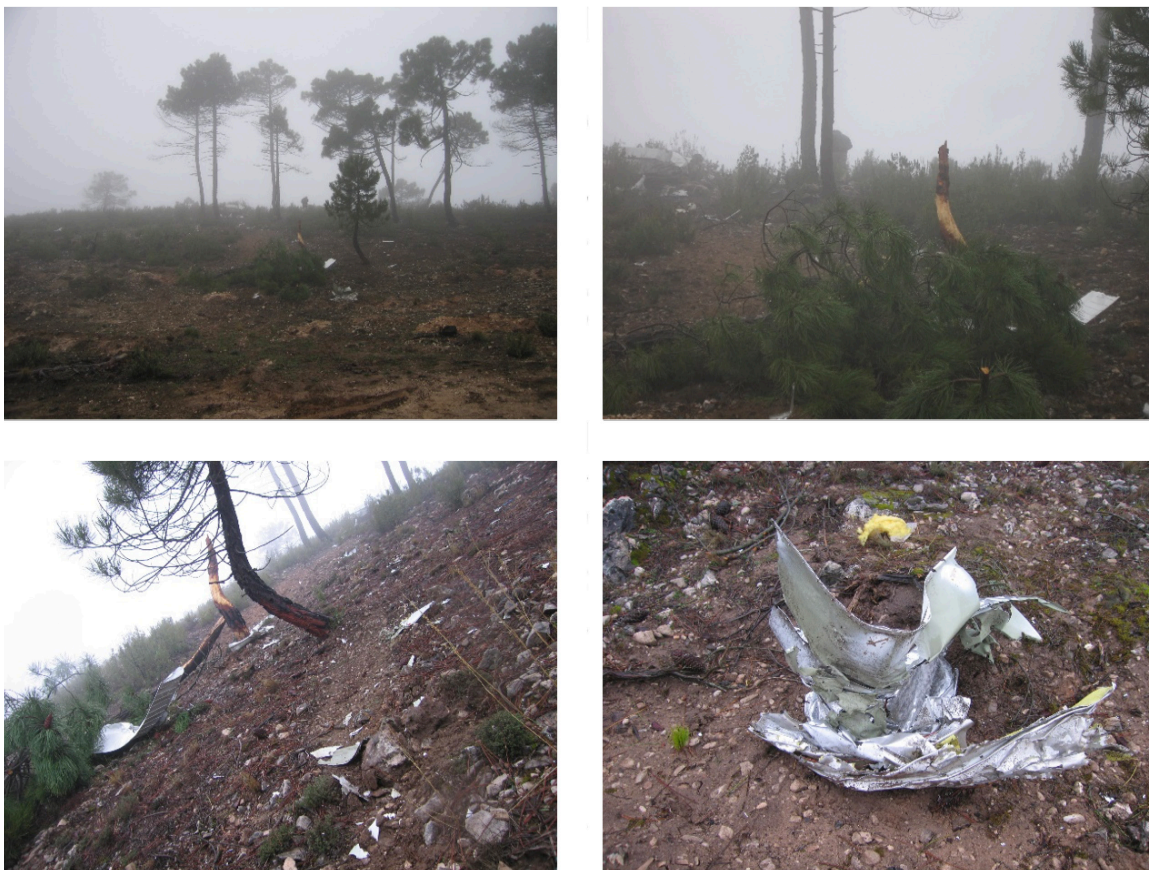
The initial impact with the ground was with the tip or outer edge of the right wing. Further ahead and to the left, the fuselage impacted a pine tree at an altitude of 1 m above the ground. The tree was cut at an angle of 45 to 60°, with the top of the tree breaking and falling backwards. On the ground next to the tree trunk was a mark left by the impact from the nose wheel. The following components were found next to the tree: right wing tip, aileron axis, right wing leading edge and part of the fuselage. Wrapped around the tree was the strut from the right wing.

Figure 17. Initial debris field

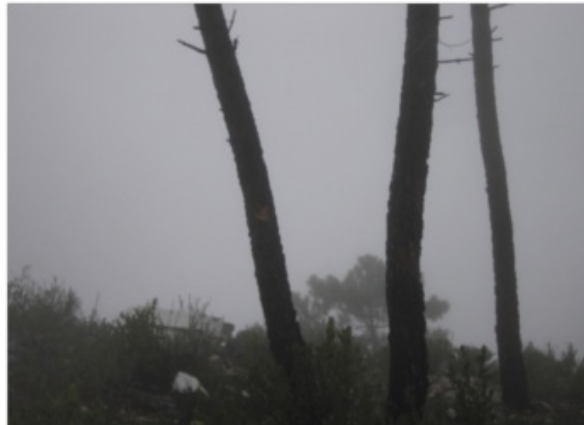
At the top of a mountain, to the left of the two pine trees mentioned earlier, was the left seat, part of the left window and a section from the part of the fuselage that has a step to climb into the airplane.

Figure 18. Second debris field

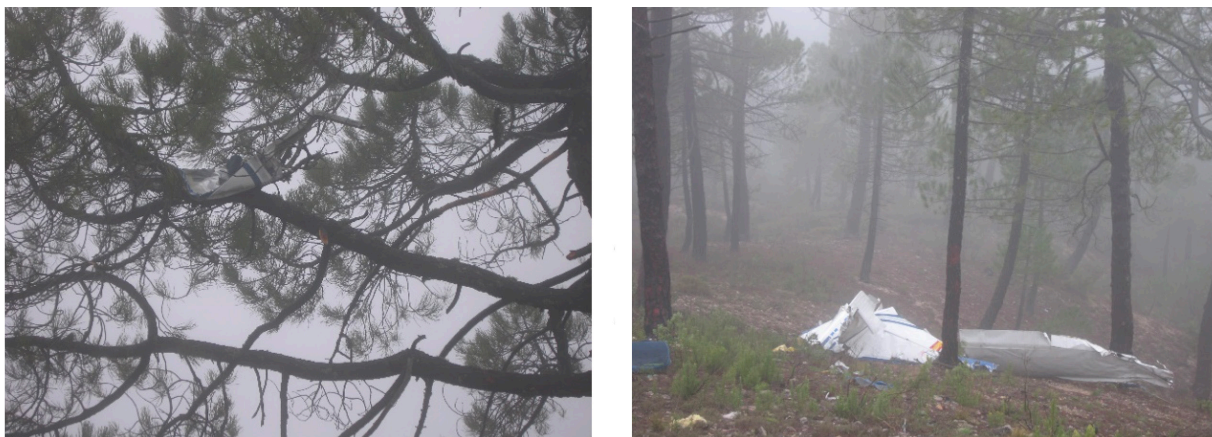
At the other side of the mountain, next to a pine tree, was the main airplane wreckage: tail section, left wing, a part of the fuselage that included the left main landing gear leg, the exhaust manifold, which was heavily damaged, and the emergency transmitter. The right fuselage door was hanging from the branches of a pine tree.

Figure 19. Main wreckage

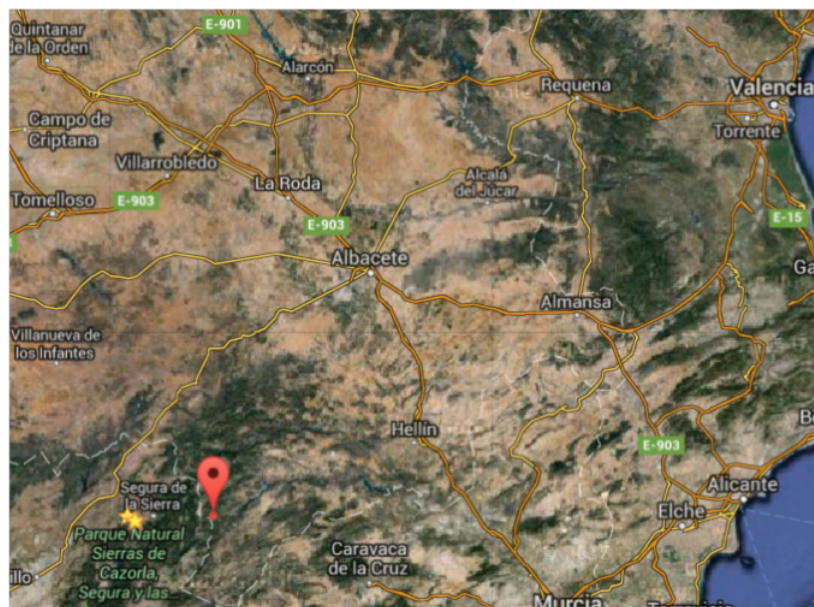
Mountain waves are particularly dangerous when flying with a headwind, as in this case. In this situation, the pilot should either avoid the mountains or fly very high. If the airplane enters an area with strong wave action, the recommended course of action is to turn around before it is too late. If the route takes the airplane parallel to a mountain range, the leeward side must be avoided, even if the mountain waves are moderate or weak.

The map below shows the aircraft's position (in red) when the pilot decided to divert to the Beas de Segura aerodrome (marked with a yellow star). At that time, the airplane was at coordinates $38^{\circ} 17' 47''$ N, $02^{\circ} 26' 04''$ W, near the town of Alcantarilla (Albacete). As the figure shows, the pilot was flying over the Natural Park of Sierras de Cazorla, Segura y Las Villas, on the leeward side, with the Beas de Segura aerodrome located on the other side of the range.

Figure 24. Aircraft's position when the pilot contacted the controller to report he was diverting Beas to de Segura

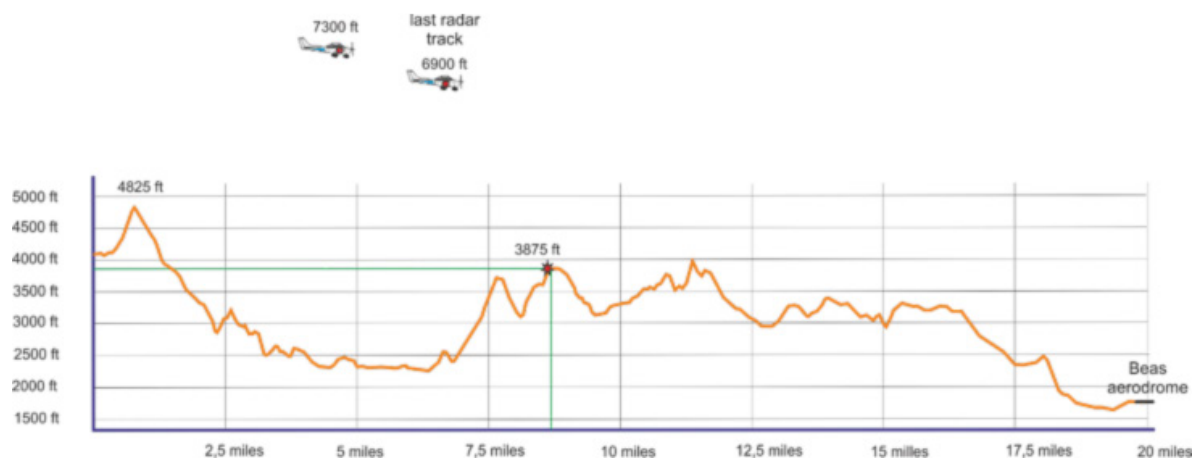
The graph below shows the final moments of the aircraft before it crashed into the mountain. Based on the last radar position, it was flying at an altitude of 6900 feet and it impacted the mountain at an elevation of 3875 feet, meaning it descended 3025 feet (922 meters) in approximately 2.5 miles (4 km).

Figure 25. Aircraft's position in the final seconds of the flight

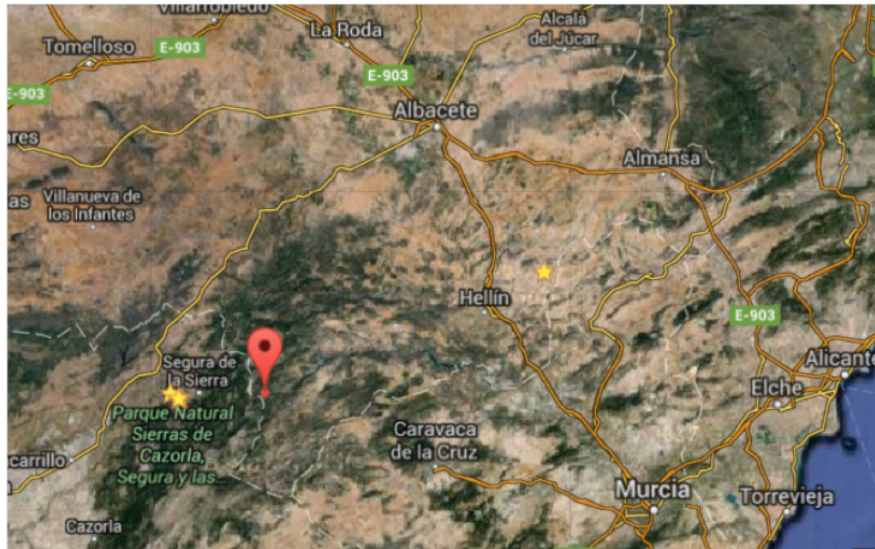
Given the weather conditions, with mountain waves in the east, the best option would have been to select the alternate aerodromes of Almansa and Ontur, which are not in mountainous areas.

The figure below shows the position of the aircraft in red when the pilot decided to divert to the Beas de Segura aerodrome, and the locations of the Beas de Segura and Ontur aerodromes (both marked with a yellow star).

Figure 26. Positions of the Ontur and Beas de Segura aerodromes

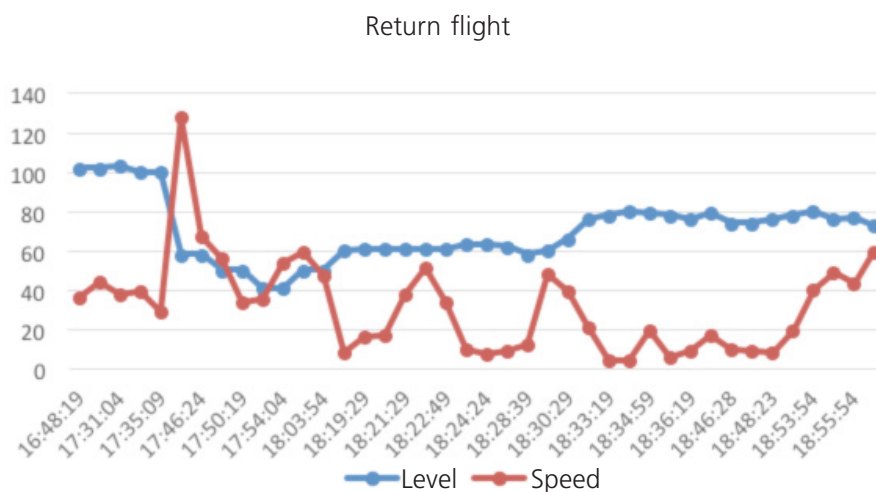
Figure 28: Flight level and speed on the return flight

The average cruise speed before the pilot contacted the controller to report his intention to divert to Beas de Segura was 48 knots. This transmission was made at 18:13:33, by which time the pilot had been flying for 2:13 hours. Between then and the time of the accident, the average speed fell to 23 knots, meaning that diverting to the Beas de Segura aerodrome and changing the heading resulted in the wind braking the aircraft even more.
