Report IN-007/2016

**Incident involving a Boeing 737-800 aircraft,
registration LN-NHG, operated by Norwegian,
and a paraglider, on the approach to the Malaga
airport (Spain), on 12 March 2016**

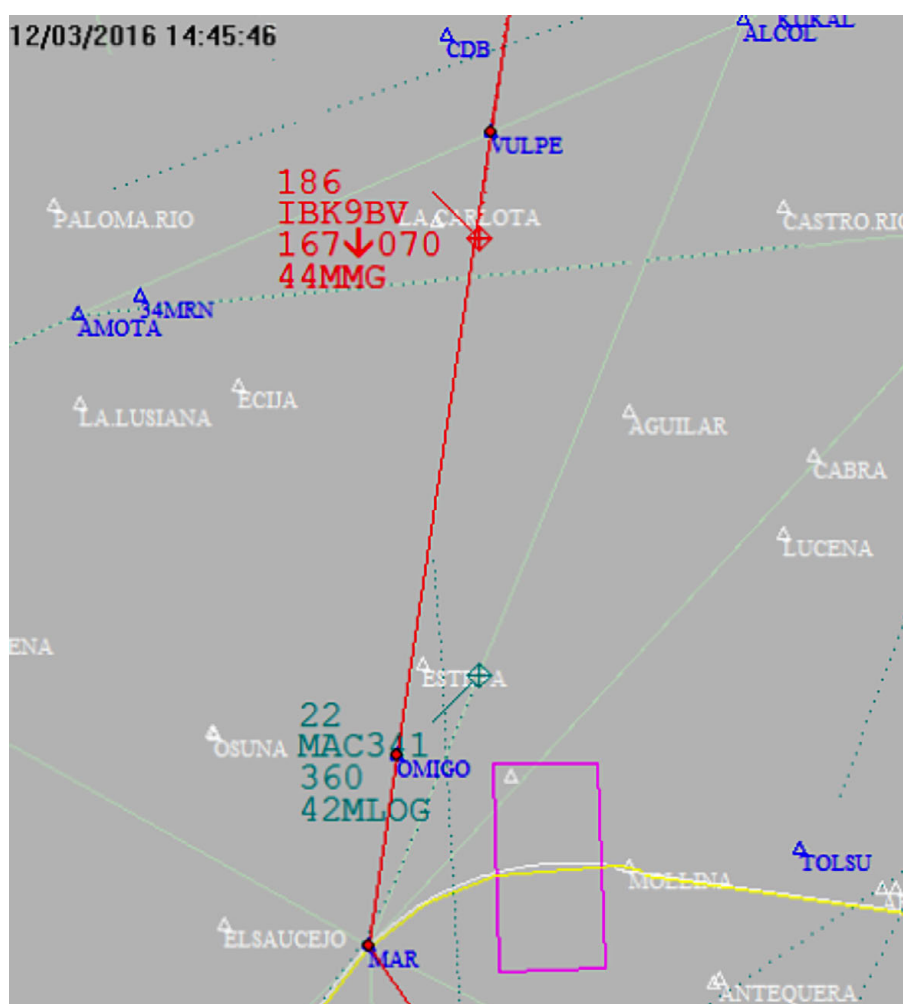
Figure 1 shows the aircraft established on the initial segment of the approach to runway 13, proceeding to point OMIGO on heading 186 and cleared by ATC to descend to FL 70.

Figure 1. Flight IBK9BV on approach

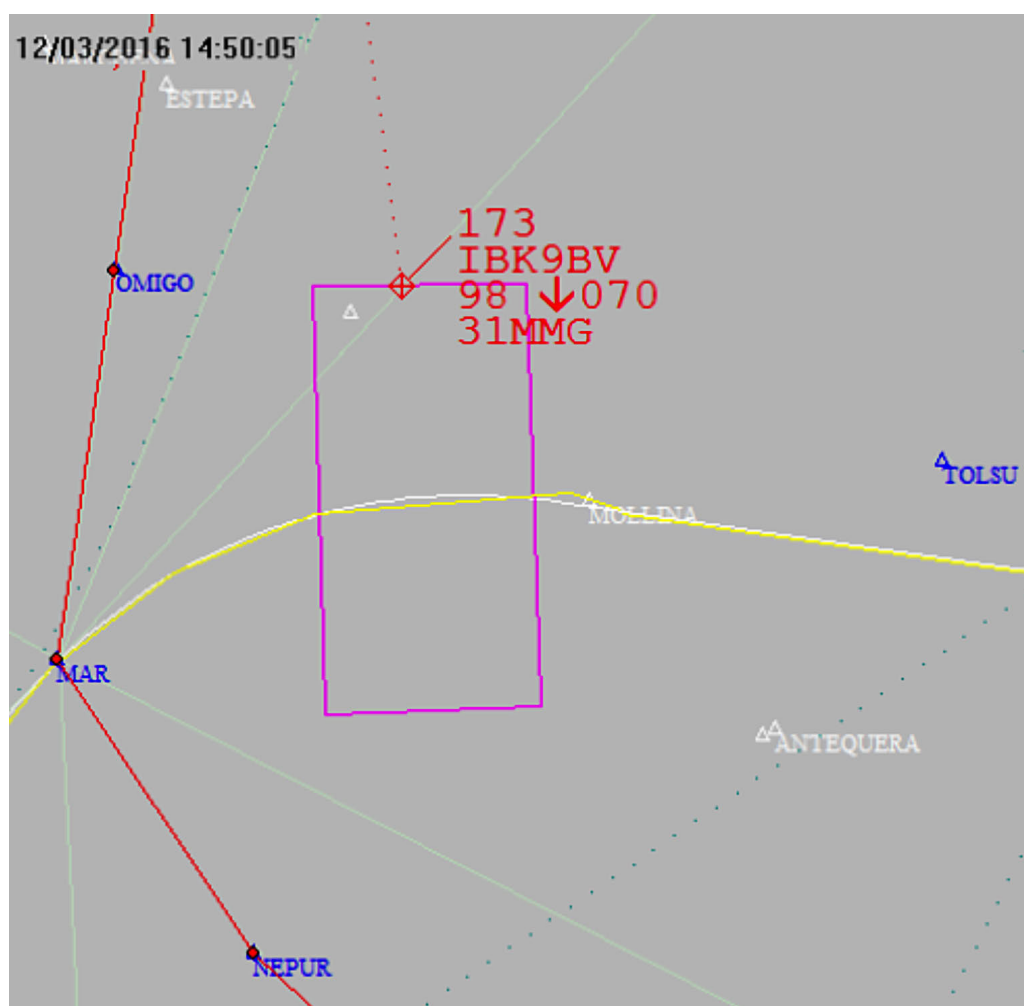
They then requested to proceed to short final, and were cleared by APP to 15 NM, as shown in figure 2.

Figure 2. ATC cleared direct to ILS RWY 13

At 14:45:57 it was cleared by APP to proceed on final at 15 NM and at 14:50:05 it descended to 5,500 ft to intercept the runway 13 ILS. The aircraft started the descent as shown in figure 2.

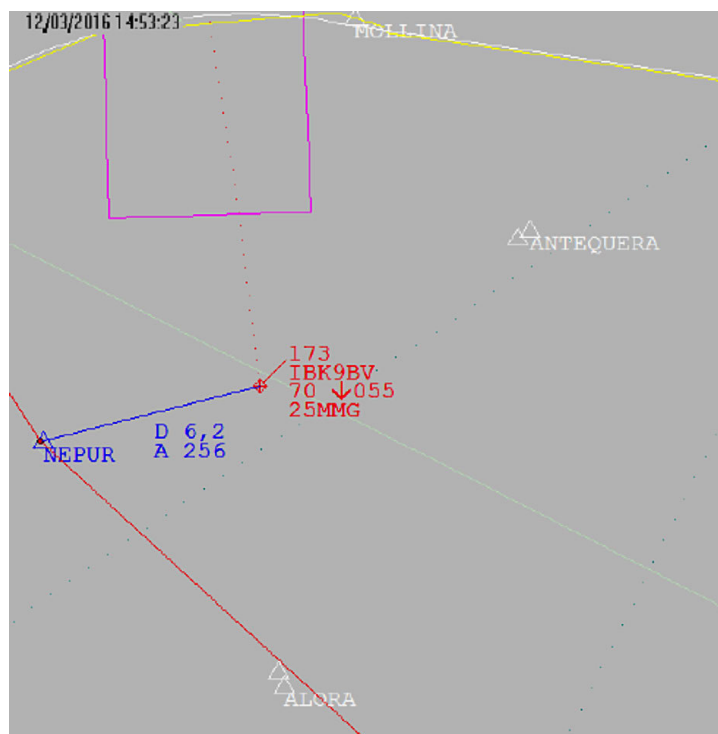
At 14:53:23, while continuing to descend on heading 173, the crew reported to APP control the presence of a paraglider in front of the aircraft. Figure 3 shows that their approximate position at that time was 6.2 NM east of point NEPUR at an altitude of about 7,000 ft.

Figure 3. IBK9BV reports presence of paraglider

At 14:53:23 the crew detected a paraglider in their way, and as a result the pilot made a right turn to avoid it, as is evident from a comparison of figures 3 and 4. These images show how the aircraft altered its heading from 173 to 191 due to this turn, as indicated by the captain in his statement. According to the report made by the crew, they were at an altitude of 6,800 ft. The paraglider was not detected by the radar and thus was not recorded in the images, meaning that its position can only be estimated based on the information provided by the crew.

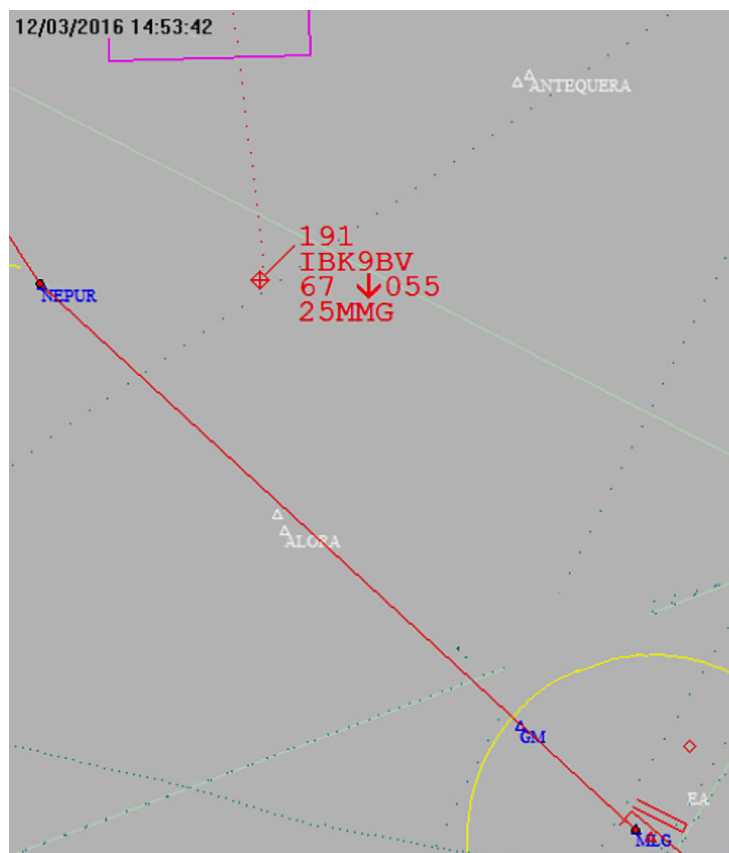
To avoid colliding with the paraglider, the pilot made a right turn. Figure 4 shows the change recorded in the radar tag for the aircraft's heading as a result of the turn.

Figure 4. Change in aircraft's course

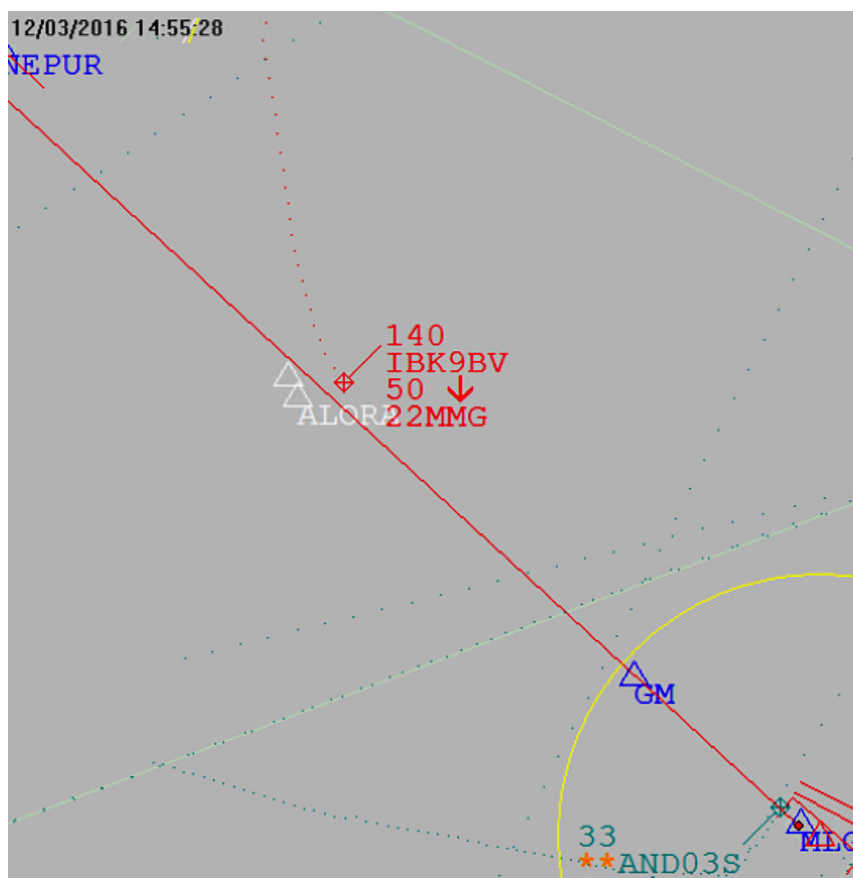
Figure 5. IBK9BV joins the final segment of the approach

After the incident, the crew resumed the flight until they intercepted the runway 13 localizer. They then completed the approach and landing normally.
