CIAIAC

Report A-011/2016

Accident involving a
SCHLEICHER ASK 23 aircraft,
registration G-DEVY,
in Meranges (Girona, Spain),
on 14 April 2016

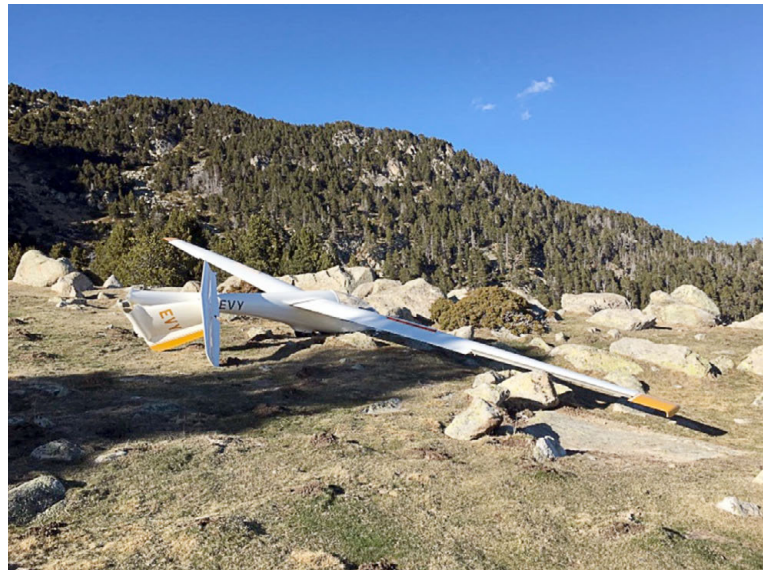
Figure 1. Aircraft after the impact

The pilot was seriously injured by the impact and the aircraft sustained heavy damage.

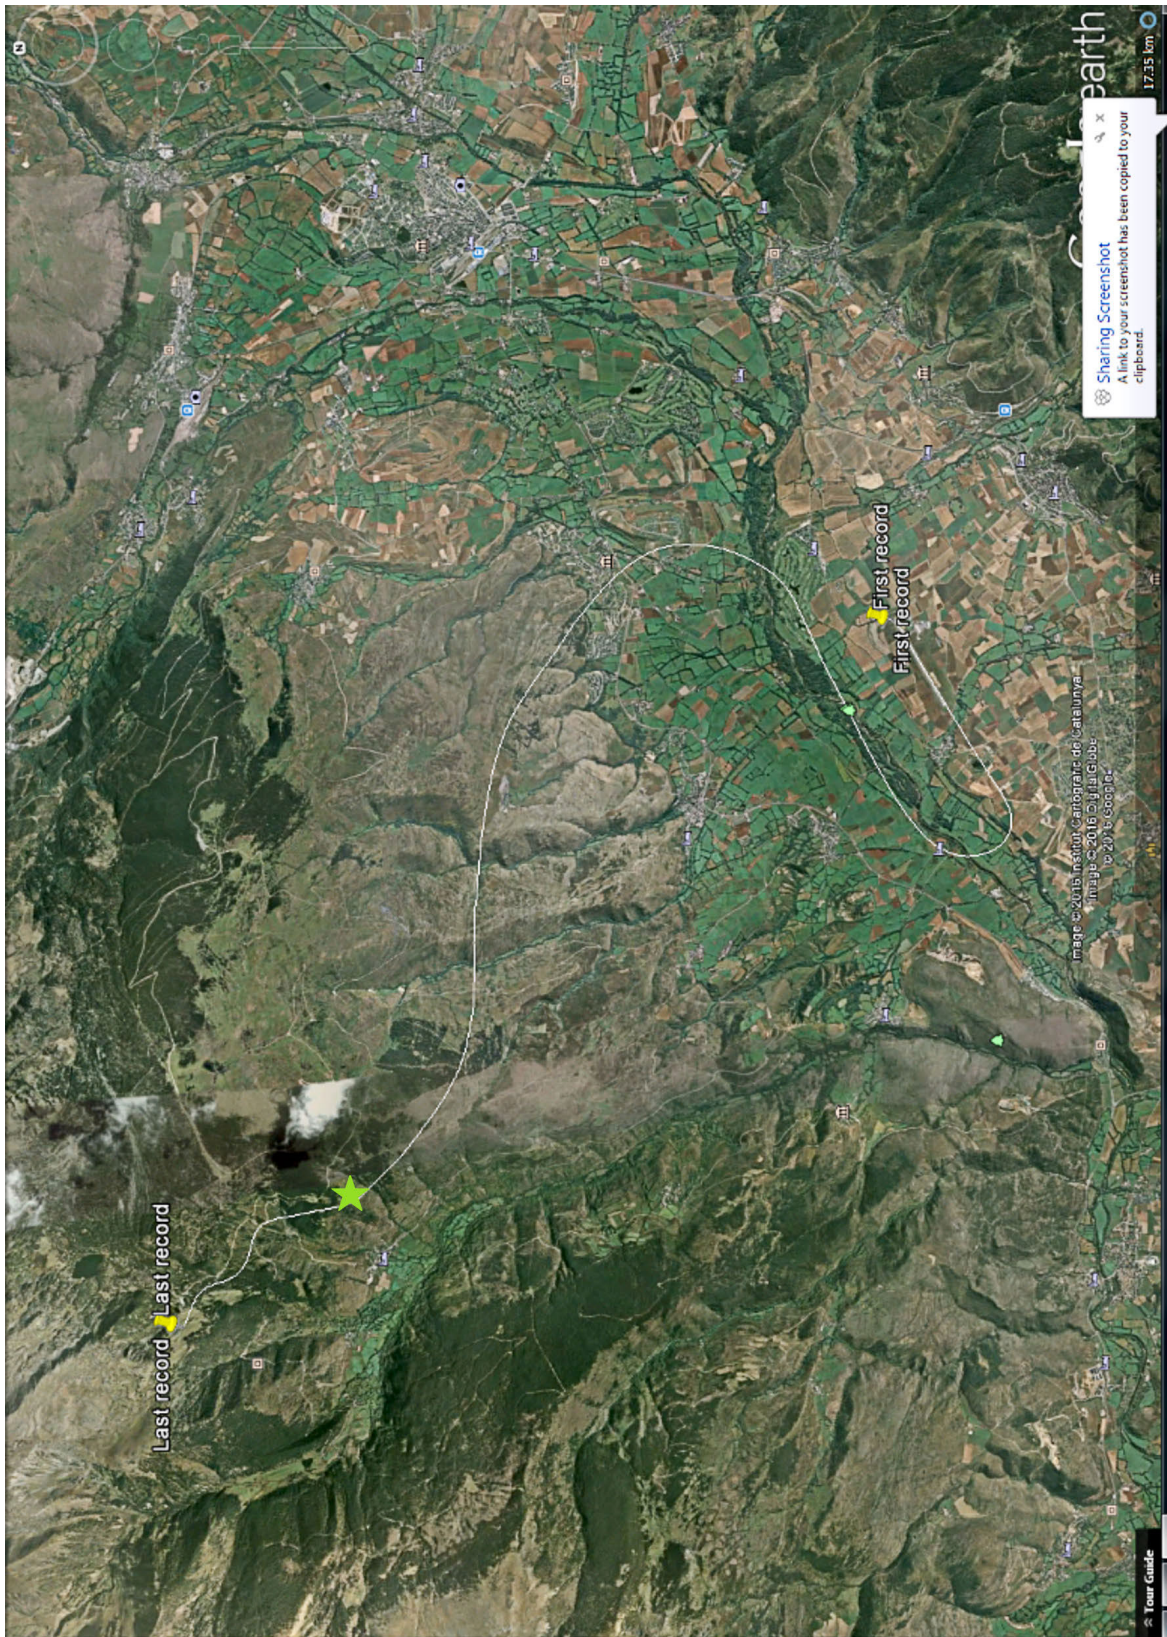
Figure 2. Aircraft's route

This file yielded the route shown in Figure 2:

At the top of the figure is the point where the system first started to record data, this being the La Cerdanya aerodrome, and the last point recorded by the system is at the bottom.

The green point indicates the instant when the glider released the towrope. This point is about 20 seconds from impact

As Figure 2 shows, the pilot took off and released the towrope without any problems. From that point he flew north toward the mountains to practice the ridge lift technique, but he made practically no turns. This means that the aircraft likely lost energy and the pilot was forced to make an off-field landing.

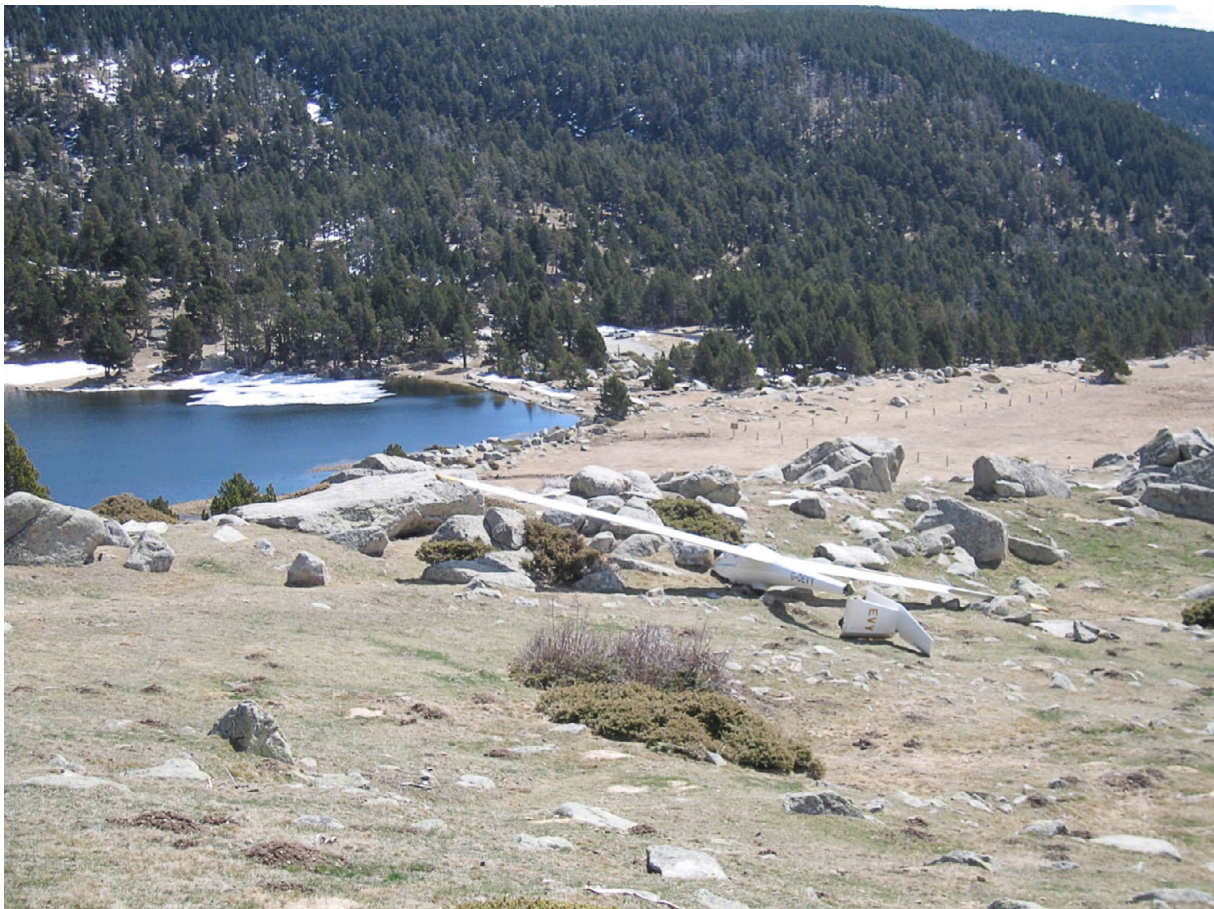
Figure 3. Crash site

It is probable that the pilot tried to reach a field that was beyond this rocky area (see Figure 3). This area is much lower and has practically no obstacles, which would have made it suitable for an off-field landing. The aircraft may not have had sufficient energy to remain airborne and reach this area, and as a result, it ended up impacting the rocks.

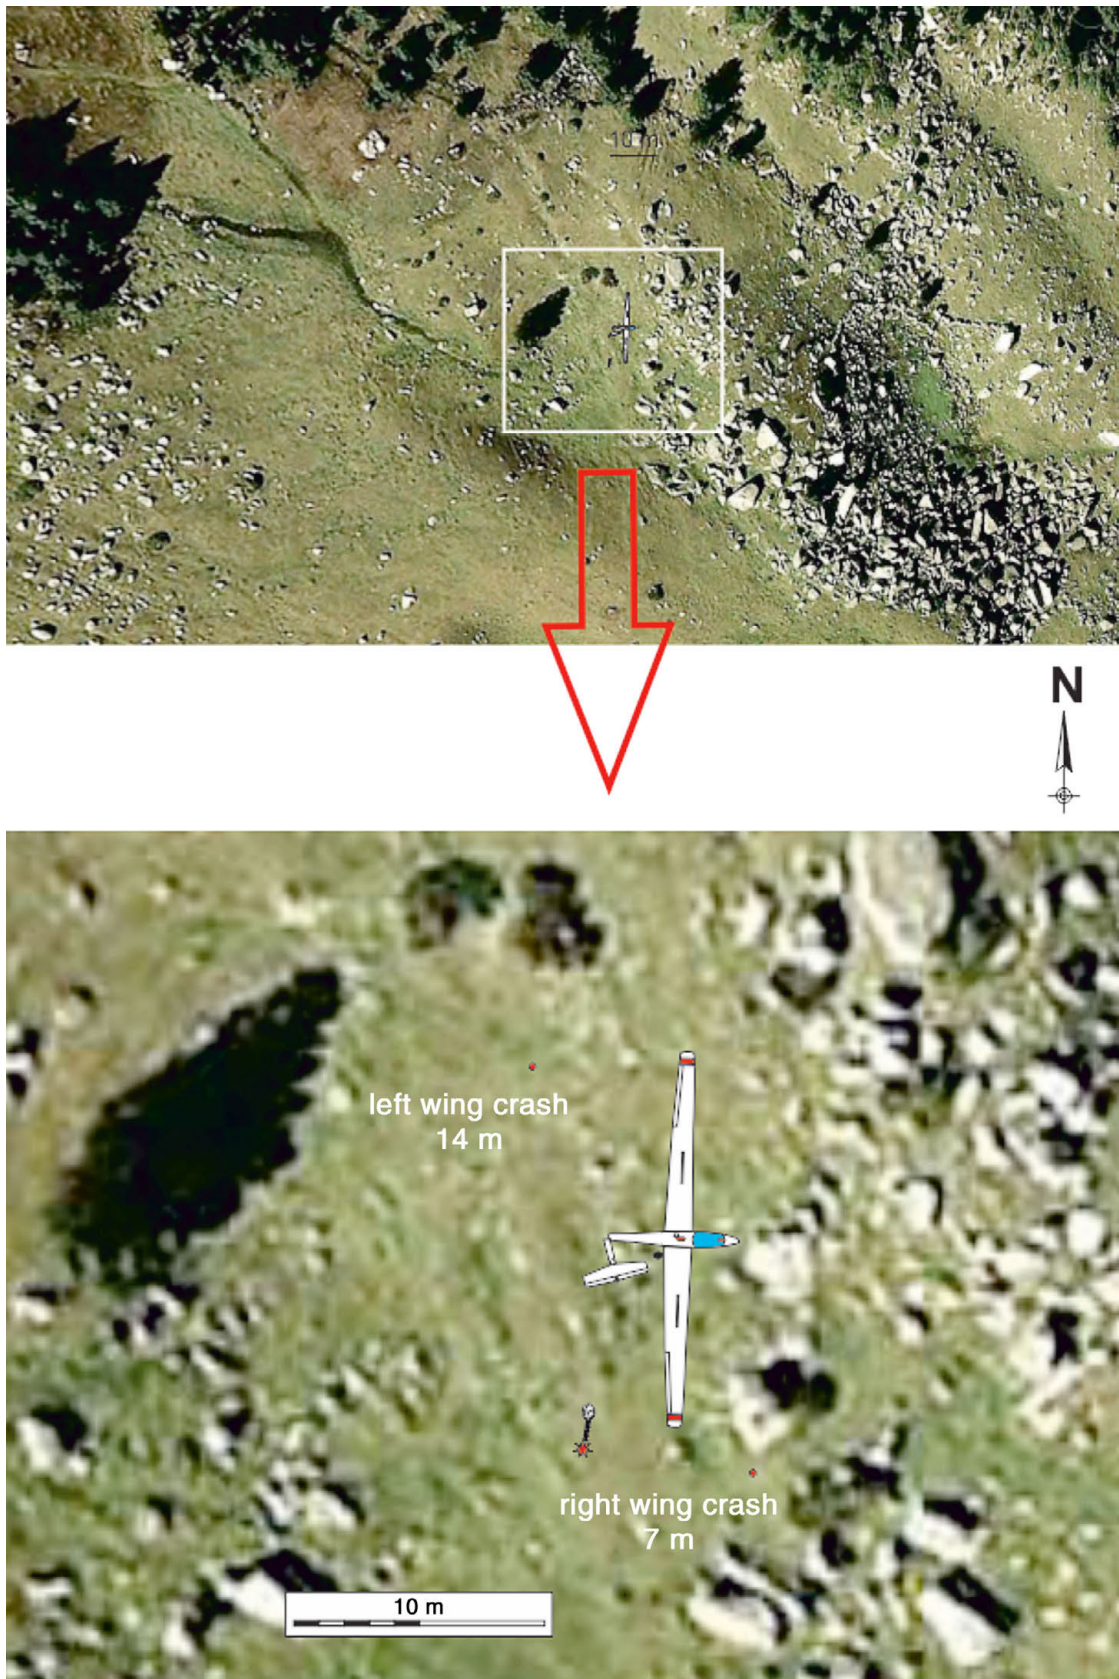
Figure 4. Aircraft wreckage

The aircraft initially impacted the ground (shown with a red star in Figure 4) when the right side of the nose struck a rock weighing some 70 kg. This impact moved the rock from its location and left blue marks on it, matching the paint on the nose of the aircraft.

After this impact, the aircraft began to move sideways, as a result of which its left wing struck another rock. During this time the nose wheel on the landing gear impacted another stone, which penetrated the cockpit. The main gear wheel slid on the ground until it struck a rock, where it came to a stop.

The left wing had marks on the outboard third of the leading edge, and in the same area on the lower wing surface.

The right wing also had marks on its lower surface and it was shifted forward with respect to the airframe in the area of the wing root. There was a fracture that spanned from the leading edge to the middle of the wing, some 15 centimeters away from the root.

Both air brakes were exposed, but not completely deployed.

The cockpit floor had given way, shifting inward. The trim lever was in a nose up position and the air brake lever was in its forward-most position, without engaging the nose wheel brake.

The aft part of the fuselage broke symmetrically about the longitudinal axis of the aircraft. As a result, the tail fell forward on the right side of the aircraft.
