## **Report IN-012/2016**

Incident involving a Boeing  
737-700 aircraft, registration  
PH-XRZ, operated by Transavia  
Airlines at the Barcelona-El Prat  
Airport (Spain) on 17 April 2016

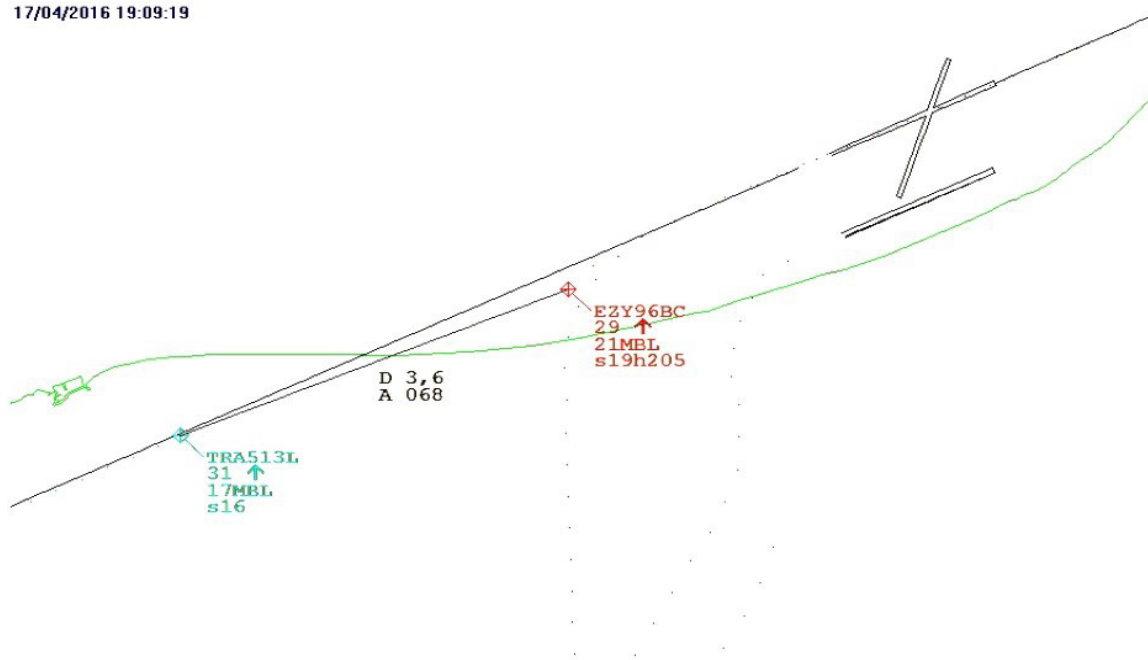
17/04/2016 19:09:19

At 19:09:43, the two aircraft reached their minimum separation, 2,2 NM and 500 ft. At that time they were on diverging headings.

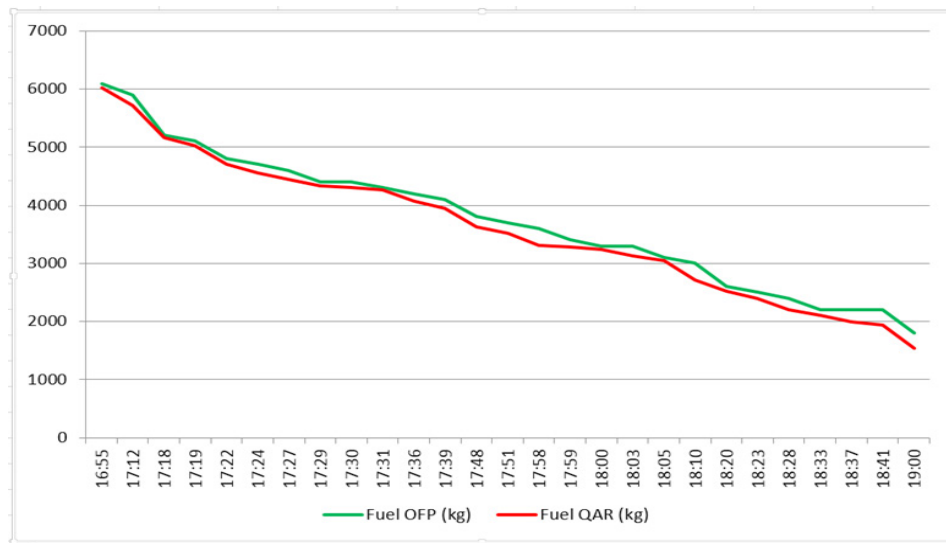
The figure shows the difference in the fuel values present at different points during the flight between those specified in the OFP and those logged by the QAR. Notice that the fuel remaining onboard was consistently below the planned amounts.

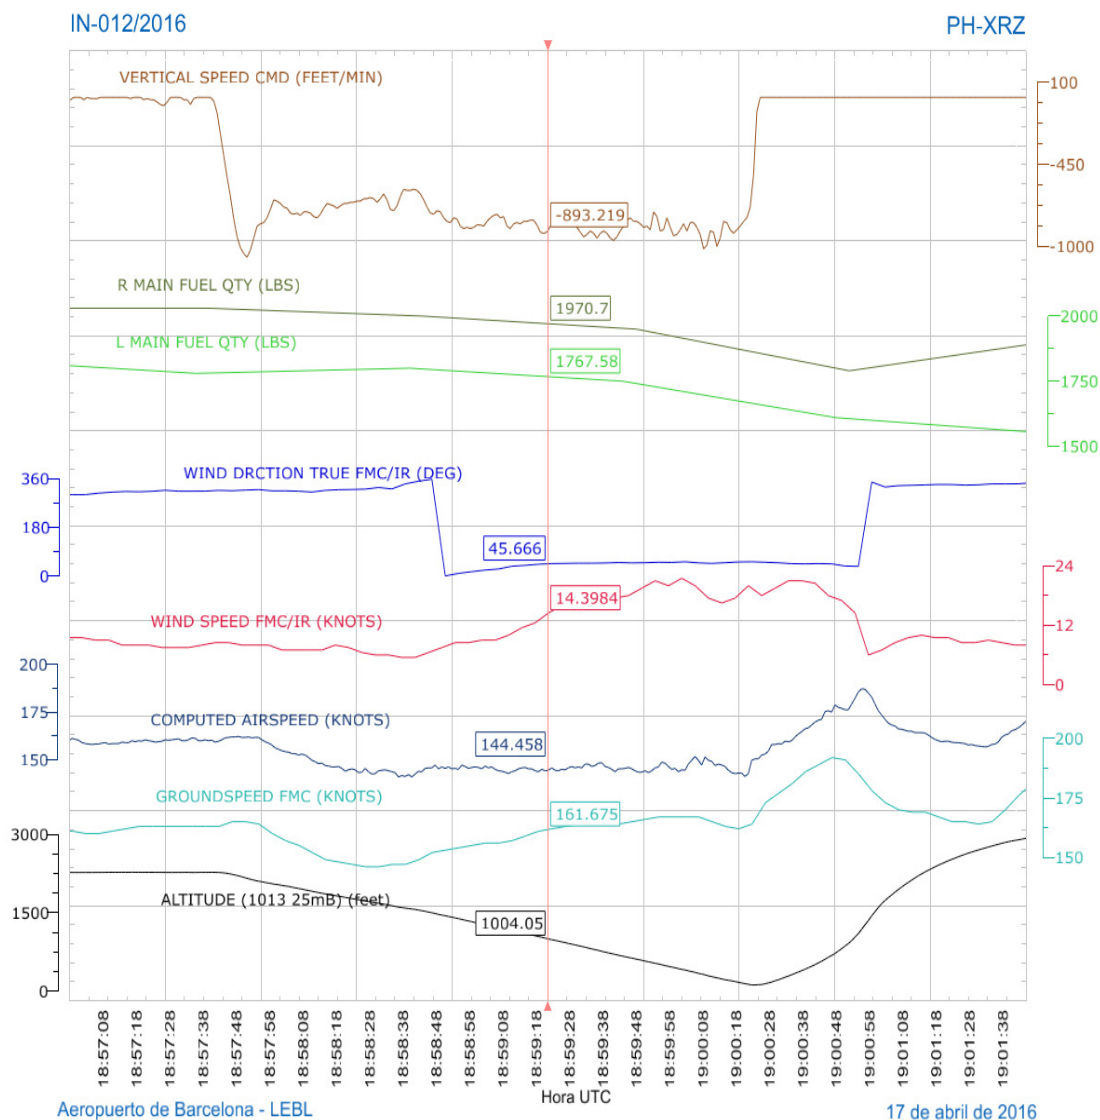
## GO AROUND MANEUVER

As the graph shows, the wind speed and direction, as detected by the FMC, varied drastically.

At 18:58:41, there was an increase in the wind speed, which reached a maximum value of 22 knots from 053° at 19:00:01. The wind also shifted from its previous direction, which had been 315°.

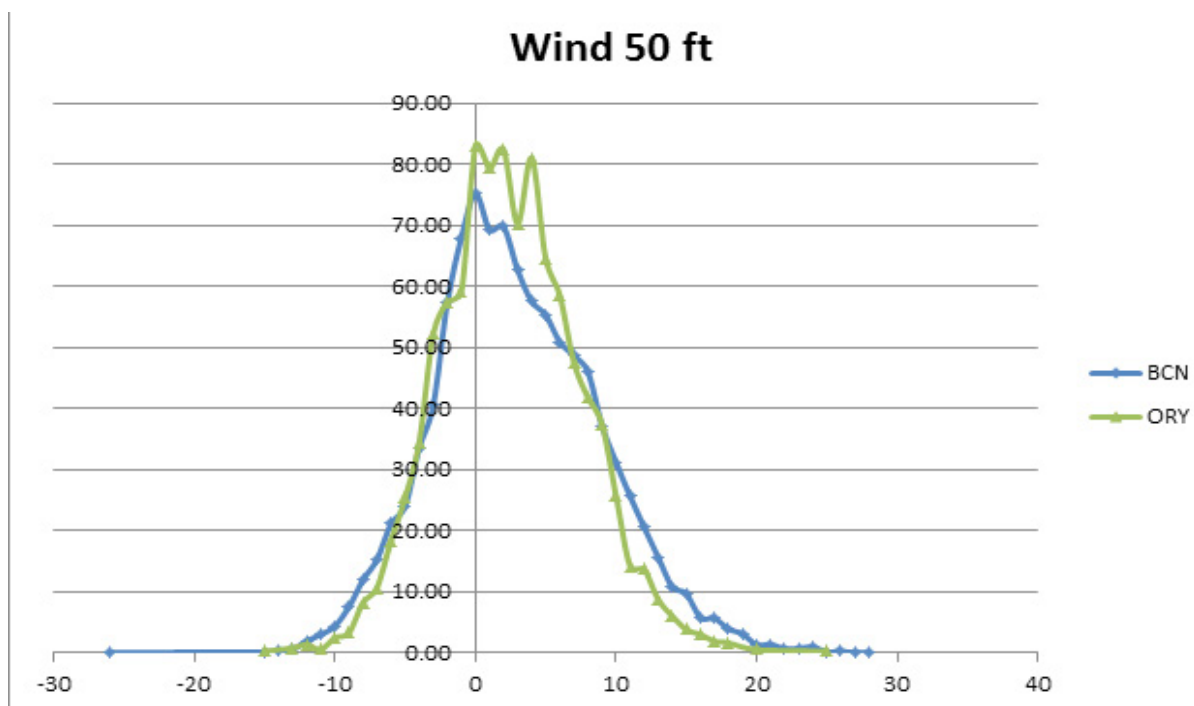
Figure 7.- Comparison of landing statistics based on tailwind component at the Barcelona and Paris-Orly airports.

These statistics (Figure 7) show that the number of landings made in Barcelona with a tailwind component in excess of 10 kt was around 5%, versus less than 1% at Paris-Orly.
