Report A-016/2016

Accident involving a Robin DR-400-180
aircraft, registration F-GXBB,
in the town of Arbizu, Navarre (Spain)
on 19 May 2016

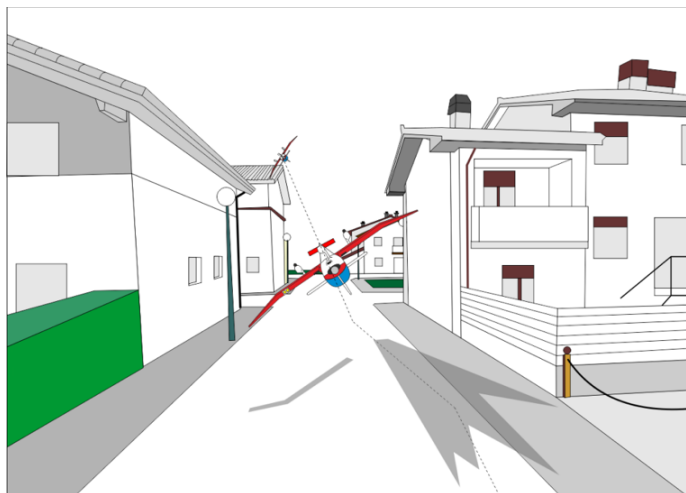
Figure 2. Diagram of the aircraft's trajectory and attitude on impact.

The first impact mark left by an airplane component was found on the eaves of a rooftop of a three-story house in Arbizu, from which a small number of shingles had broken and detached.

On the asphalt ground of a street in the town, a few meters beyond the first house, there was a mark from a strong impact left by a metallic component, along with

blackened traces of oil. The inlet angle indicated by the line connecting the first two impact points yields an angle with the horizontal of 45 to 60°.

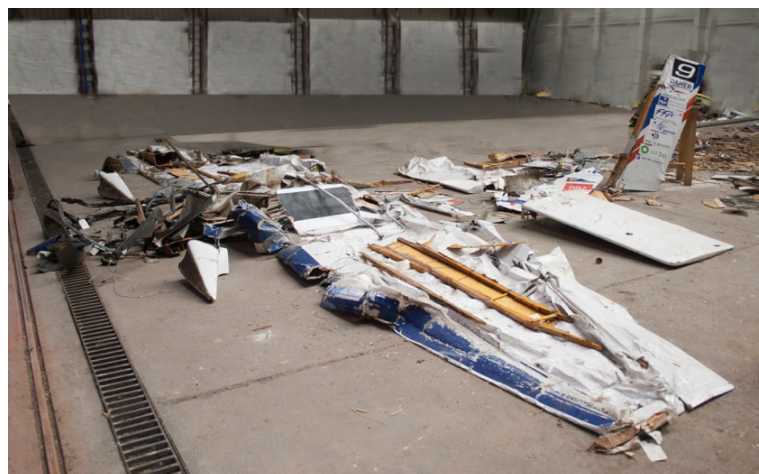
Figure 3. Two-dimensional reconstruction of the wreckage.

All of the pieces of fabric covering the wings were located and identified. They accounted for the entirety of the wing surface, with no wing parts missing. The damage to the structure of the wing, made mostly of wood, was significant and allowed for a very limited two-dimensional reconstruction. This reconstruction, however, revealed that there were no components missing, which indicates that no components detached from the airplane prior to impacting the ground.

Of note during the reconstruction of the wing structure is the fact that the least damaged structural component was the box for the main outboard beam on the right wing, in the zone where the wing's dihedral angle increases. The greater integrity and less damage to that structural element could well indicate that the outboard part of the right wing did not preserve its structural integrity upon impacting the ground. This is also consistent with the absence of a clear wing imprint at the impact point with the ground (on the side wall of a house on the left side of the airplane's direction of motion, and considering that the outline of the left wing was on the right side).

The majority of the control surfaces on the tail section (horizontal and vertical stabilizers and elevators) was found less damaged and with no signs of a concentrated impact or partial detachment, with the exception of the fin, from which significant debris was identified with that was more heavily damaged.

The investigation of the aircraft wreckage also revealed, thanks to the minor damage found on the outboard third of the main beam on the right wing, and given the extreme damage to this wooden beam, the possibility that the tip of this wing had lost its structural integrity before the aircraft crashed into the ground. This wing would thus not have provided as much lift, which would explain the relatively lesser damage it exhibited. This possibility also agrees with the fact that the right wing left no discernible mark on the ground, as well as with the airplane's inverted attitude. In contrast, most of the leading edge on the left wing left a mark on the ground.

Although a combination of these findings means that the vulture most likely impacted the airplane at the midpoint of the airplane's right wing, negatively affecting the structural integrity of said wing, what is certain is that the condition of the wreckage and the absence of organic matter from the bird on the parts examined made it impossible to determine the exact area where the vulture impacted the airplane; or whether, due to the impact, it caused the pilot to lose control of the airplane, resulting in the airplane impacting the ground upside down at a high angle of attack.

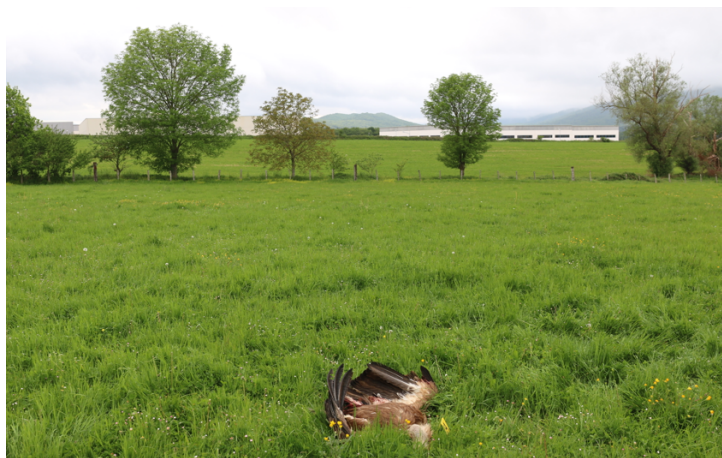
Figure 4. Carcass of the griffon vulture found in Arbizu.

The distal part of the bird's right wing had been amputated at the metacarpals, there was an open wound in the abdomen and trauma. No buckshot was found and there were no signs of disease.

With its wing cut, the vulture could not maneuver. The open abdominal wound seemed to be associated with the strike/impact and the primary cause of death. The severed distal part of the wing accounted for one-third of the wing's length and weighed about one kilo. The vulture's total wingspan would have been in the two-meter range. It was a healthy male with a total estimated weight of 6.5 kg.

The forensic study of the bird indicated the possibility that one of its wings, the end of which was severed, could have struck the airplane's propeller, while the abdominal wound, identified as the main cause of death, seems to have been associated with the impact with the aircraft.

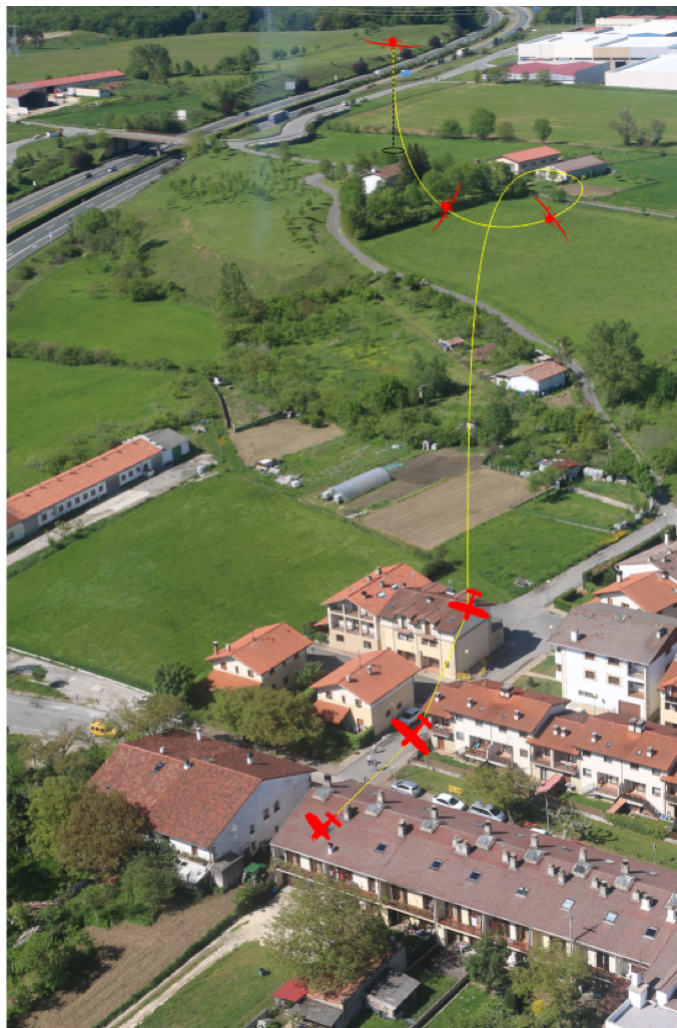
Figure 5. Trajectory after striking the griffon vulture.

After a certain moment, which, according to the eyewitnesses, was the impact with the vulture, the aircraft followed an erratic trajectory both horizontally and in terms of its steep descent. The aircraft crashed to the ground at a high speed and angle of attack, meaning the energy of the impact was very high. Moreover, the area where the airplane impacted the ground contained resistant surfaces and vertical walls made of construction materials, resulting in a large deceleration. These conditions of the aircraft's impact reduced the likelihood of survival of the aircraft's occupants.

In zone a), which included the entire right wing, no traces of organic material from a bird were found. In the area where the dihedral angle changes, which is where a crack was found in both the skin and the structure, and which was thus considered to be the most likely impact zone, nothing was found.

In zone b), no traces were found of organic material on the metallic propeller, which was to be expected since one of the vulture's wings was severed.

Similarly, no organic material from a bird was found in zone c).

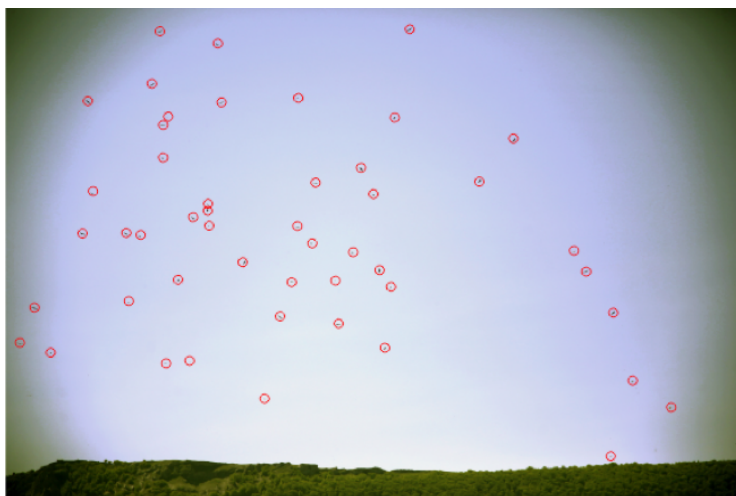
Figure 7. Griffon vultures present in the sky over Arbizu the day after the accident

Based on direct sightings by eyewitnesses and investigators on the day of the event and on subsequent days in the county of Barranca/Sakana, most of the griffon vultures in this area were gliding in the skies over the towns of Arbizu and Echarri-Aranaz, possibly due to the uplift conditions present. The number of specimens present was estimated at around 200 (Figure 6 shows

In these conditions, as they were continuing through the valley, the crew of the aircraft encountered a large number of gliding vultures covering much of the sky over the valley. As investigators confirmed at the location, with so many large birds in the aircraft's path, it was likely that the aircraft would impact a bird that was unaware of its presence.

REC 05/18: It is recommended that the Ministry of Agriculture and Fishing, Food and the Environment boost and coordinate actions to minimize the excessive concentration and proliferation of griffon vulture (*Gyps fulvus*) colonies with the autonomous communities and for the whole of the on Spanish territory affected.
