**COMISIÓN DE
INVESTIGACIÓN
DE ACCIDENTES
E INCIDENTES DE
AVIACIÓN CIVIL**

Report ULM A-016/2016

Accident involving a RANS S6 Coyote II aircraft, registration EC-YDQ, in the vicinity of the "Los Garranchos" airfield (San Javier - Murcia, Spain) on 15 July 2016

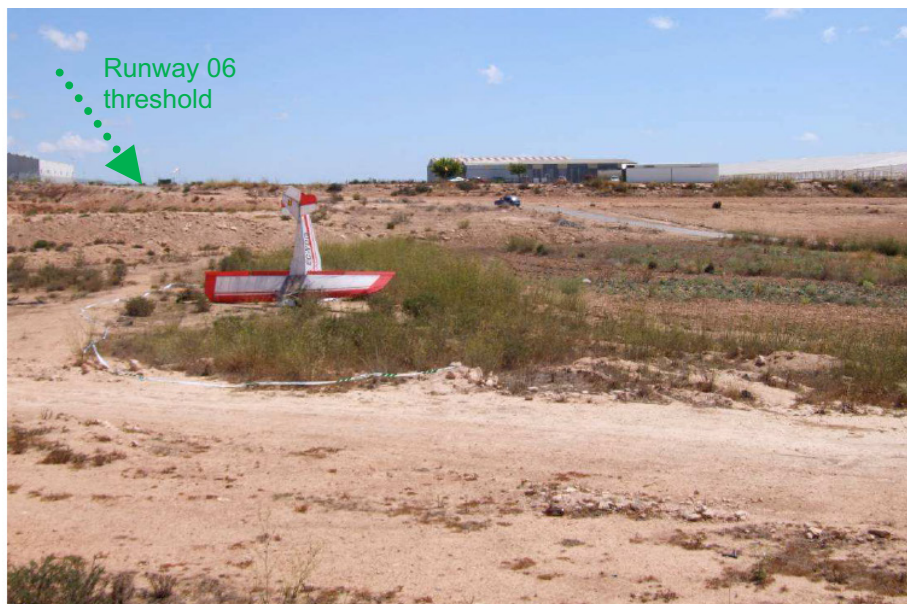
Figure 1. Aircraft after the accident

The aircraft was found in the vertical position with the nose touching the ground and the tail in the air in a nose-down attitude. It was at coordinates 37° 50' 41.33" N and 0° 52' 54.95" W and facing 280° (opposite heading to the flight path it was taking to reach the runway, see *Photograph 1 and Appendix 1*). The main wreckage was confined to a small area. A few centimeters away were wooden fragments from the propeller. The inside of the cockpit was crushed and the control panel broken.

All of the control surfaces were in good condition. The cables and control linkages were visible, provided continuity and moved freely. The flaps were not deployed and the right aileron was deflected upward, though it could have been moved into this position by the impact or when the pilot attempted to exit the aircraft.

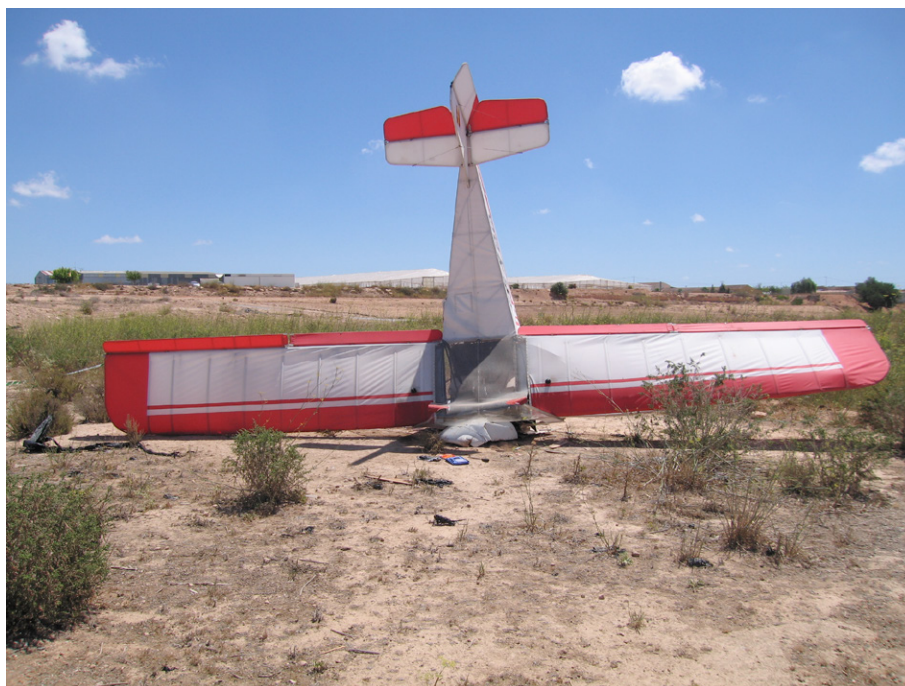
Figure 2. Aircraft after the accident before GEDEX personnel took any actions

The aircraft was seriously damaged. As a result of the efforts made by Murcia GEDEX² personnel to deactivate the ballistic parachute, the aircraft caught fire and was destroyed.

The aircraft had a ballistic parachute that had not been deployed. The activation handle has been secured by the flight manager from the Ontur aerodrome with a wire acting as the safety pin. Subsequently, the Murcia GEDEX personnel decision to carry out a controlled explosion of the parachute caused a fire that burned the aircraft.
